**Hazardous Materials Risk Assessment**  
**Abacus**  
**Goods Shed North**  
**710 Collins Street, Melbourne VIC 3000**

**Site Reference: APS-PRO-059**

**Our Reference : C107307 : J144435**

**Date: January 2017**

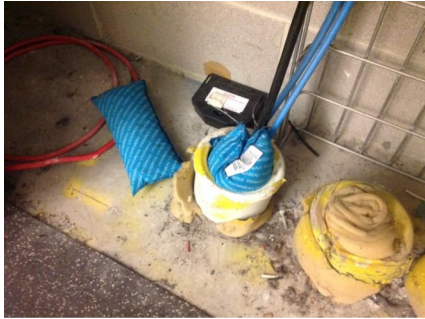
PHOTO NO.: J144435-APS-PRO-059-PHOTO010  
 RESULT: SMF - POSITIVE  
 BUILDING/LEVEL: 710 COLLINS STREET (GOODS SHED NORTH) - ALL LEVELS  
 ROOM/LOCATION: ELECTRICAL RISERS - GENERAL THROUGHOUT  
 FEATURE/MATERIAL: PENETRATIONS - PILLOW INSULATION  
 SAMPLE NO.: -

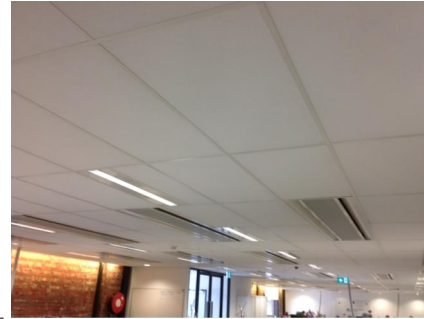
PHOTO NO.: J144435-APS-PRO-059-PHOTO008  
 RESULT: SMF - POSITIVE  
 BUILDING/LEVEL: 710 COLLINS STREET (GOODS SHED NORTH) - ALL LEVELS  
 ROOM/LOCATION: OFFICE AREAS - VARIOUS THROUGHOUT  
 FEATURE/MATERIAL: CEILING TILES - COMPRESSED CEILING TILES  
 SAMPLE NO.: -

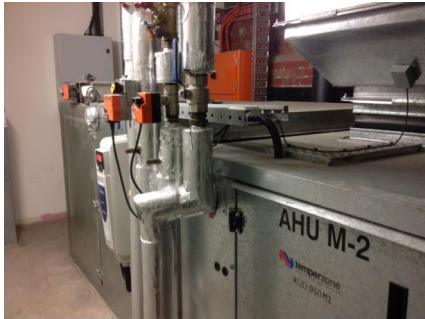
PHOTO NO.: J144435-APS-PRO-059-PHOTO017  
 RESULT: SMF - POSITIVE  
 BUILDING/LEVEL: 710 COLLINS STREET (GOODS SHED NORTH) - GROUND LEVEL  
 ROOM/LOCATION: AIR HANDLING PLANT ROOMS X 6 - THROUGHOUT  
 FEATURE/MATERIAL: PIPEWORK INSULATION - SARKING INSULATION  
 SAMPLE NO.: -

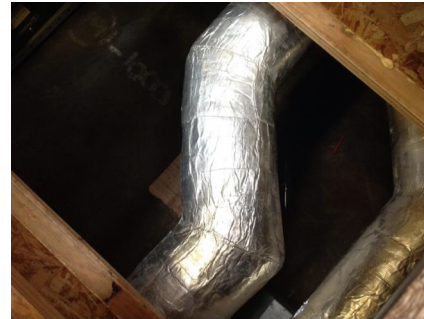
PHOTO NO.: J144435-APS-PRO-059-PHOTO018  
 RESULT: SMF - POSITIVE  
 BUILDING/LEVEL: 710 COLLINS STREET (GOODS SHED NORTH) - GROUND LEVEL  
 ROOM/LOCATION: SUBFLOOR ACCESS - WITHIN  
 FEATURE/MATERIAL: DUCTWORK INSULATION - SARKING INSULATION  
 SAMPLE NO.: -

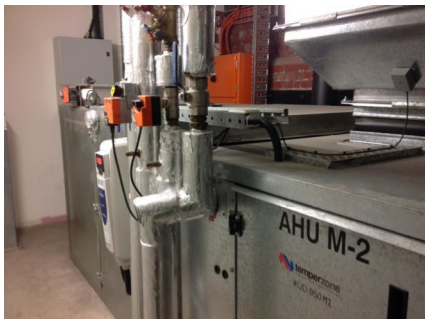
PHOTO NO.: J144435-APS-PRO-059-PHOTO016  
 RESULT: SMF - POSITIVE  
 BUILDING/LEVEL: 710 COLLINS STREET (GOODS SHED NORTH) - MEZZANINE LEVEL  
 ROOM/LOCATION: AIR HANDLING PLANT ROOMS X 6 - THROUGHOUT  
 FEATURE/MATERIAL: PIPEWORK INSULATION - SARKING INSULATION  
 SAMPLE NO.: -

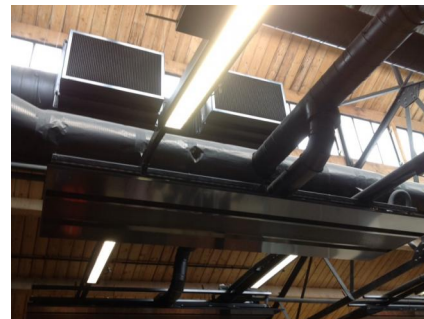
PHOTO NO.: J144435-APS-PRO-059-PHOTO015  
 RESULT: SMF - POSITIVE  
 BUILDING/LEVEL: 710 COLLINS STREET (GOODS SHED NORTH) - MEZZANINE LEVEL  
 ROOM/LOCATION: OFFICE AREAS (HERITAGE SECTION) - CEILING AREAS  
 FEATURE/MATERIAL: DUCTWORK INSULATION - SARKING INSULATION  
 SAMPLE NO.: -

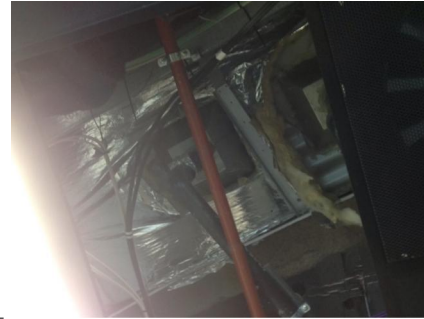
Ceiling Space - Office Areas Beams - Sprayed Vermiculite - Beige	Asbestos	J144435-APS-PRO-059-002	Negative											
Ceiling Space - Office Areas Ductwork Insulation - Sarking Insulation - Foil/SMF	SMF		Positive	J144435-APS-PRO-059-Photo009	50 m <sup>2</sup>	Good	Bonded (SMF)						Maintain in good condition and incorporate into a HMMP. Remove under controlled conditions prior to demolition or refurbishment.	
Ceiling Space - Office Areas Flexible Ductwork Insulation - Sarking Insulation	SMF		Positive	J144435-APS-PRO-059-Photo013	50 m	Good	Bonded (SMF)						Maintain in good condition and incorporate into a HMMP. Remove under controlled conditions prior to demolition or refurbishment.	
Ceiling Space - Office Areas Roof Lining - Sarking Insulation - Foil/SMF	SMF		Positive		500 m <sup>2</sup>	Good	Bonded (SMF)						Maintain in good condition and incorporate into a HMMP. Remove under controlled conditions prior to demolition or refurbishment.

PHOTO NO.: J144435-APS-PRO-059-PHOTO009  
 RESULT: SMF - POSITIVE  
 BUILDING/LEVEL: 710 COLLINS STREET (GOODS SHED NORTH) - LEVEL TWO  
 ROOM/LOCATION: CEILING SPACE - OFFICE AREAS  
 FEATURE/MATERIAL: DUCTWORK INSULATION - SARKING INSULATION  
 SAMPLE NO.: -

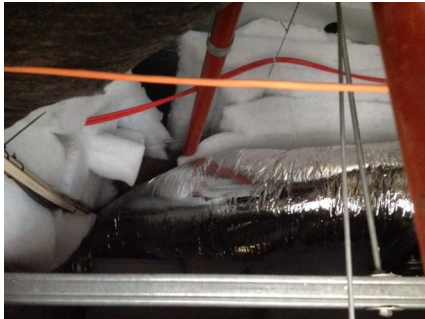
PHOTO NO.: J144435-APS-PRO-059-PHOTO013  
 RESULT: SMF - POSITIVE  
 BUILDING/LEVEL: 710 COLLINS STREET (GOODS SHED NORTH) - LEVEL TWO  
 ROOM/LOCATION: CEILING SPACE - OFFICE AREAS  
 FEATURE/MATERIAL: FLEXIBLE DUCTWORK INSULATION - SARKING INSULATION  
 SAMPLE NO.: -

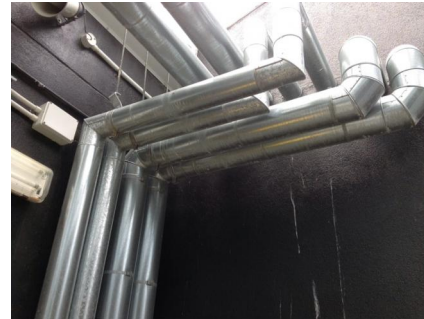
PHOTO NO.: J144435-APS-PRO-059-PHOTO002  
 RESULT: SMF - POSITIVE  
 BUILDING/LEVEL: 710 COLLINS STREET (GOODS SHED NORTH) - ROOF ROOM  
 ROOM/LOCATION: PLANT ENCLOSURE - VARIOUS THROUGHOUT  
 FEATURE/MATERIAL: PIPEWORK INSULATION - GLASS FIBRE  
 SAMPLE NO.: -

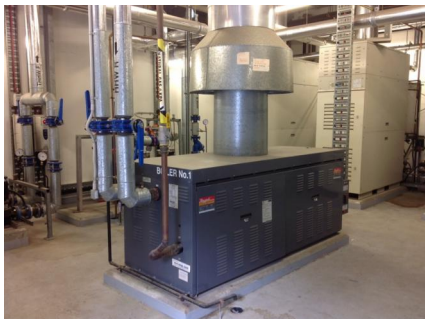
PHOTO NO.: J144435-APS-PRO-059-PHOTO005  
 RESULT: SMF - PRESUMED POSITIVE  
 BUILDING/LEVEL: 710 COLLINS STREET (GOODS SHED NORTH) - ROOF ROOM  
 ROOM/LOCATION: BOILER PLANT ROOM - CENTRAL  
 FEATURE/MATERIAL: BOILER INSULATION - GLASS FIBRE  
 SAMPLE NO.: -

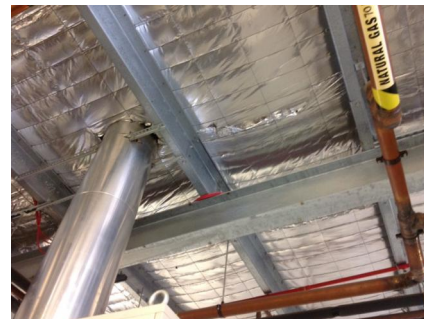
Boiler Plant Room - Throughout Ceiling - Sarking Insulation - To underside of metal roof	SMF		Positive	J144435-APS-PRO-059-Photo003	100 m <sup>2</sup>	Good	Bonded (SMF)						Maintain in good condition and incorporate into a HMMP. Remove under controlled conditions prior to demolition or refurbishment.	
Boiler Plant Room - Various Throughout Pipework Flange Joint - Gasket	Asbestos	Similar To: J144435-APS-PRO-059-001	Presumed Negative											
Boiler Plant Room - Various Throughout Pipework Insulation - Sarking Insulation	SMF		Positive	J144435-APS-PRO-059-Photo011	50 m <sup>2</sup>	Good	Bonded (SMF)						Maintain in good condition and incorporate into a HMMP. Remove under controlled conditions prior to demolition or refurbishment.	
Chiller Plant Room - Ceiling Areas Ductwork Flange Joint - Mastic Sealant - Modern ductwork installed 2009 assumed not to contain asbestos	Asbestos	Not Sampled	Presumed Negative

PHOTO NO.: J144435-APS-PRO-059-PHOTO003  
 RESULT: SMF - POSITIVE  
 BUILDING/LEVEL: 710 COLLINS STREET (GOODS SHED NORTH) - ROOF ROOM  
 ROOM/LOCATION: BOILER PLANT ROOM - THROUGHOUT  
 FEATURE/MATERIAL: CEILING - SARKING INSULATION  
 SAMPLE NO.: -

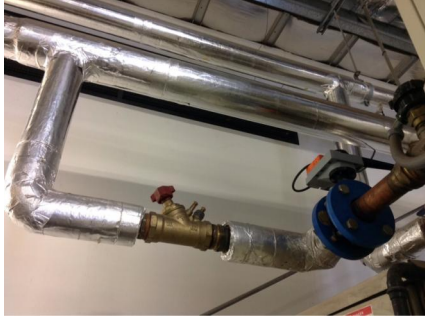
PHOTO NO.: J144435-APS-PRO-059-PHOTO011  
RESULT: **SMF - POSITIVE**  
BUILDING/LEVEL: 710 COLLINS STREET (GOODS SHED NORTH) - ROOF  
ROOM/LOCATION: **BOILER PLANT ROOM - VARIOUS THROUGHOUT**  
FEATURE/MATERIAL: **PIPEWORK INSULATION - SARKING INSULATION**  
SAMPLE NO.: -

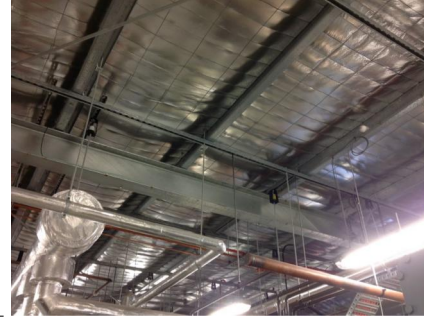
Chiller Plant Room - Throughout Ceiling - Sarking Insulation - To underside of metal roof	SMF		Positive	J144435-APS-PRO-059-Photo004	100 m <sup>2</sup>	Good	Bonded (SMF)						Maintain in good condition and incorporate into a HMMP. Remove under controlled conditions prior to demolition or refurbishment.	
Chiller Plant Room - Various Throughout Pipework Flange Joint - Gasket	Asbestos	Similar To: J144435-APS-PRO-059-001	Presumed Negative											
Chiller Plant Room - Various Throughout Pipework Flange Joint - Gasket	Asbestos	Similar To: J144435-APS-PRO-059-001	Presumed Negative											
Chiller Plant Room - Various Throughout Pipework Insulation - Glass Fibre - Metal clad & sarking insulation	SMF		Positive	J144435-APS-PRO-059-Photo012	50 m	Good	Bonded (SMF)						Maintain in good condition and incorporate into a HMMP. Remove under controlled conditions prior to demolition or refurbishment.	
Chiller Plant Room - Various Throughout Plant & Equipment - Insulation - Chiller plant assumed not to contain asbestos internal insulation	Asbestos	Not Sampled Restricted Access	Presumed Negative

PHOTO NO.: J144435-APS-PRO-059-PHOTO004  
RESULT: **SMF - POSITIVE**  
BUILDING/LEVEL: 710 COLLINS STREET (GOODS SHED NORTH) - ROOF  
ROOM/LOCATION: **CHILLER PLANT ROOM - THROUGHOUT**  
FEATURE/MATERIAL: **CEILING - SARKING INSULATION**  
SAMPLE NO.: -

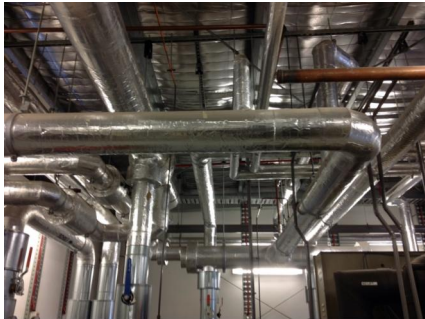
PHOTO NO.: J144435-APS-PRO-059-PHOTO012  
RESULT: **SMF - POSITIVE**  
BUILDING/LEVEL: 710 COLLINS STREET (GOODS SHED NORTH) - ROOF  
ROOM/LOCATION: **CHILLER PLANT ROOM - VARIOUS THROUGHOUT**  
FEATURE/MATERIAL: **PIPEWORK INSULATION - GLASS FIBRE**  
SAMPLE NO.: -
