## Asbestos Assessment

Lantern & South Goods Shed, Collins Square, 707  
Collins Street, Docklands, Victoria

**25 July 2024**

**Project Reference: 2054**

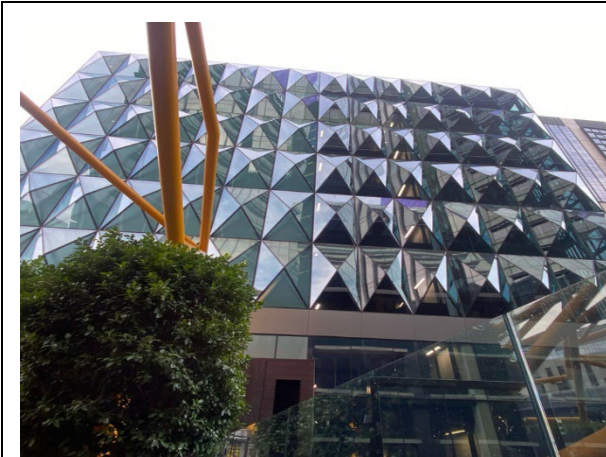
1. Lantern - Asbestos - Negative

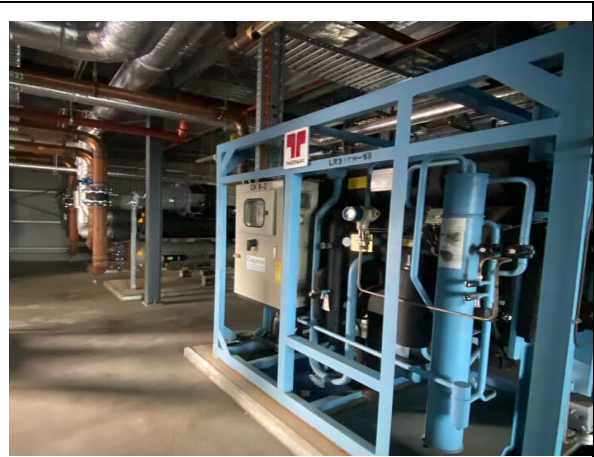
2. Imported Chiller units - Asbestos - Negative

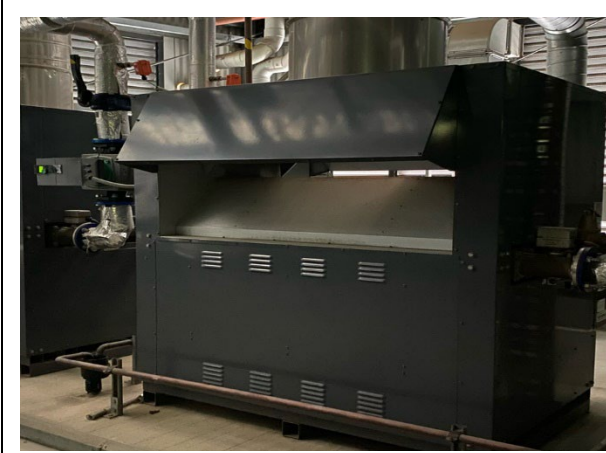
3. Australian Manufactured Boilers, internal lining - Asbestos - Negative

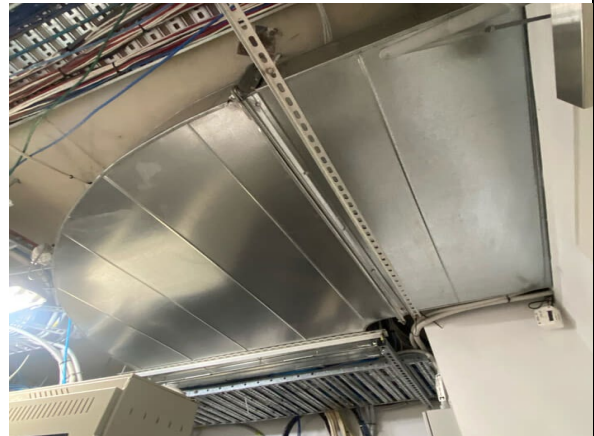
4. Ductwork, flanges - Asbestos - Negative

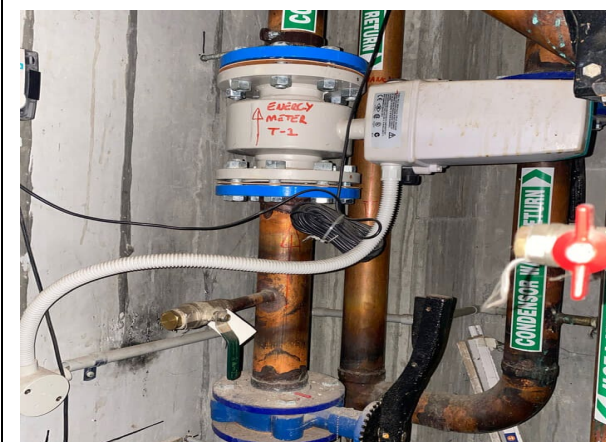
5. Pipework - Asbestos - Negative

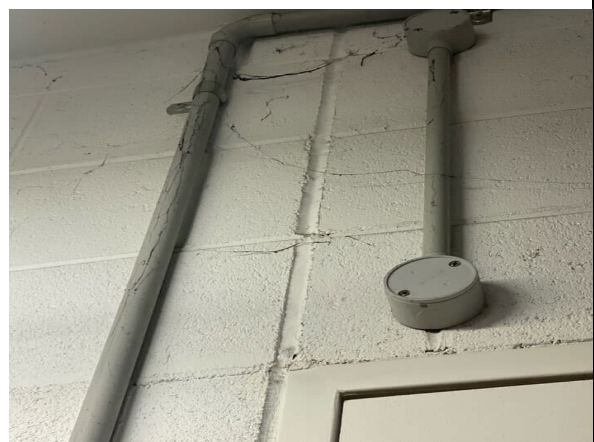
6. Walls, expansion joint - Asbestos - Negative

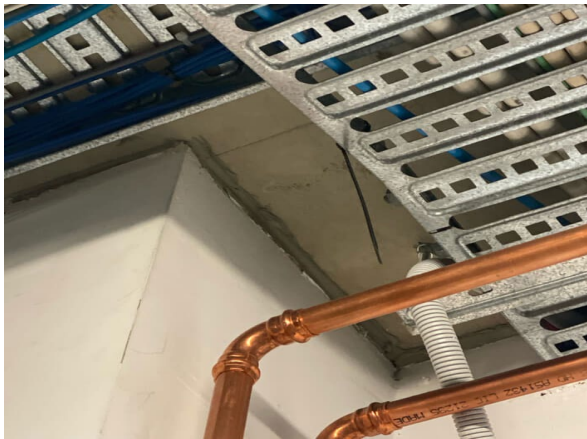
7. Between walls and concrete ceilings -  
Asbestos - Negative

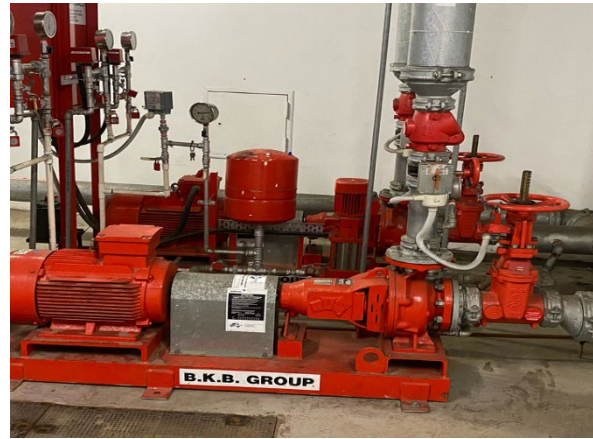
8. Fire Pump Room, pumps - Asbestos -  
Negative

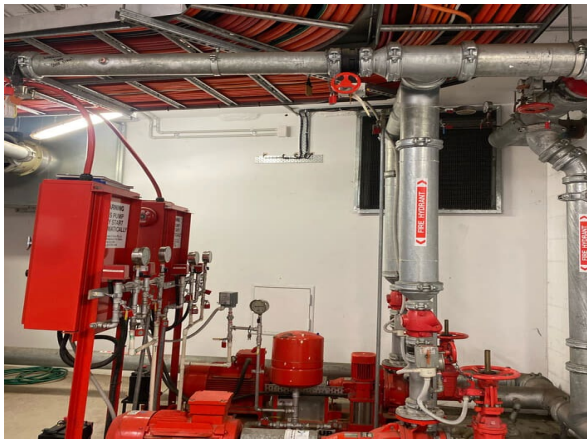
9. Fire Pump Room, back wall - Asbestos -  
Negative

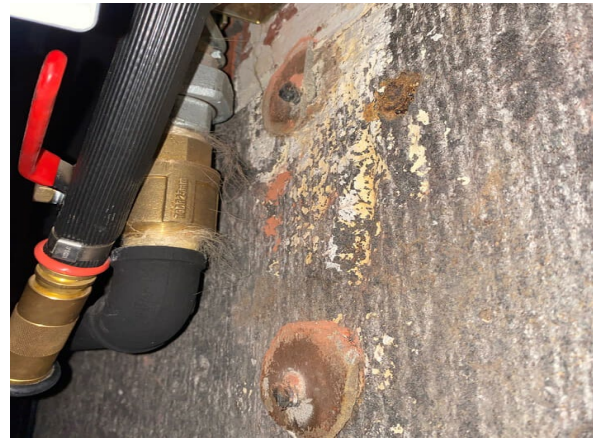
10. East side, under fire hose reel, residue on  
wall - Asbestos - Negative

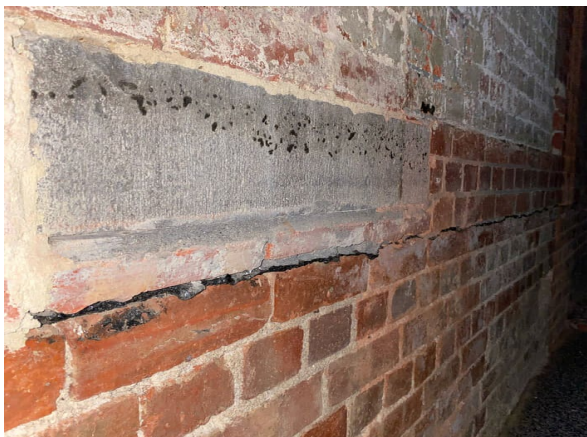
11. Central, dividing brick wall, damp proof  
course - Asbestos - Negative

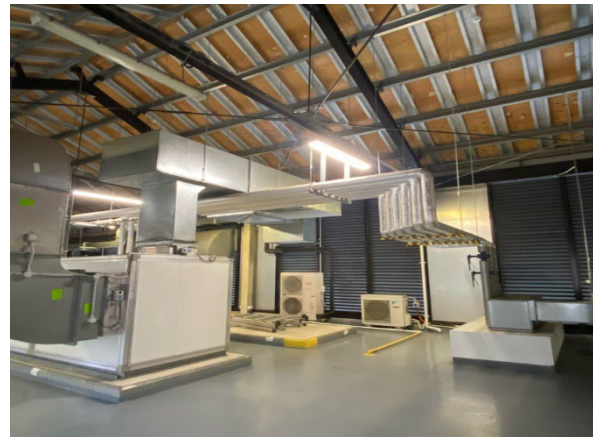
12. First Floor, Plant Room - Asbestos -  
Negative

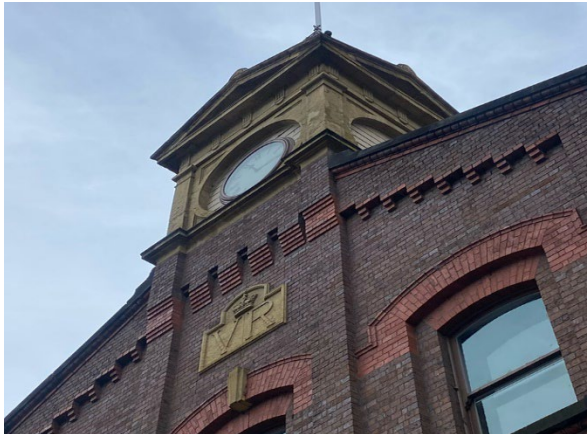
- Restricted access beneath floor coverings in the South Goods Shed, access would have caused damage.
- No access within the clocktower of the South Goods Shed, no access points visible.
- No access in the substation.

13. Clock tower - Asbestos - No Access

- Areas which were inaccessible during the Assessment, should be assessed for ACMs by a competent person prior to access or disturbance.

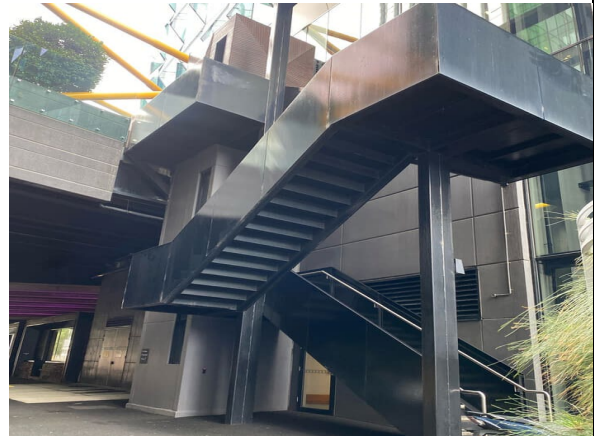
14. External stairs to upper level, wall panels - Asbestos - Negative

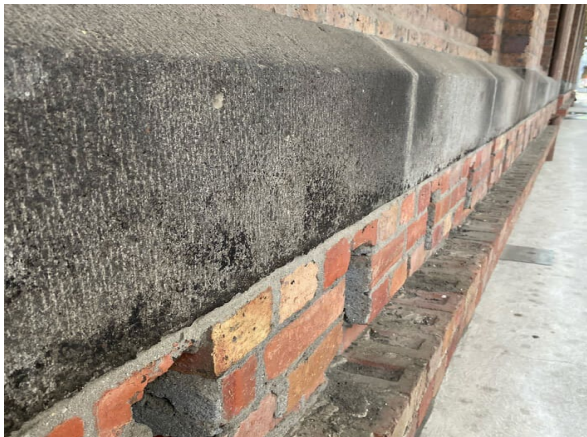
15. External east wall, bottom of stone course - Asbestos - Negative

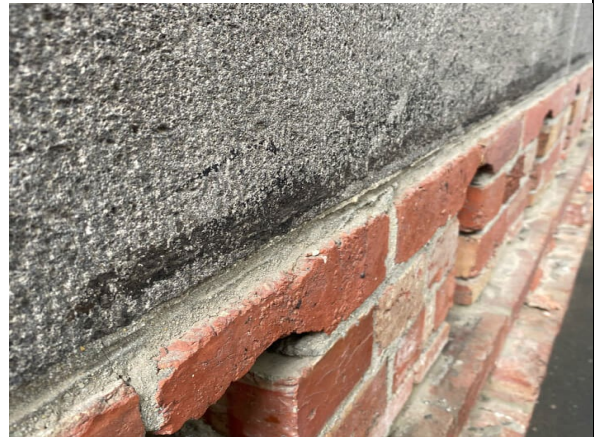
16. External west wall, bottom of stone course - Asbestos - Negative
