CERTIFICATE OF INSPECTION

2021 Height Safety / Industrial Rope Access System Inspection Report

Collins Square | Tower 1

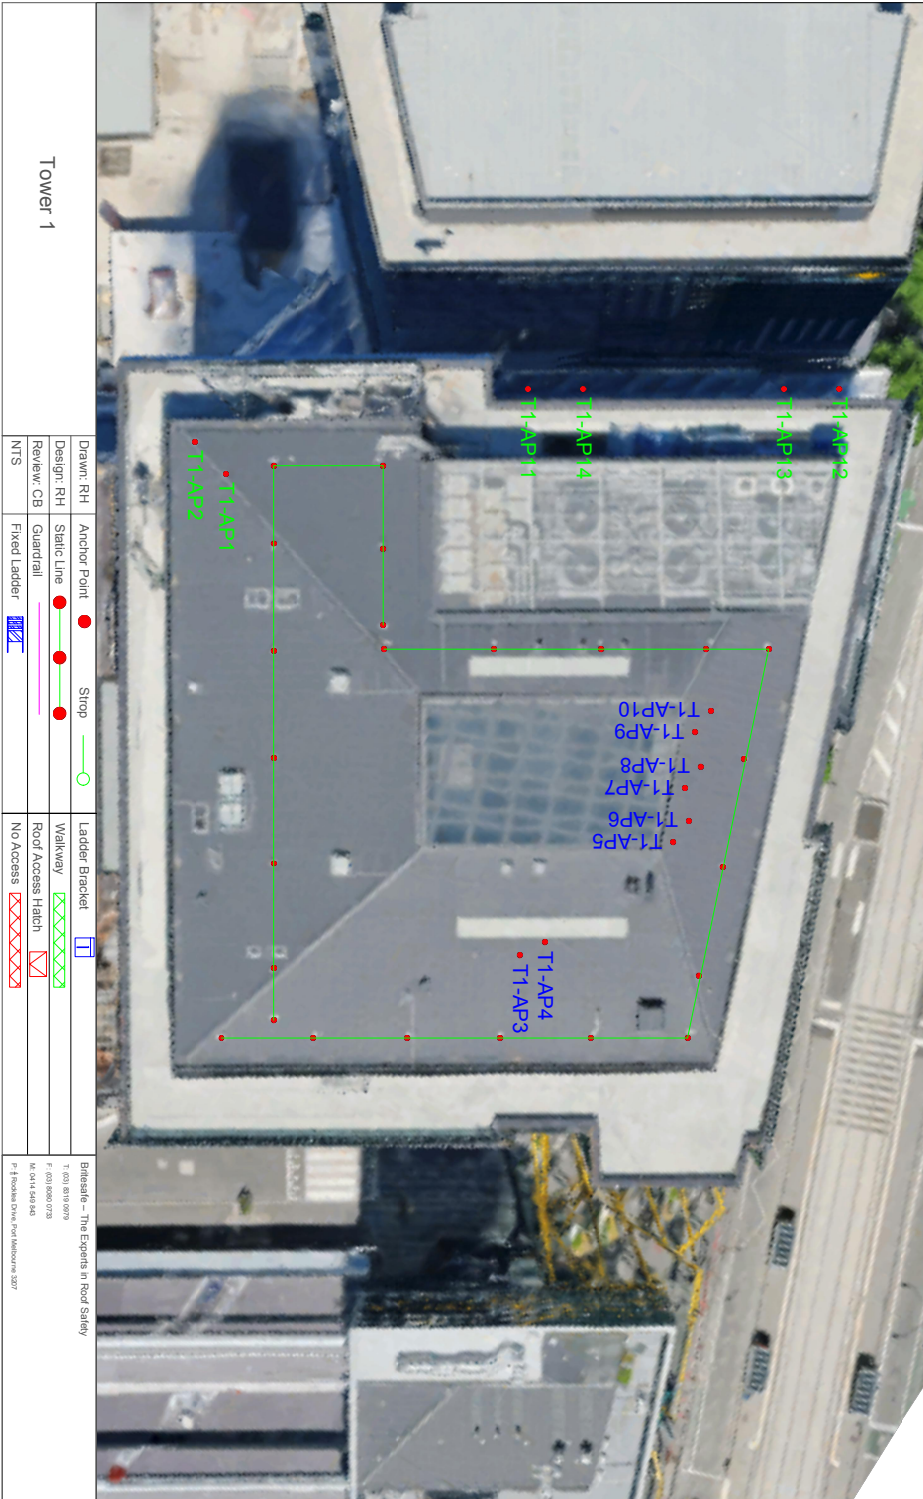
Layout Plan

System Summary			
Compliant Anchor Point Quantity	20	Non-Compliant Anchor Point Quantity	0
Compliant Static Line Quantity	3	Non-Compliant Static Line Quantity	1
<p>Details:</p> <ul style="list-style-type: none"> There is no safe access to T1-8-SL1 which is located on level 8. The line couldn't be safely accessed therefore, it has not been inspected.

1. Assess the access to level 8.

We suggest that an access audit is conducted by Britesafe to establish a safe means of access to the level 8 static line.
