**Working at Heights Assessment**  
**One Festival Tower**  
**Station Road, Adelaide, South Australia**

**Walker Corporation**  
**March 2024**

Job No: 123375M

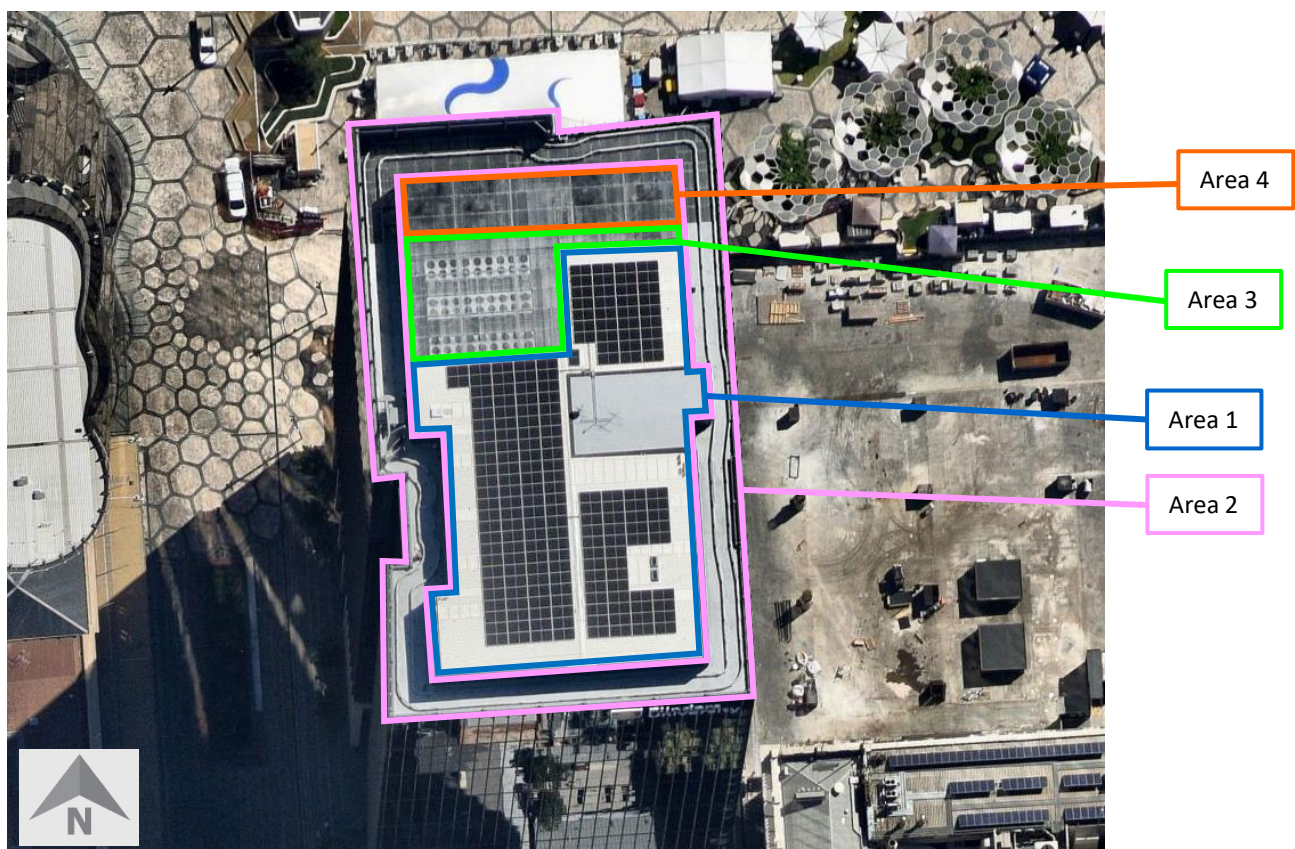
**Figure 1: Indication of roof areas**

- Area 1 – Level 29 Upper Roof;
- Area 2 – Level 29 BMU Track;
- Area 3 – Level 29 Plant Room (external only); and
- Area 4 – Level 28 Cooling Tower Area.
