## **Working at Heights Assessment**

**3 Parramatta Square**

**153 Macquarie Street, Parramatta NSW 2150**

**Walker Corporation**

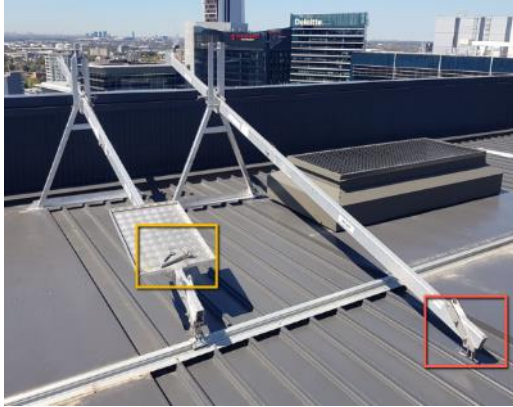
- Upper Rooftop, South-Eastern Corner:
  - A needle system was observed to be unsecured (**Figure 1**);
  - Loose pins, associated with needle system, were observed to be stored on a needle system, presenting a risk of being blown off the roof (**Figure 2**); and
  - Loose fall arrest equipment was observed to be stored adjacent to the needle systems.
- Upper Rooftop, South-Western Elevation:
  - A needle system was observed to be stored on its side (**Figure 3**).

**Figure 1:** Rooftop, South-Eastern Corner – A needle was observed to be unsecured (red) and minor components were observed to be stored on a needle system (yellow) (left).

- Store loose components associated with the needle systems securely, either internally or in a secured store, to reduce the risk of the components being blown off the roof; and
- Relocate loose fall arrest equipment to an internal location.

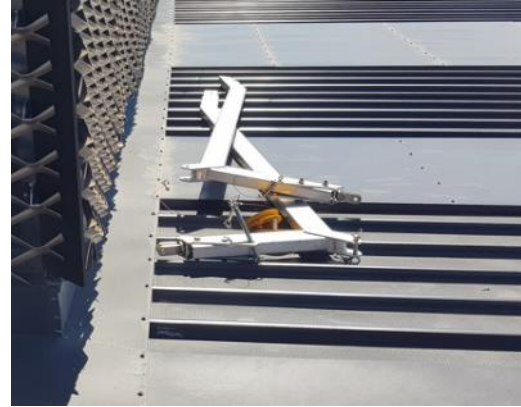
**Figure 2:** Loose fall arrest equipment was observed to be stored adjacent the needle systems (right).

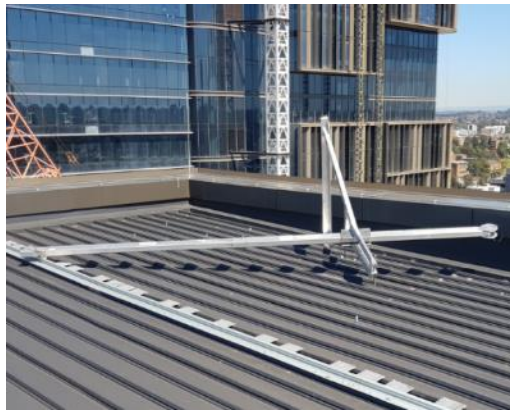
**Figure 3:** Upper Rooftop, South-Western Elevation – A needle system was observed to be stored on its side

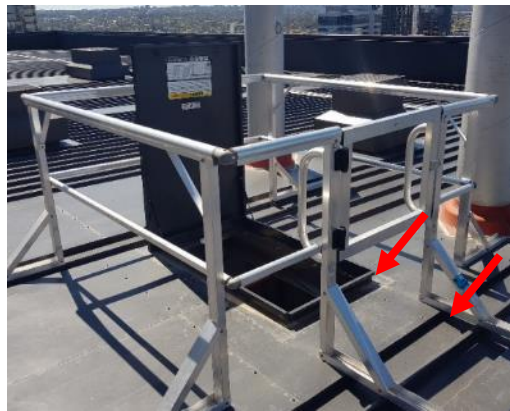
- The ladder landing was noted to not be level due to the raised lip of the access hatch and raised sections of the corrugated roofing presenting trip hazards. AS1657 specifies that a ladder landing must be provided with a flat level landing, extending 900 mm from the ladder (**Figure 4**); and

- The distance between the rung ladder and the handle of the access hatch was noted to result in difficulty in closing the hatch while descending the ladder, and required the user to lean into the open space, thereby increasing the risk of falls.

**Figure 4:** Level 17, Upper Level, Rooftop Access Hatch – Raised hatch lip and roofing sections presenting trip hazards.

2	Rooftop	Rooftop Access	Person falling off ladder	Single hand carried tools	Yes	Yes	No	Flat	Yes	Unlikely	Good	Monthly	Maintenance personnel	2m to 6 m	Flat hard stand	<ul style="list-style-type: none"> <li>Secured behind locked plant room doors;</li> <li>Ladder gate provided; and</li> <li>Grab rails provided on the roof.</li> </ul>	<ul style="list-style-type: none"> <li>The ladder landing was noted to not be level due to the raised lip of the access hatch and raised sections of the corrugated roofing presenting trip hazards. AS1657 specifies that a ladder landing must be provided with a flat level landing, extending 900 mm from the ladder; and</li> <li>The distance between the rung ladder and the handle of the access hatch was noted to result in difficulty in closing the hatch while descending the ladder.</li> </ul>	Unlikely	Moderate	Low	<ul style="list-style-type: none"> <li>Install a level landing from the access hatch extending 900 mm from the ladder; and</li> <li>Install an extended handle or cord to the underside of the hatch handle to assist in closing the hatch whilst descending the ladder.</li> </ul>	Figure 4

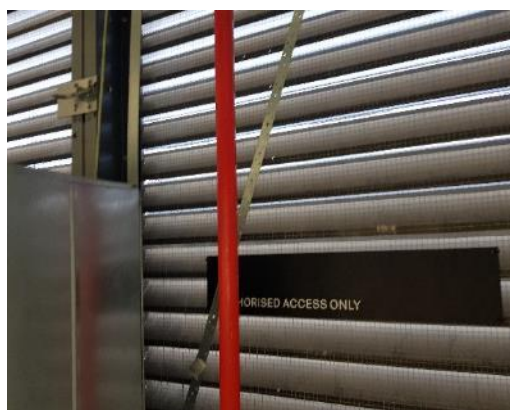
A door labelled ‘*Authorised Access Only*’ was provided adjacent to the supply air fan (SAF) 17-1. The door opens to an external live edge. Fall prevention and/or arrest systems such as anchor points or parapet walls were not observed to be provided to this location presenting an increased risk of falls. The door was noted to be provided with a door bolt, however this was not lockable. The Senior Facilities Manager explained that the door was provided for construction purposes and was no longer utilised (**Figure 5**).

**Figure 5:** Level 17, Upper Level, Plant Room, Adjacent SAF 17-1 – Doorway opening to roof area.

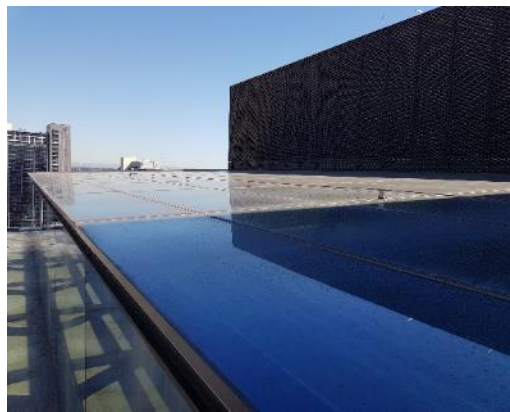
The roof area was provided with a fixed rung ladder and three (3) static line systems. The fixed rung ladder was noted to be free of obstructions and was provided with grab rails. Two (2) of the static lines were located adjacent to the roof access door and perpendicular to the two (2) exposed edges, while the third was located on the upper level. A review of the certification tags indicated the static lines were inspected on 30<sup>th</sup> March 2021. The upper level was noted to be consist of trafficable glass panelling. However, signage displaying a Safe Weight Limit was not provided at the location (**Figure 6**).

**Figure 6:** Exterior, Level 17, Roof Area, Upper Level – Signage displaying a Safe Weight Limit for the trafficable glass panelling was not displayed.

3	Level 17, Upper Plant Room, Lower Roof Area (1)	Plant maintenance	Person falling off roof	Single hand carried tools	Yes	Yes	Yes	Flat	No	Unlikely	Good	Monthly	Maintenance personnel	> 6m	Flat hard stand	<ul style="list-style-type: none"> <li>Located within a locked plant room; and</li> <li>'Authorised Access Only' signage provided to the door.</li> </ul>	The door was noted to be provided with a door bolt, however this was not lockable.	Rare	Major	Low	Secure the roof access door with a lock.	Figure 5
4	Level 17, Exterior, Lower Roof Area (2)	Cleaning windows and plant maintenance using static line	Person falling off roof	Single hand carried tools	Yes	Yes	Yes	Flat	No	Thoroughfare	Good	Yearly	Maintenance personnel	> 6m	Flat hard stand	<ul style="list-style-type: none"> <li>Static lines provided and maintained annually;</li> <li>Locked door; and</li> <li>'Authorised Access Only, Abog Access' signage was provided to the door.</li> </ul>	The upper level was noted to be consist of trafficable glass panelling. However, signage displaying a Safe Weight Limit was not provided.	Rare	Major	Low	Display signage in a prominent location at the entry point to the trafficable glass panelling stating the safe weight limit (SWL).	Figure 6

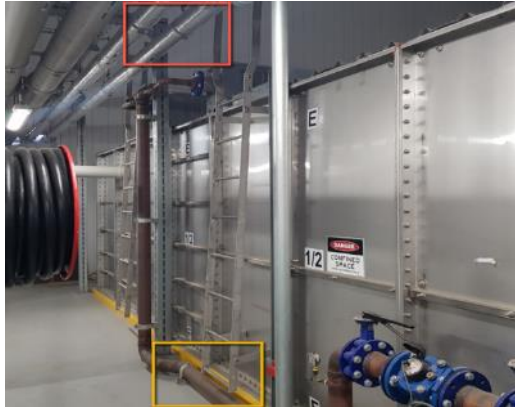
- The clearance from the back edge of the rung was noted to be obstructed by a metal pipe, presenting a trip hazard (**Figure 7**);
- Head clearance was noted to be obstructed by HHW Flow and HHW return pipework (**Figure 7**); and
- A bolt was noted to be missing from the lower securement bracket (**Figure 8**).

**Figure 7:** Level 17, Plant Room, Water Tank Area – A metal pipe beneath the bottom rung was considered to pose a trip hazard when descending the rung ladder (yellow) and head clearance was noted to be obstructed by HHW Flow and HHW return pipework (red).

- Provide highlighting to the metal pipe beneath the metal rung;
- Display '*Warning Low Headroom*' signage at a prominent location adjacent to the ladder; and
- Provide the missing bolt from the lower securement bracket of the rung ladder.

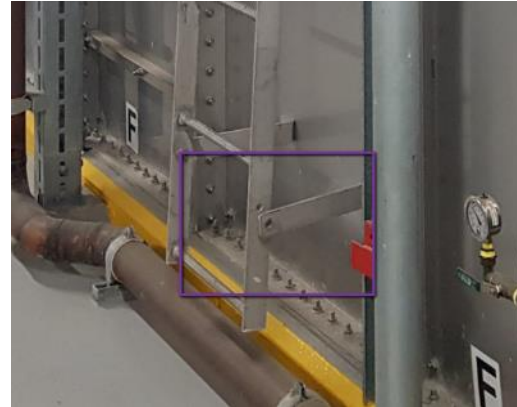
**Figure 8:** Level 17, Plant Room, Water Tank Area – A bolt was noted to be missing from the lower securement bracket (purple).

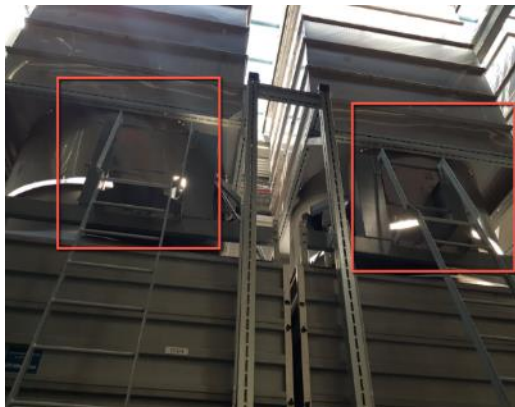
**Figure 9:** Level 17, Cooling Tower Plant Room – The gates provided to access cooling towers were noted to be difficult to open which may increase the risk of falls.

Repair and maintain the ladder gates to enable them to open easily.

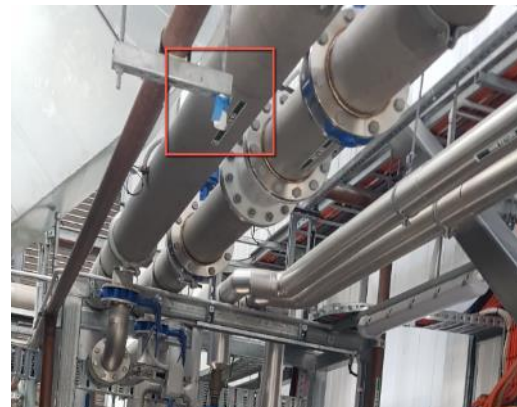
Seven (7) cooling towers were situated within the Level 17, Cooling Tower Plant Room. Each of the cooling towers was provided with a fixed rung ladder, which was understood to be used by contractors on a monthly basis to conduct cooling tower maintenance works. The ladder gates located at the top of the ladders were noted to be seized and difficult to open, presenting an increased risk of falls when opening (Figure 9). In addition, low headroom was observed on a platform walkway adjacent to the cooling towers due to the presence of pipework and a bracket (Figure 10).

**Figure 10:** Level 17, Cooling Tower Plant Room – Low headroom was observed on a platform walkway adjacent to the cooling towers due to the presence of pipework and a bracket.

6	Level 17, Cooling Tower Plant Room	Cooling tower maintenance	Person falling off ladder	Single hand carried tools	No	Yes	No	Flat	No	Unlikely	Good	Quarterly	Maintenance personnel	2m to 6 m	Flat hard stand	<ul style="list-style-type: none"> <li>Secured behind locked plant room doors;</li> <li>Ladder gates provided, to cooling tower ladders; and</li> <li>Grab rails provided for rung ladders.</li> </ul>	<ul style="list-style-type: none"> <li>The ladder gates located at the top of the cooling tower ladders were noted to be seized and difficult to open.</li> </ul>	Unlikely	Moderate	Low	Repair and maintain the cooling tower ladder gates to enable them to open easily.	Figure 9
7	Level 17, Cooling Tower Plant Room, Platform Walkway	Plant maintenance	Person falling from walkway	Single hand carried tools	Yes	Yes	No	Flat	No	Unlikely	Good	Fortnightly	Maintenance personnel	Less than 2 m	Flat hard stand	<ul style="list-style-type: none"> <li>Located within a locked plant room;</li> <li>Handrails provided to platform walkway.</li> </ul>	<p>Low headroom was observed due to the presence of pipework and a bracket.</p>	Unlikely	Moderate	Low	<ul style="list-style-type: none"> <li>Display 'Warning Low Headroom' signage in a prominent location adjacent to protruding pipework and bracket; and</li> <li>Install highlighted padding to the protruding pipework and bracket.</li> </ul>	Figure 10

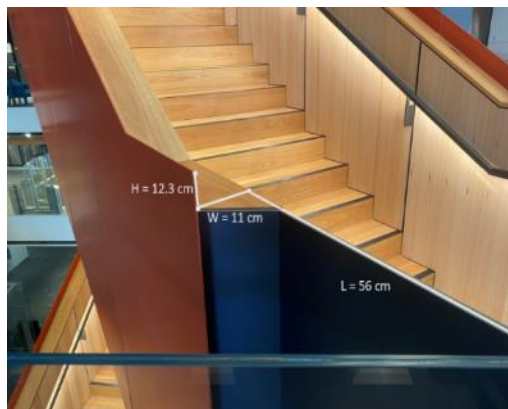
- Stair barriers were noted to be provided with a flat top with a horizontal width of approximately 11cm wide, which may entice occupants to temporarily store items on the barrier (e.g. laptop, coffee, keys, phone, etc.); and
- Edge protection was generally provided to the flat top of the barrier, to reduce the risk of items being knocked off the edge. However, a gap in the panelling was observed at the base of the stairs presenting an increased risk of objects falling or sliding off the barrier (**Figure 11**).

**Figure 11:** Atrium, Throughout Internal Levels – Edge protection to barrier not observed at base of stairs.

Item #	Location	Activity	Factors Affecting Likelihood of Fall											Factors Affecting Consequence of Fall		Current Risk Controls	Deficiencies	Likelihood	Consequence	Risk	Recommended Additional Risk Controls	Photo Reference
			Hazard Description	Carry Equipment	Three points of contact	Work within 2 m of edge	Operator facing the edge	Pitch	Trip Hazard Present	Occupancy below	Condition / maintenance of equipment	Frequency of Access	Access By	Height of fall	Nature of landing							
8	Atrium, Throughout	Items stored on the flat top of the stair barriers.	Falling object	Single hand carried tools	Yes	No	Not Applicable	Flat	No	Thoroughfare	Good	Daily	Any site occupant	> 6m	Flat hard stand	Edge protection was generally provided to the flat top of the stair barrier to reduce the risk of items being knocked off the edge.	A gap was noted, at the base of the stairs, in the edge protection provided to the flat top of the stair barriers presenting a risk of objects falling or sliding off the barrier to lower levels.	Possible	Major	Medium	Install edge protection to the flat top of the stair barriers, at the base of the stairs traversing the atrium, to reduce the risk of falling objects.	Figure 11

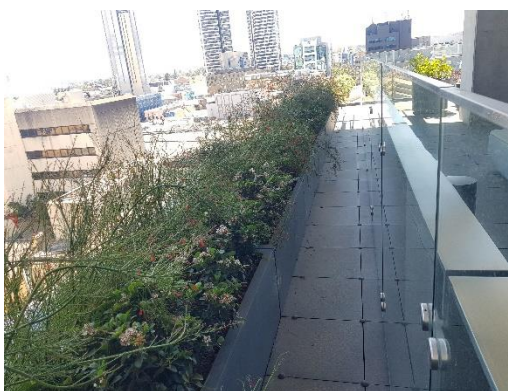
The balcony areas of Level 6 and Level 2 were provided with perimeter edge protection in the form of glass barriers. However, a number of planter boxes were noted to be provided outside the barriers, adjacent to the edge of the building. It was understood that contractors were engaged to maintain the planter boxes on a monthly basis. The planter boxes were accessed through the use of an anchorage rail which was provided to the ceiling of the balcony area and extends along the perimeter of the balcony. An inspection of the anchorage rail indicated that the working line may pass over the top of the glass barriers. The barriers were observed to be provided with steel capping to facilitate industrial rope access, as per the *3 Parramatta Square - Façade Performance Specification*, dated 28/07/2017, provided to Prensa for review (**Figure 12**).

**Figure 12:** Level 6 Balcony Area – Steel capping provided to glass barrier to facilitate industrial rope access for façade and planter box maintenance.

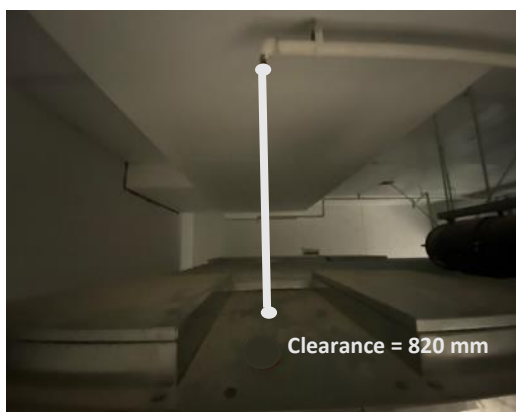
An on-site stormwater detention tank (OSD tank) was situated within the Level 2, Plant Room. The OSD tank was provided with a fixed rung ladder and was understood to be accessed by contractors on a quarterly basis for maintenance works. AS1657 prescribes a landing headroom clearance of 2000 mm or higher for fixed ladders and a front clearance (from front of nosing) of 750 mm or higher for rung ladders. However, the landing headroom provided at the top of the ladder was measured to be 820 mm high (**Figure 13**) and the front clearance was measured to be 510 mm due to protruding metal brackets located adjacent to the ladder (**Figure 14**). These reduced clearances may result in an increased risk of falls.

**Figure 13:** Level 2 Plant Room, OSD Tank – the landing headroom provided at the top of the rung ladder was measured to be 820 mm high.

9	Level 6 and Level 2, Balconies	Maintaining planter boxes using anchorage rail systems.	Person falling off roof	Single hand carried tools	Yes	Yes	Yes	Flat	No	Transient	Good	Monthly	Maintenance personnel	> 6m	Flat hard stand	<ul style="list-style-type: none"> <li>Access is secured by locked gates;</li> <li>Anchorage rail systems provided and maintained annually;</li> <li>Glass balustrades observed to be provided with steel capping to facilitate industrial rope access.</li> </ul>	None.	Rare	Major	Low	None	Figure 12
10	Level 2 Plant Room	Storage tank maintenance	Person falling off ladder	Single hand carried tools	Yes	Yes	No	Flat	No	Unlikely	Good	Quarterly	Maintenance personnel	2m to 6 m	Flat hard stand	Located within a locked plant room.	<ul style="list-style-type: none"> <li>A low headroom height of a 820 mm was provided at the OSD tank landing platform; and</li> <li>A low front clearance distance of 510 mm was provided to the OSD tank access ladder due to protruding metal brackets.</li> </ul>	Unlikely	Moderate	Low	<ul style="list-style-type: none"> <li>Display signage stating 'Warning, Low Headroom' adjacent to the OSD tank ladder; and</li> <li>Install highlighted padding to the protruding metal bracket adjacent the OSD tank.</li> </ul>	Figures 13 and 14

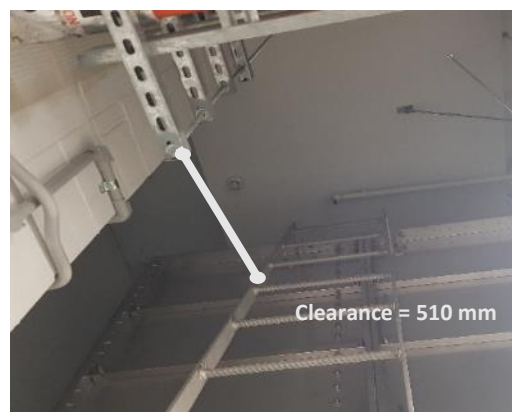
**Figure 14:** Level 2 Plant Room, OSD Tank – The front clearance was measured to be 510 mm due to protruding metal brackets located adjacent to the ladder.

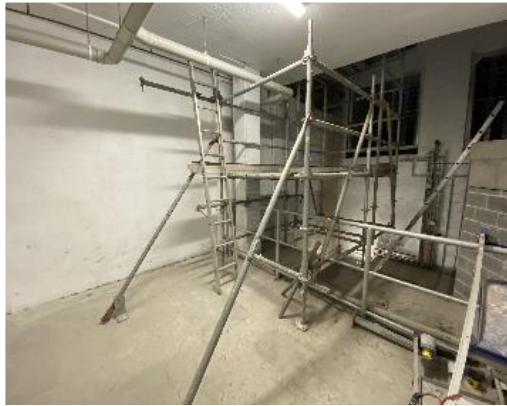
Scaffolding was observed to be provided within a room labelled 'Authorised Access Only', located within a plenum on Level B2. The Senior Facilities Manager explained that the scaffolding was erected to provide access to an area impacted by reoccurring issues of water ingress, and was intended to remain in place for the foreseeable future to provide access to the upper areas of the plenum. The scaffolding was noted to be greater than four (4) meters high. As such, the integrity and stability of the scaffolding must be inspected at least every 30 days. Copies of handover certificates and/or inspection reports were not made available to Prensa for review (Figure 15).

**Figure 15:** Level B2, Plenum, Authorised Access Only Room – Scaffolding erected to provide access to an area impacted by reoccurring issues of water ingress.

- Obtain the handover certificate from the building contractor, or engage a competent person to conduct a handover inspection; and
- Engage a competent person to undertake the following inspection program:
  - Before the scaffold is used following repairs or an incident that might affect the stability of the scaffold; and
  - At least every 30 days.

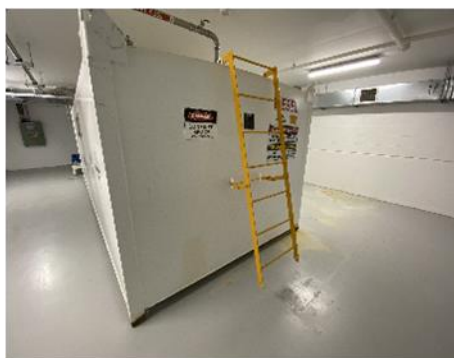
A fixed ladder was provided to access the diesel tank within the Level B3, Plant Room. It was understood that the ladder was used for accessing the dip point. The rung ladder was noted to be free from obstructions. The ladder was not provided with grab rails, however it was noted that the dip point could be accessed without exiting the ladder, as such a recommendation has not been raised (Figure 16).

**Figure 16:** Level B3, Plant Room, Diesel Storage Tank – Rung ladder provided to access the dip point of the diesel storage tank.
