Working at Heights Assessment

4 Parramatta Square

Walker Corporation

October 2021

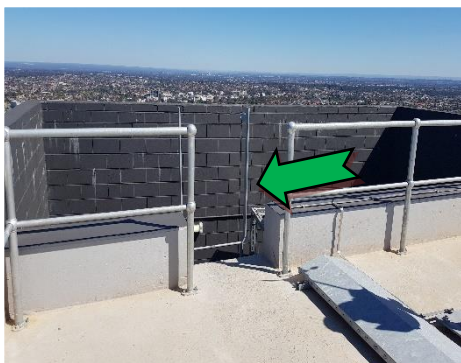
The Upper Rooftop was accessed via a metal rung ladder from the Rooftop area below (**Photo 1**). Various telecommunications equipment was present in this area. A fall from the fixed rung ladder or the landing would result in a fall to the floor of the Rooftop. A metal guard rail with a mid-rail was provided around the entire Upper Rooftop.

1. Upper Rooftop – The roof was provided with a rung ladder, with stiles extending approximately 1,000 mm, for access.

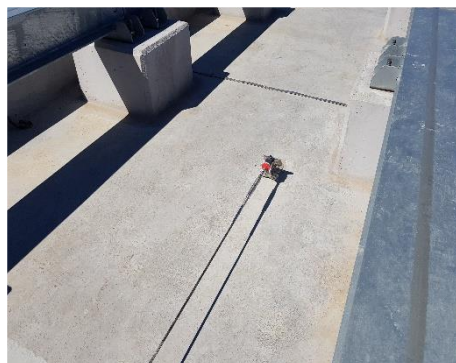
- Anchor points and a static line were provided throughout the rooftop (**Photo 2**). A yearly inspection report, dated 24/05/2021, was sighted;
- A BMU rail was provided, the BMU was accessed from Level 34 and was reported to be used for window cleaning and façade maintenance on a monthly basis. A quarterly BME Inspection report (dated 01/07/2021) was observed; and
- The Rooftop edge was observed to be provided with a parapet wall (**Photos 3**).

2. Rooftop– Static lines observed throughout roof area.

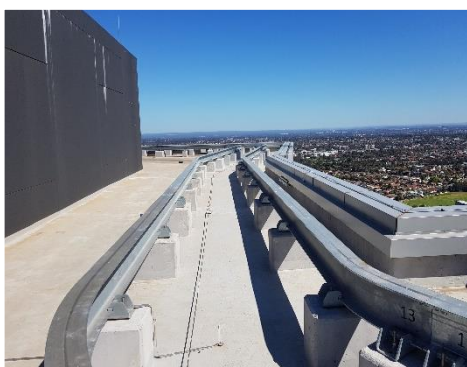
3. Rooftop – Parapet walls provided

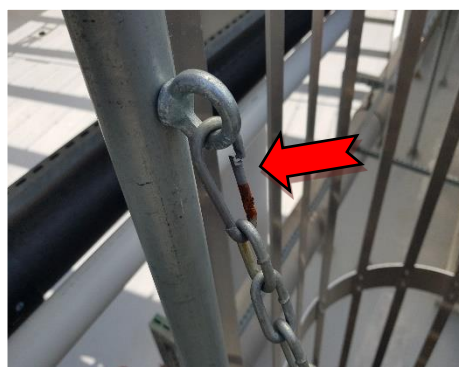
The upper sections of the six (6) cooling towers in the Level 34 Mechanical Plant Room were provided with an elevated platform. The platforms were accessed via fixed steel rung ladders with cages. Chains were provided at the top of the ladders in place of ladder gates. It was noted that a number of the

chains' carabiner clips were corroded and difficult to open (**Photo 4**), presenting a risk of falls when accessing this area.

4. Level 34, Mechanical Plant Room – A Metal Rung ladder was provided for access to the upper level of the cooling towers. It was observed that the carabiners on the ladder chain were corroded.

- Replace/repair the corroded carabiner clips provided to the cooling tower ladder chains;
- Install low headroom warning signage adjacent the rung ladders accessing the potable drinking water tank; and
- Provide highlighting to the pipework located at the base of the potable water tank, right ladder.

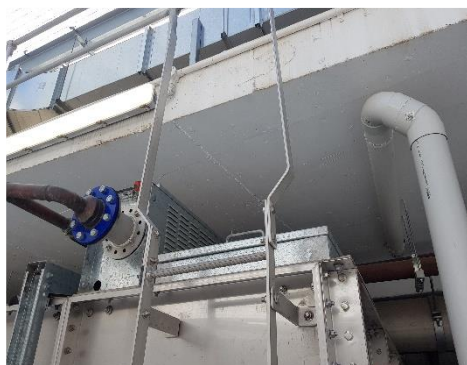
- Reduced head clearance was provided above the water tank and tank access hatch (**Photo 5**); and
- Pipework at the base of the right ladder was noted to be within the 200 mm of clearance from the back edge of the rung, as specified in AS1657, presenting a potential trip hazard when exiting the ladder (**Photo 6**).

5. Level 34, Mechanical Plant Room – Restricted head height at the top of the Potable Drinking Water Tank.

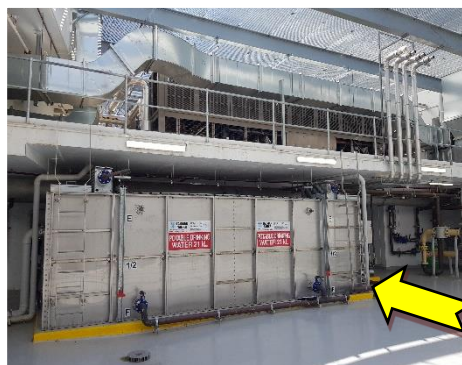
6. Level 34, Mechanical Plant Room – The pipework at the base of the western ladder was observed to obstruct the rear ladder clearance.

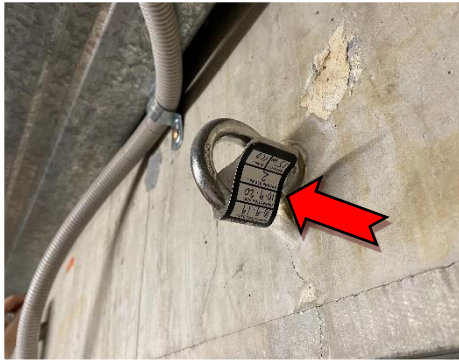
- Inspection tags for the fall arrest points were observed to be out of date (**Photo 7**); and
- Contractors undertaking inspections of fire penetrations were noted to have to stand adjacent the ladder edge (**Photo 8**), however, a ladder gate or closure system had not been installed to reduce the risk of a fall when inspecting the penetrations.

7. Level 1, OSD tank – The inspection tags for the anchor points at the top of the tank were observed to be out of date.

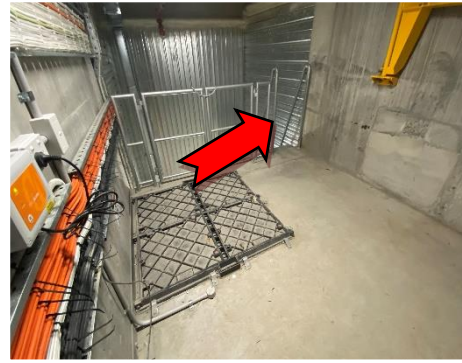
8. Level 1, OSD tank – The landing at the top of the step ladder was not provided with a gate, increasing the risk of a fall whilst working in close proximity.

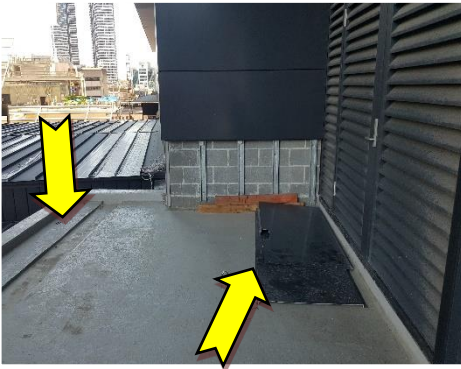
- No indication of the load bearing capacity for the trafficable glass roof was observed (**Photo 9**); and
- Building materials were stored in front of the door, obstructing access (**Photo 9**).

9. Podium 3, Western Elevation Roof – Glass Safe Weight Limit was not displayed and building materials were observed to obstruct the entrance.

Install a sign displaying the Safe Weight Limit (SWL) of the glass.

Remove building materials obstructing the entryway.

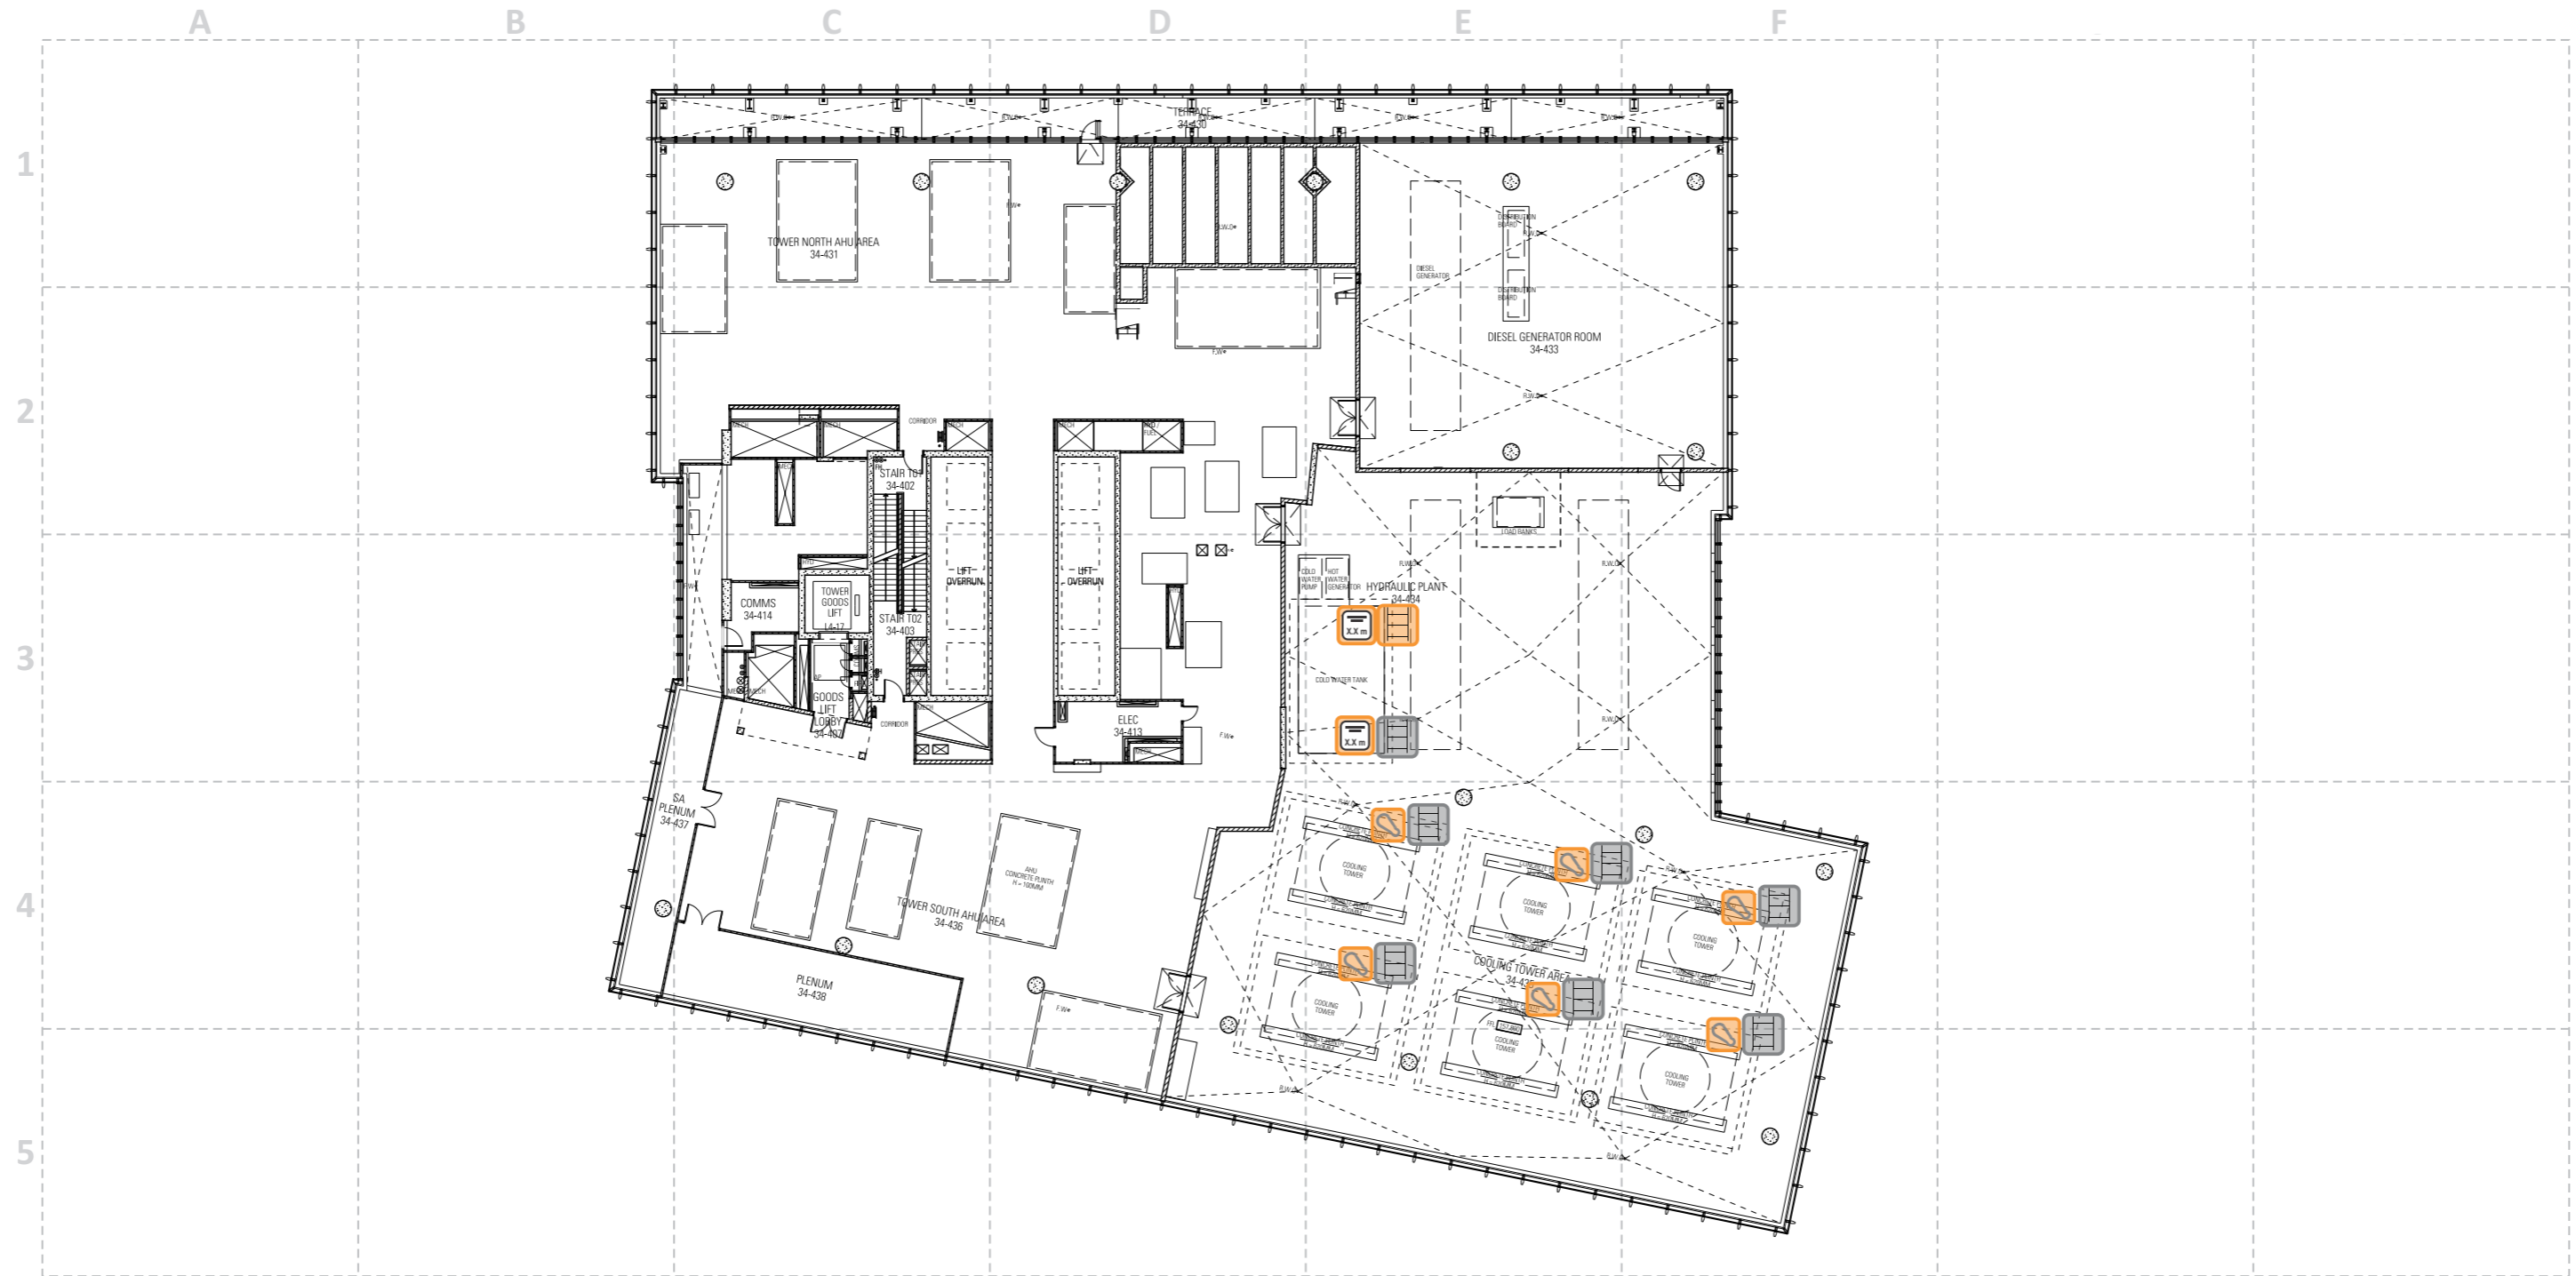
Level 34, Working at Heights Control Measures

Corroded Carabiner.

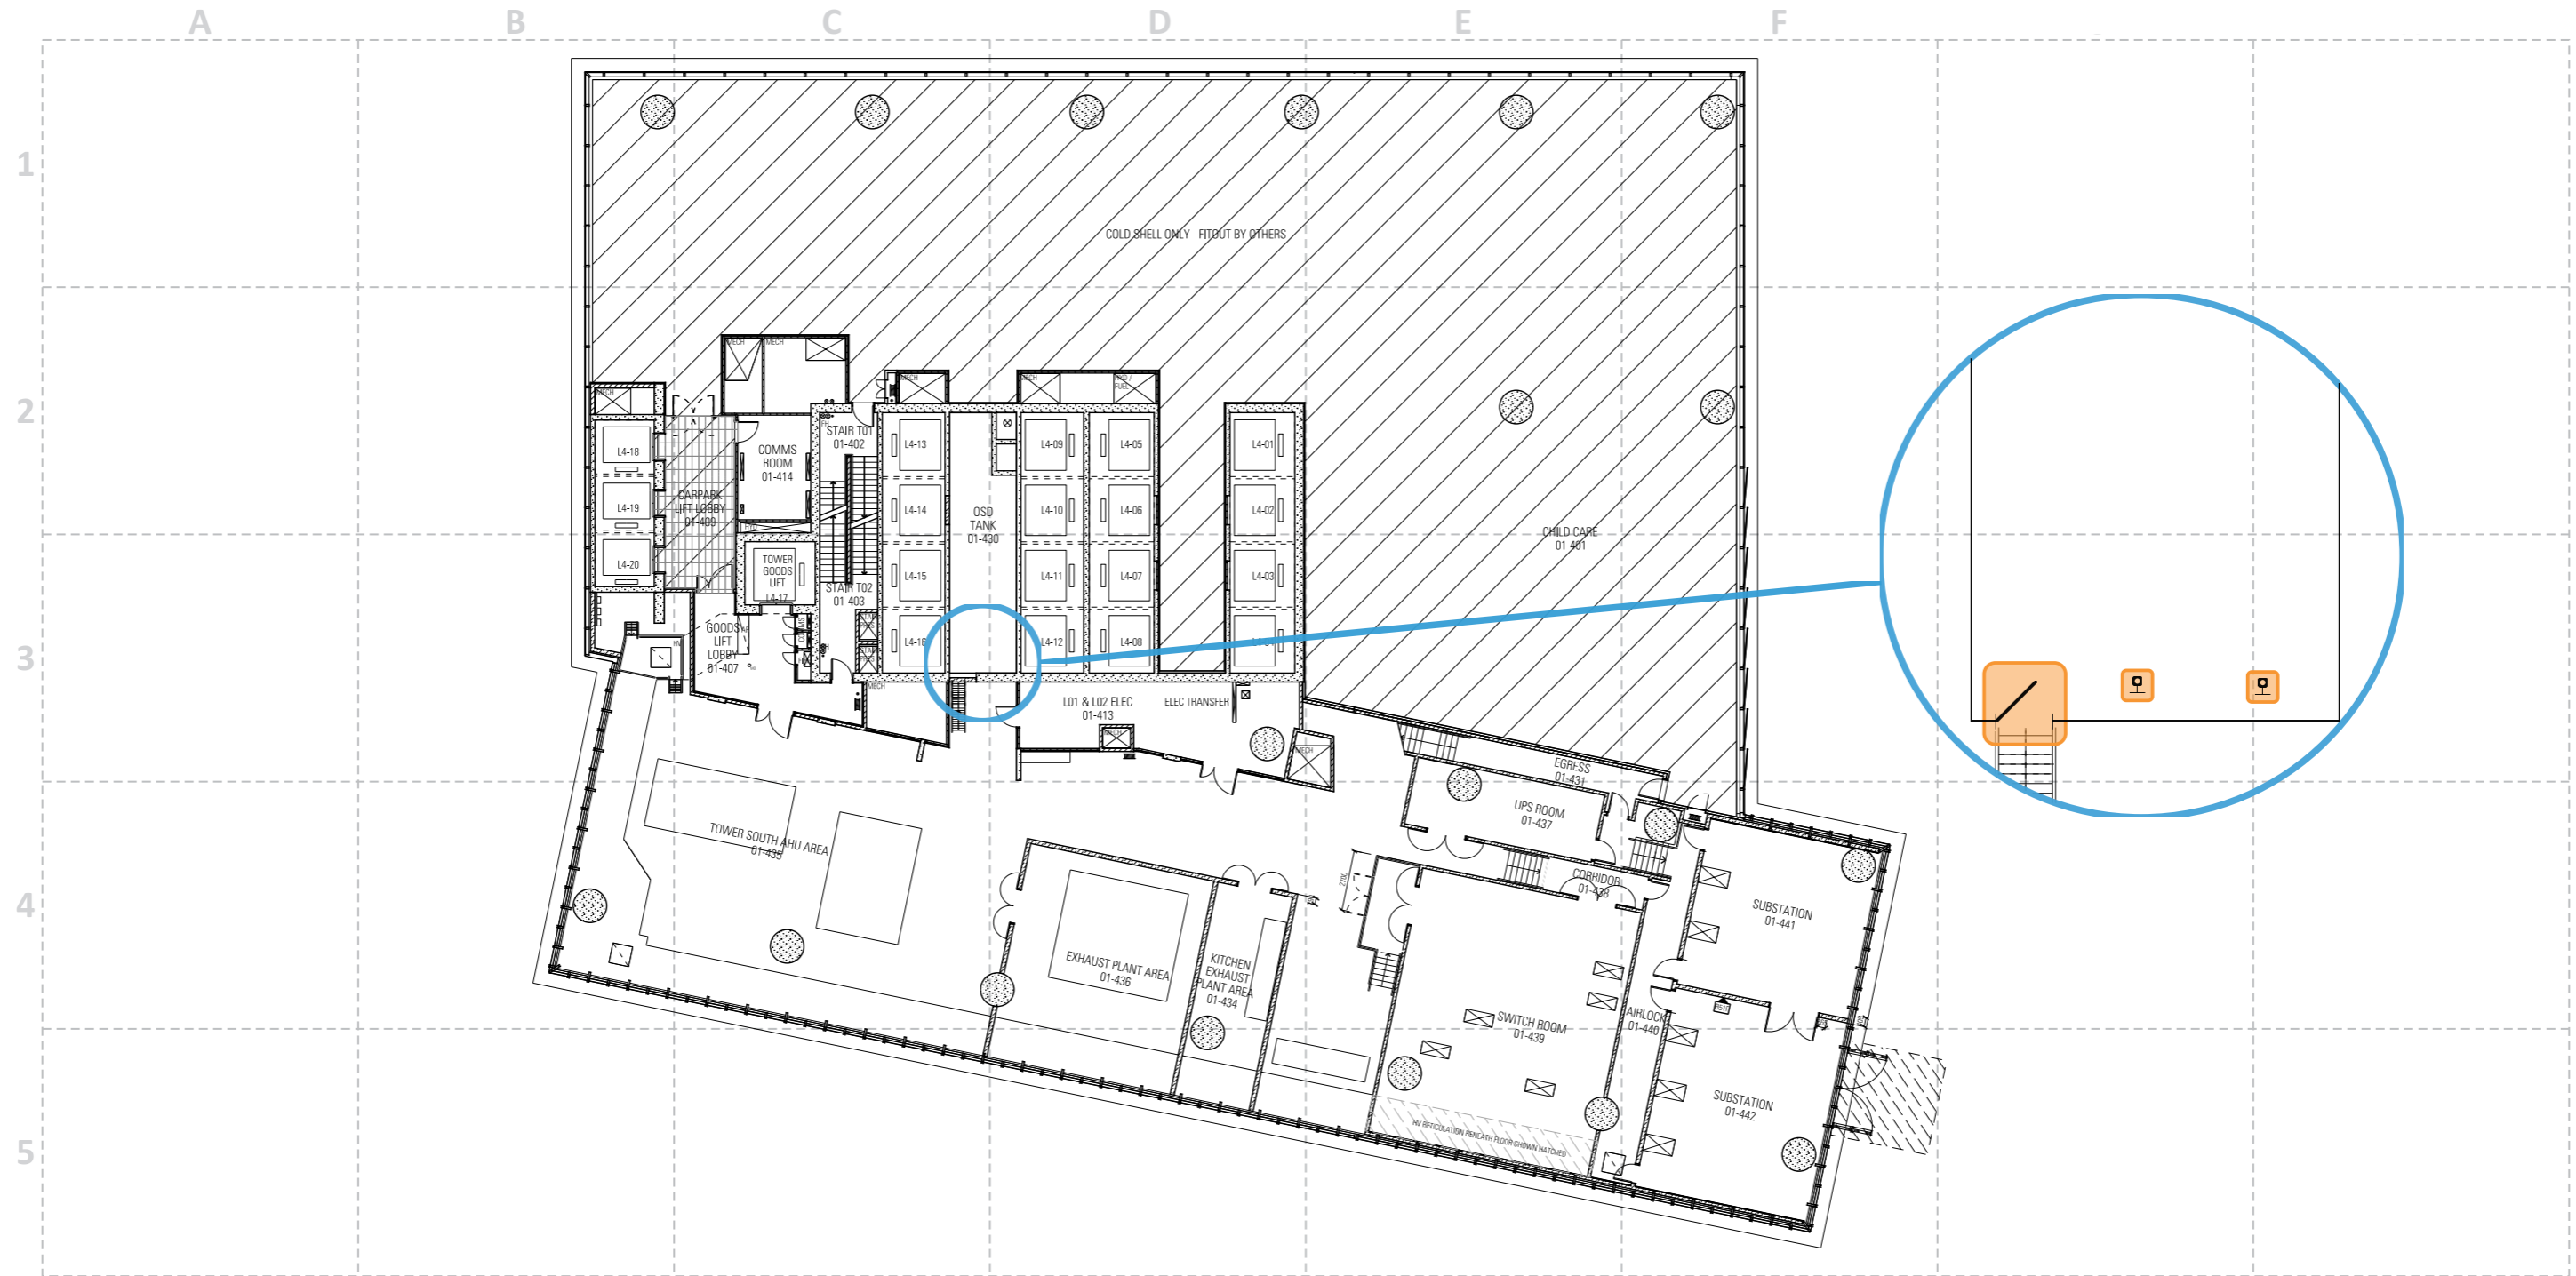
Level 1, Working at Heights Control Measures

- Legend:
- Existing Anchor Point with out of date tag.
 - Proposed Installation of a Ladder Gate
