Work at Height Assessment

6 & 8 Parramatta Square

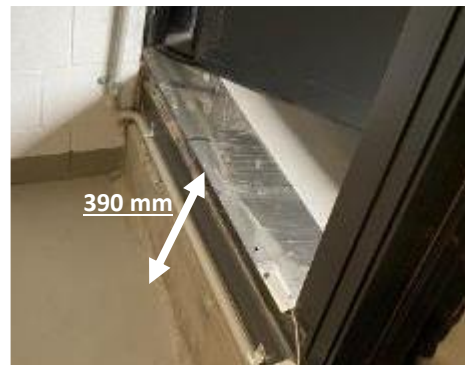
4. Exterior, Podium 3, Plant Room, Balcony – The thresholds/steps at the base of the door frames were measured to extend 390 mm above the ground, presenting trip hazards.

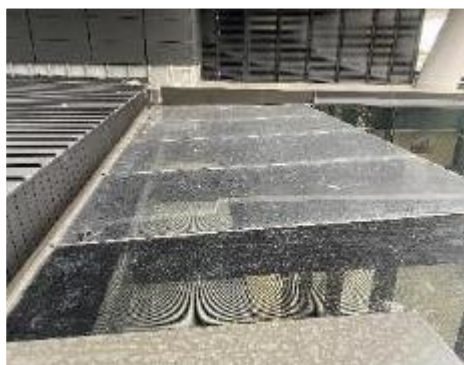
5. Exterior, Podium 3, Roof above Podium 1 connection to 4 Parramatta Square – SWL of glass panels was not displayed.

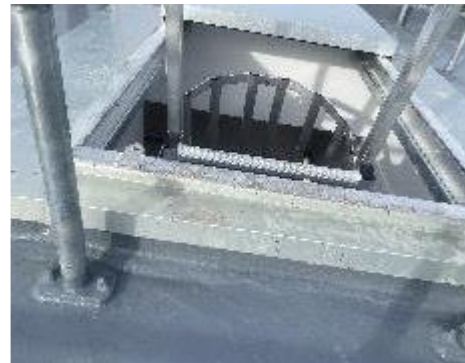
10. Exterior, Level 52, Rooftop, Upper Level - No upper landing platform provided. Uneven surface surrounding the access hatch presenting a trip hazard.

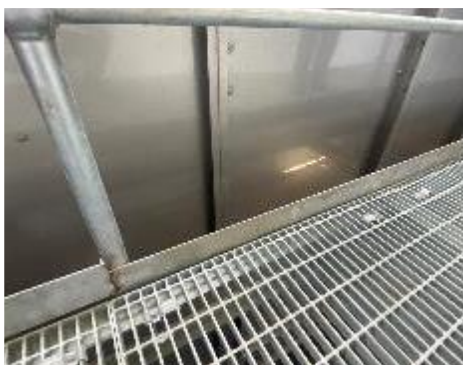
11. Interior, Level 51, Plant Room, Upper Level – Unsecured toe board presenting a risk of falling objects.

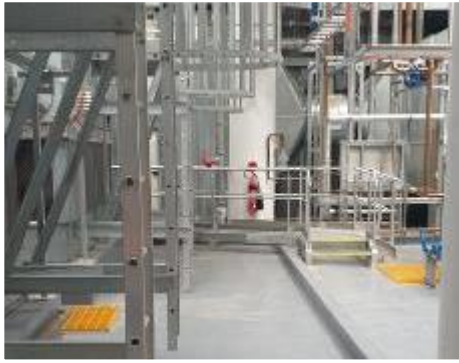
13. Interior, Level 51, Plant Room, Cooling Towers, Upper Level – Rung to-ground spacing was observed to be greater than the rung-rung spacing.

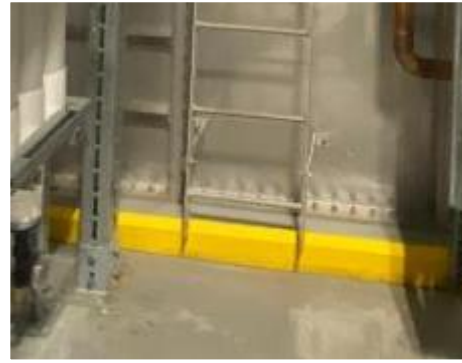
14. Interior, Level 26, Plant Room, Rain Water Tank – The concrete platform, located beneath the tank, was observed to impede the required 200 mm clearance from the back edge of the rungs of the rung ladder.

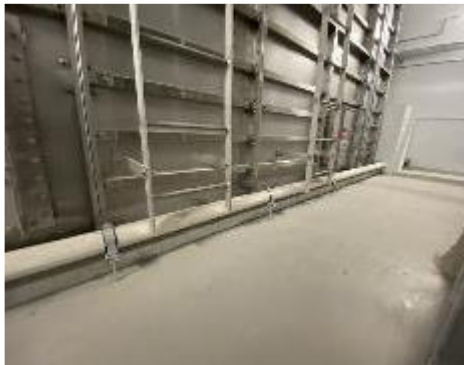
15. Interior, Level 26, Plant Room, Potable Water Tank – PVC pipe obstructing the required 200 mm clearance from the back edge of the rungs of the rung ladder.

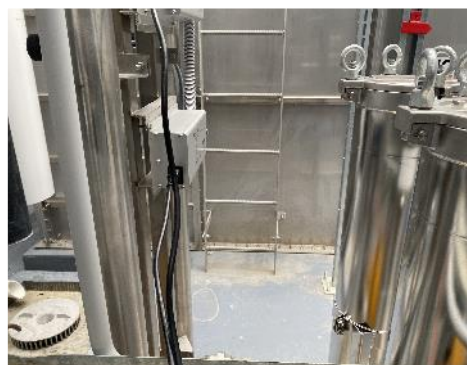
17. Interior, Level 51, Plant Room, Rain Water Tank – Rung to-ground spacing was observed to be less than 90% of the rung-to-rung spacing.

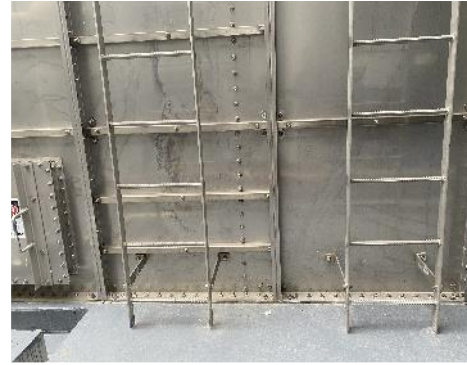
18. Interior, Level 51, Plant Room, Potable Water Tank – Rung to-ground spacing was observed to be less than 90% of the rung-to-rung spacing.
