Working at Heights Assessment
Western Sydney University - Bankston City Campus
74 Rickard Road, Bankstown, New South Wales

Walker Corporation
September 2023

Job No: 117259S

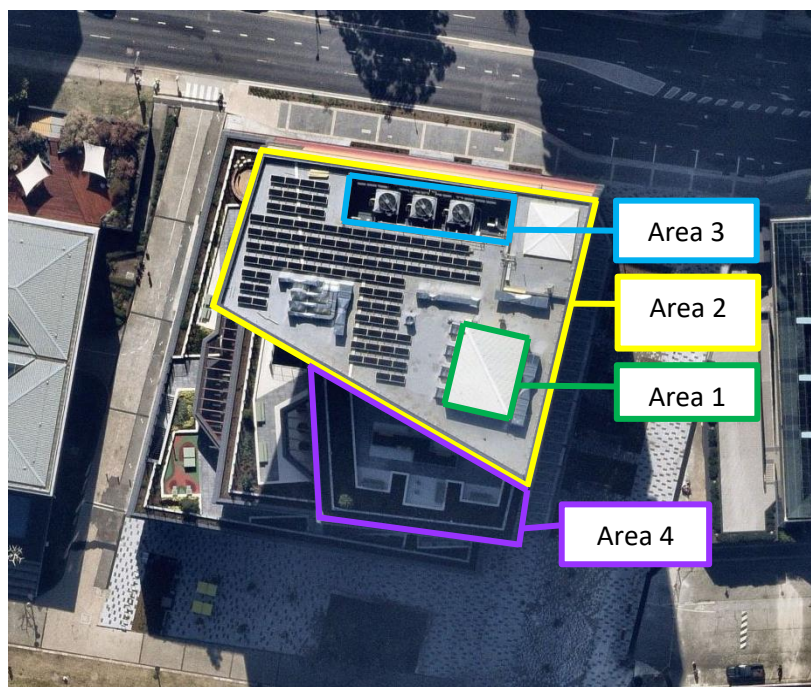
- Area 1 – Level 19 upper roof;
- Area 2 – Level 19 rooftop;
- Area 3 – Level 18, cooling tower area; and
- Area 6 – Level 14 Terrace.

Figure 1: Indication of roof areas

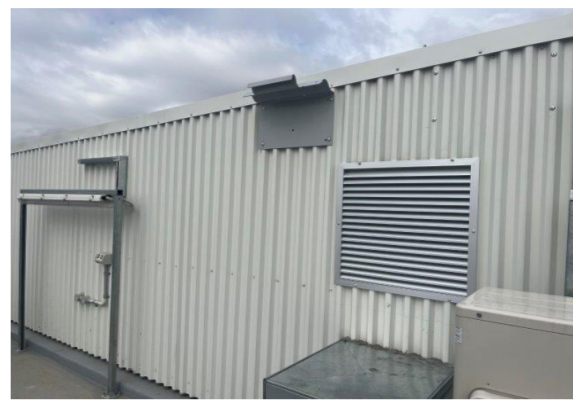
Area	Location	Activity	Observations / Findings	Factors - Likelihood of Fall	Factors - Consequence	Current Risk Controls	Deficiencies Identified	Likelihood	Consequence	Residual Risk	Additional Risk Controls	Photographs	Photographs
1	Exterior, Level 19, Upper Rooftop	<ul style="list-style-type: none"> Accessing upper roof level (housing beacon) 	<ul style="list-style-type: none"> Access to this area is provided via a locked door from Level 18; and A ladder bracket was provided to access to the upper roof from the Level 19 rooftop (Photo 1). 	Three points of contact - N Work within 2 m of unprotected Edge - Y Occupancy below - Transient Carry Equipment - Y Trip Hazards - N Pitch - Flat Operator facing edge - Y Frequency of access - Low	Height of Fall - 1m to 6m Landing - Flat hard stand	<ul style="list-style-type: none"> Access restricted to competent contractors only; Contractors to submit SWMS, risk assessments and complete permits prior to undertaking works; Ladder bracket to reduce unauthorised access. 	The ladder bracket was not listed in the Rigcom Site Certificate, dated 25/10/2022.	Unlikely	Moderate	Low	Include the ladder bracket in future annual height safety certification inspections.

<p>Photo 1: Ladder bracket provided to access Level 18 upper roof, not listed in the Rigcom Site Certificate, dated 25/10/2022.</p>

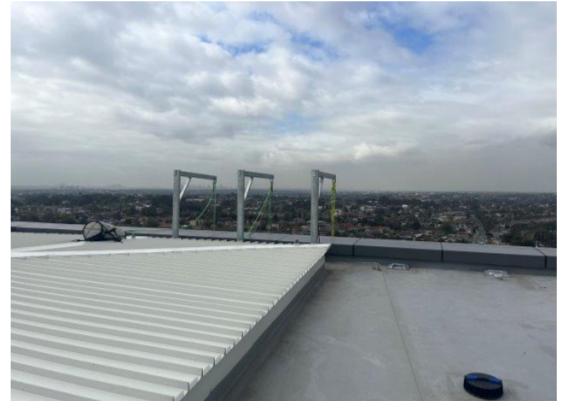
<p>Photo 2: Level 19 rooftop davit arms</p>

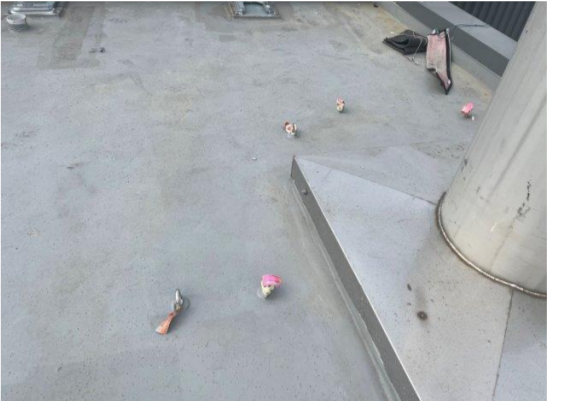
<p>Photo 3: Level 19 rooftop anchor points</p>

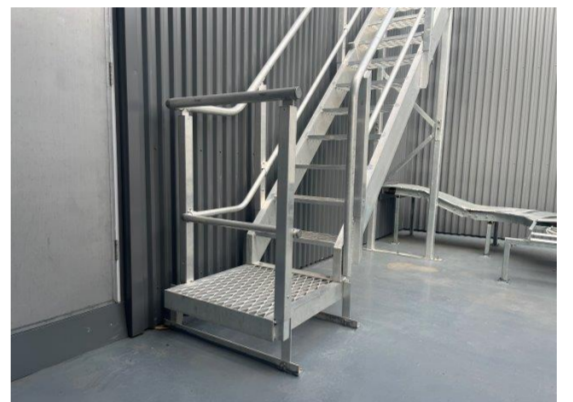
3	Exterior, Level 18, Cooling Tower Area	<ul style="list-style-type: none"> Access to Level 19, Rooftop 	<ul style="list-style-type: none"> Access to this area is provided via a locked door from Level 18; The cooling tower area is provided with perimeter walls greater than the minimum requirement of 2000 mm; and A fixed staircase is provided to access Level 19. 	Three points of contact - Y Work within 2 m of unprotected Edge - Y Occupancy below - Rare Carry Equipment - Y Trip Hazards - N Pitch - Flat Operator facing edge - N Frequency of access - Low Work within 2 m of unprotected Edge - N	Height of Fall - 1m to 6m Landing - Flat hard stand	<ul style="list-style-type: none"> Access restricted to competent contractors only; Contractors to submit SWMS, risk assessments and complete permits prior to undertaking works; Perimeter walls greater than the minimum requirement of 2000 mm provided; Fixed staircase providing access to Level 19; and Grab rails extend greater than the minimum requirement of 1000 mm above the platform. 	The step provided at both the base (600mm) and top (650mm) of the staircase were greater than the maximum recommended height of 300mm and not provided with an intermediary step (Photos 4 and 5).	Unlikely	Minor	Low	Provide an intermediary step at both the base and top of the fixed ladder.

<p>Photo 4: Step provided at the base of the staircase was 600mm</p>

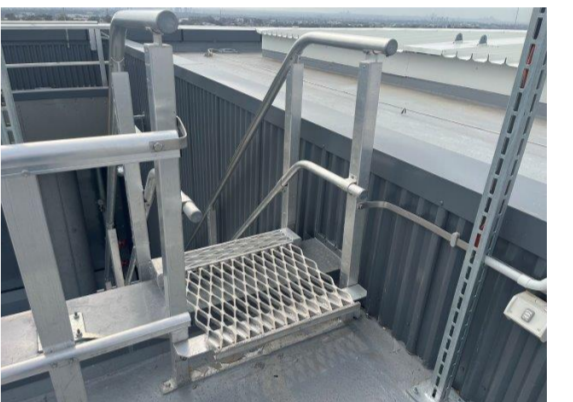
<p>Photo 5: Step provided at the top of the staircase was 650mm</p>

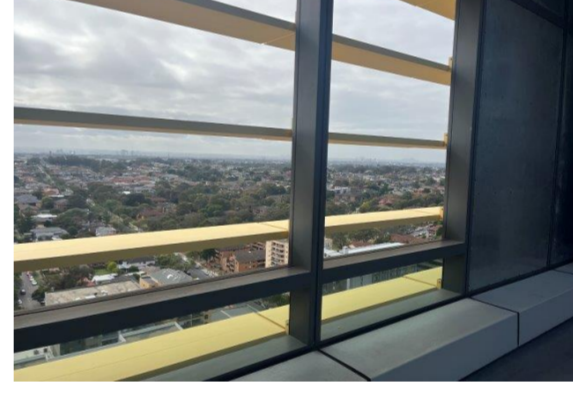
- Level 18, Cooling Tower Area – The gaps between louvres on the perimeter wall varied, with a maximum gap of 585 mm. This was noted to be greater than the maximum gap of 450 mm which is recommended within Australian Standard (AS) 1657, *Fixed Platforms, Walkways, Stairways and Ladders – Design Construction and Installation*; and
- Exterior, Level 3 Terrace - The raised garden bed adjacent to the stairs to Level 2 reduced the effective height of the barrier, reducing it to a height less than the minimum requirement of 1000 mm as per the BCA.

4	Exterior, Level 18, Cooling Tower Area	<ul style="list-style-type: none"> Maintenance of cooling towers Access to Level 19, Rooftop 	<ul style="list-style-type: none"> Access to this area is provided via a locked door from Level 18; The cooling tower area is provided with perimeter walls greater than the minimum requirement of 2000 mm; Three (3) cooling towers are provided within this area; and Fixed rung ladders are provided to access the upper section of the cooling towers. 	Three points of contact - Y Work within 2 m of unprotected Edge - Y Occupancy below - Transient Carry Equipment - Y Trip Hazards - Y Pitch - Flat Operator facing edge - Y Frequency of access - Low	Height of Fall > 6m Landing - Uneven hard stand	<ul style="list-style-type: none"> Access restricted to competent contractors only; Contractors to submit SWMS, risk assessments and complete permits prior to undertaking works; Perimeter walls greater than the minimum requirement of 2000 mm provided; and 'Toe-board' (460 mm high) provided to base of external perimeter wall. 	The gaps between louvres varied, with a maximum gap of 585 mm, and were noted to be greater than the maximum recommended 450 mm (Photo 6), and No metal mesh provided to external perimeter wall.	Unlikely	Major	Medium	Provide additional controls to the external perimeter wall such that the gaps between louvres are less than 450mm.

<p>Photo 6: Gaps between louvres were greater than 450mm</p>

- Provide additional controls to the external perimeter wall in the Level 18 Cooling Tower Area such that the gaps between louvres are less than 450mm; and
- Increase the effective height of the Level 3 Terrace wall adjacent to the stairs to Level 2, such that it meets the minimum requirement of 1000 mm.

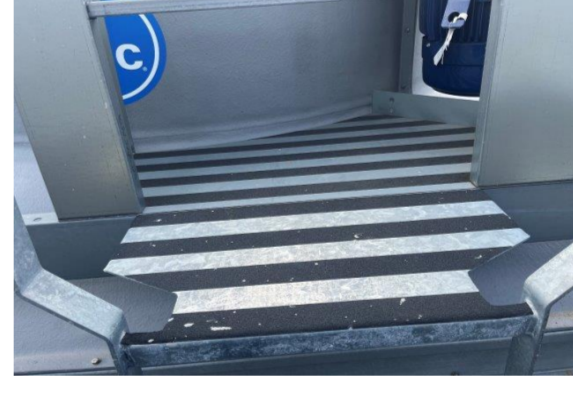
5	Exterior, Level 18, Cooling Tower Area	<ul style="list-style-type: none"> Maintenance of cooling towers 	<ul style="list-style-type: none"> Access to this area is provided via a locked door from Level 18; Three (3) cooling towers are provided within this area; and Fixed rung ladders are provided to access the upper section of the cooling towers. 	Three points of contact - Y Work within 2 m of unprotected Edge - Y Occupancy below - N/A Carry Equipment - Y Trip Hazards - N Pitch - Flat Operator facing edge - N Frequency of access - Low	Height of Fall - 1m to 6m Landing - Flat hard stand	<ul style="list-style-type: none"> Access restricted to competent contractors only; Contractors to submit SWMS, risk assessments and complete permits prior to undertaking works; Upper sections of cooling towers provided with guard rail, fixed rung ladder and ladder gate. 	The landing provided at top of the cooling tower ladders was noted to be 800 mm, less than the minimum requirement of 900 mm (Photo 7). Given a ladder gate was provided, no recommendation has been raised.	Unlikely	Moderate	Low	None

<p>Photo 7: Ladder gate provided to top of cooling tower</p>

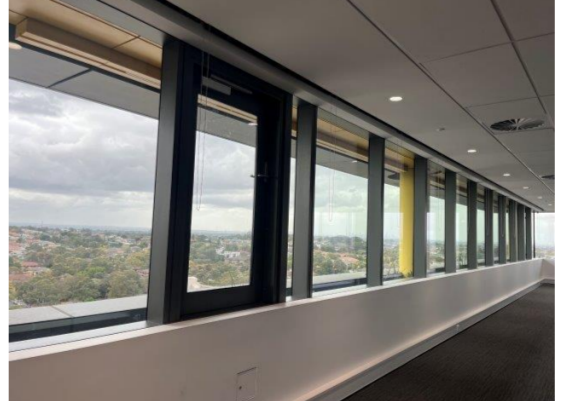
6	Exterior, Levels 14, 8 & 3 Terrace & Garden Beds	<ul style="list-style-type: none"> Garden maintenance Window cleaning Façade maintenance 	<ul style="list-style-type: none"> Access to anchor points and rigid rail systems is restricted, either through a window or a gate within the glass balustrade (Photo 8); Anchor points and rigid rail systems are provided to the garden beds (Photo 9); and Balustrades were noted to be greater than the minimum requirement of 1000 mm. 	Three points of contact - Y Work within 2 m of unprotected Edge - Y Occupancy below - Transient Carry Equipment - Y Trip Hazards - Y Pitch - Flat Operator facing edge - Y Frequency of access - Low	Height of Fall > 6m Landing - Flat hard stand	<ul style="list-style-type: none"> Access restricted to competent contractors only; Contractors to submit SWMS, risk assessments and complete permits prior to undertaking works; Anchor points and rigid rail systems provided to the garden beds; Inspection/maintenance and tagging of fall arrest systems; and Balustrades were provided and were greater than the minimum requirement of 1000 mm. 	None	Rare	Major	Low	None

<p>Photo 8: Hatch to access rigid rail systems</p>

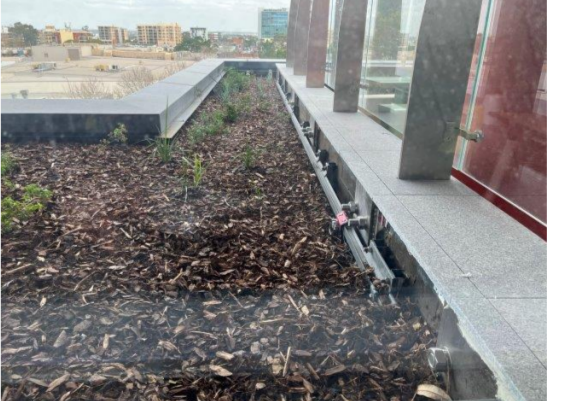
<p>Photo 9: Rigid rail systems provided in garden bed</p>

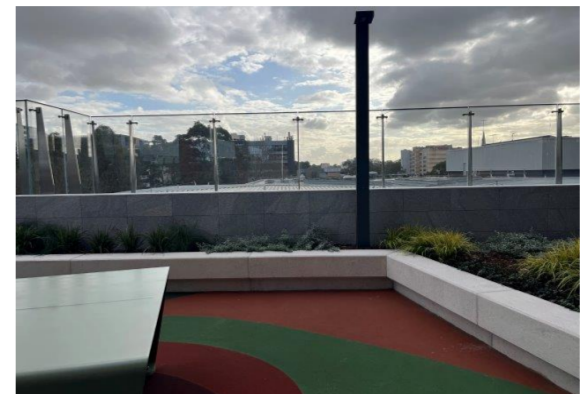
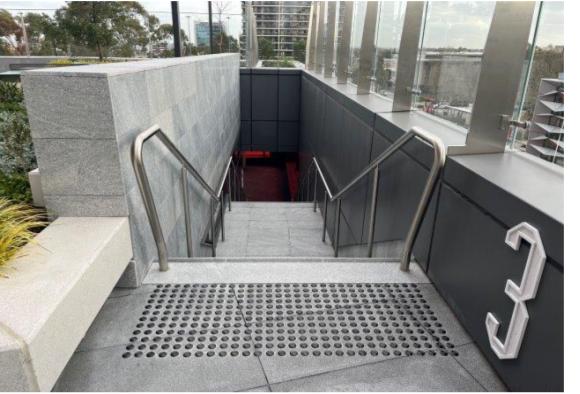
Area	Location	Activity	Observations / Findings	Factors - Likelihood of Fall	Factors - Consequence	Current Risk Controls	Deficiencies Identified	Likelihood	Consequence	Residual Risk	Additional Risk Controls	Photographs	Photographs
7	Exterior, Level 3 Terrace	• Garden maintenance	• Balustrades were provided and were generally greater than the minimum requirement of 1000 mm.	Three points of contact - Y Work within 2 m of unprotected Edge - Y Occupancy below - Transient Carry Equipment - Y Trip Hazards - Y Pitch - Flat Operator facing edge - Y Frequency of access - High	Height of Fall - 1m to 6m Landing - Uneven hard stand	• Contractors to submit SWMS, risk assessments and complete permits prior to undertaking works; and • Balustrades were provided and were generally greater than the minimum requirement of 1000 mm.	The raised garden bed adjacent to the stairs to Level 2 reduced the effective height of the wall, reducing it to a height less than the minimum requirement of 1000 mm (Photos 10 & 11).	Unlikely	Major	Medium	Increase the effective height of the barrier provided adjacent the raised garden bed, located adjacent to the stairs to Level 2, such that it meets the minimum requirement of 1000 mm.

Photo 10: Raised garden bed reducing the effective height of the wall adjacent the stairs to Level 2

Photo 11: Raised garden bed reducing the effective height of the wall adjacent the stairs to Level 2

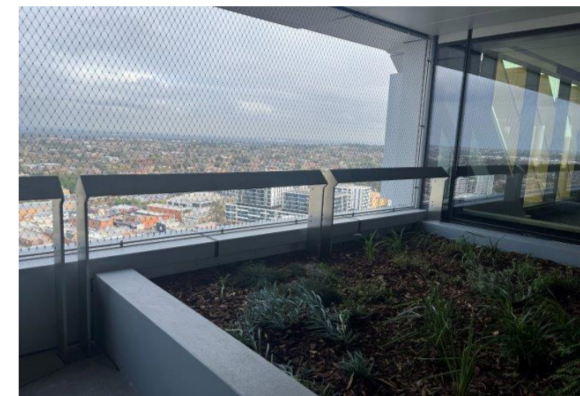
8	Exterior, Levels 18, 16, 3, 12, 11, 10, 9, 5, 2 & 1, Balcony	• Garden maintenance • Window cleaning	• Metal mesh provided to external perimeter walls; and • Generally, balustrades were noted to be greater than the maximum requirement of 1000 mm.	Three points of contact - Y Work within 2 m of unprotected Edge - Y Occupancy below - Transient Carry Equipment - Y Trip Hazards - Y Pitch - Flat Operator facing edge - Y Frequency of access - Low Trip Hazards - N Operator facing edge - N	Height of Fall > 6m Landing - Flat hard stand	• Contractors to submit SWMS, risk assessments and complete permits prior to undertaking works; • Metal mesh provided to external perimeter walls (Photo 12); and • Balustrades were provided and were greater than the maximum requirement of 1000 mm (Photo 13).	None	Rare	Insignificant	Low	None

Photo 12: Metal mesh to perimeter of balcony

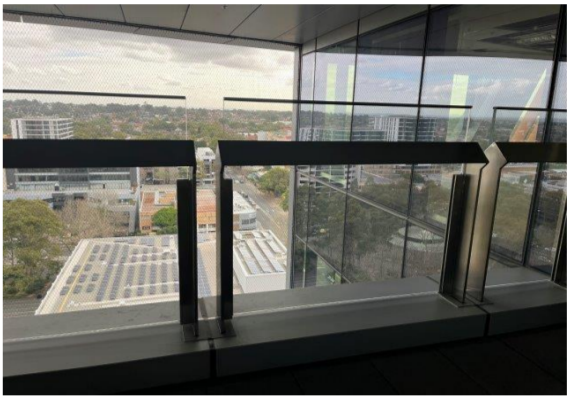
Photo 13: Balustrade provided

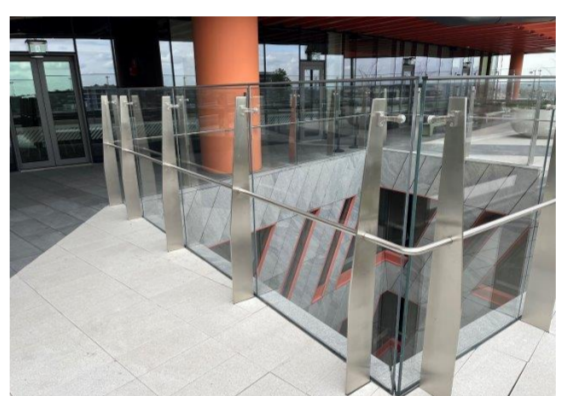
9	External/Internal, Levels 8, 3, 2 & Ground, Atriums	• Window cleaning • Garden maintenance	• Davit arms and anchor points provided to access the Level 8 Atrium (Photo 14); and • Rigid rail systems are provided to the Level 3, 2 and Ground Level Atriums (Photo 15).	Three points of contact - N Work within 2 m of unprotected Edge - Y Occupancy below - Transient Carry Equipment - Y Trip Hazards - N Operator facing edge - Y Frequency of access - Low	Height of Fall > 6m Landing - Flat hard stand	• Contractors to submit SWMS, risk assessments and complete permits prior to undertaking works; • Davit arms, rigid rail systems and anchor points provided; • Area below the atriums blocked off during works; and • Inspection/maintenance and tagging of fall arrest systems.	None	Rare	Major	Low	None

Photo 14: Level 8 atrium

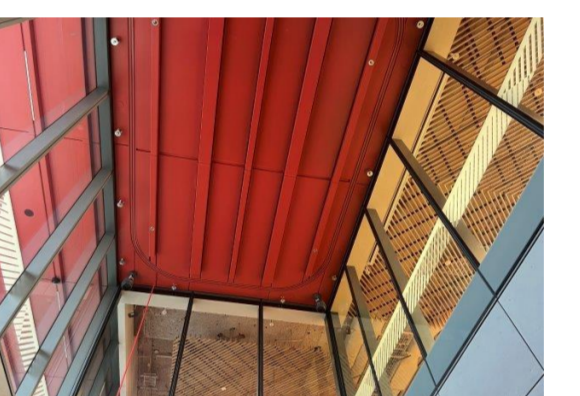
Photo 15: Rigid rail systems to Ground Level atrium
10	External, Levels 3, 1 & Ground, Awnings	• Maintenance of awning • Cleaning of awning	• Access to the Level 3 awning is provided via rope access from the rooftop (Photo 16); • Access to the Level 1 awning is provided via a locked door; • Access to the Ground Level awning is provided via the Level 3 rigid rail systems (Photo 17); and • A static line is provided along the awnings.	Three points of contact - N Work within 2 m of unprotected Edge - Y Occupancy below - Transient Carry Equipment - Y Trip Hazards - N Pitch - Flat Operator facing edge - N Frequency of access - Low	Height of Fall > 6m Landing - Flat hard stand	• Access restricted to competent contractors only; • Contractors to submit SWMS, risk assessments and complete permits prior to undertaking works; • Static lines, rigid rail systems and anchor points provided; and • Inspection/maintenance and tagging of fall arrest systems	None	Rare	Major	Low	None

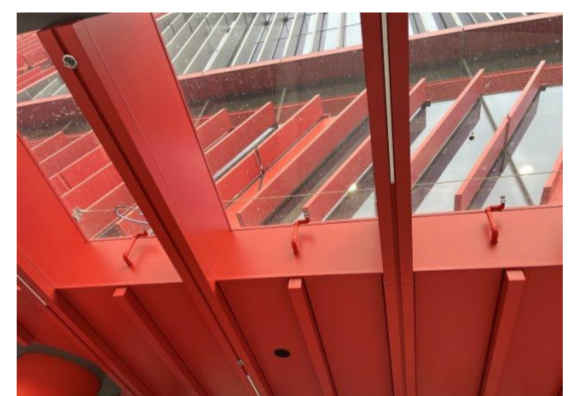
Photo 16: Level 3 awning

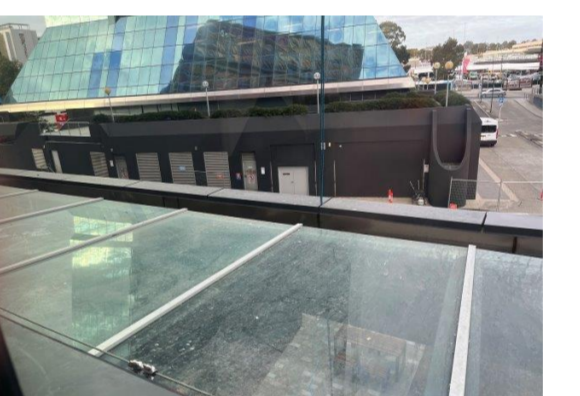
Photo 17: Ground Level awning

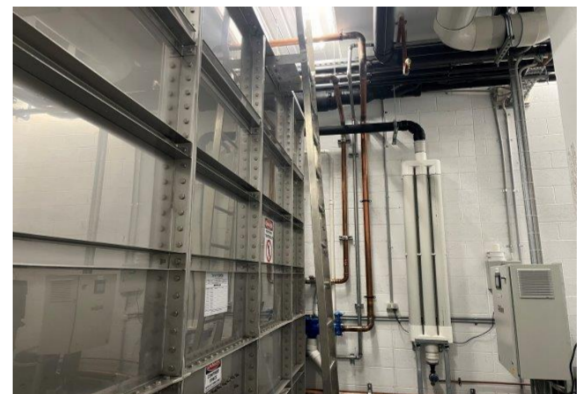
11	Internal, Level 1, Pump Room	• Maintenance of tanks	• Access to this area is provided via a locked door; • Two (2) water tanks provided (RWT & OSD); and • Fixed rung ladders are provided to access the upper section of the tanks (Photo 18).	Three points of contact - Y Work within 2 m of unprotected Edge - N Occupancy below - Rare Carry Equipment - Y Trip Hazards - N Operator facing edge - N Frequency of access - Low	Height of Fall - 1m to 6m Landing - Flat hard stand	• Access restricted to competent contractors only; • Contractors to submit SWMS, risk assessments and complete permits prior to undertaking works; • Upper sections of tanks provided with guard rail, fixed rung ladder and ladder gate.	The following was identified: • Headroom clearance at the top of the rung ladders/tanks was noted to be less than the minimum requirement of 2000 mm (Photo 19); • The landing provided at top of the water tank ladders were noted to be 450 mm, less than the minimum requirement of 900 mm; and • The extension of the ladder hand rail above for the RWT was noted to be 700 mm, less than the minimum requirement of 900 mm.	Unlikely	Moderate	Low	Request contractors to define controls/access arrangements prior to accessing the tanks.

Photo 18: Fixed rung ladder provided to water tanks

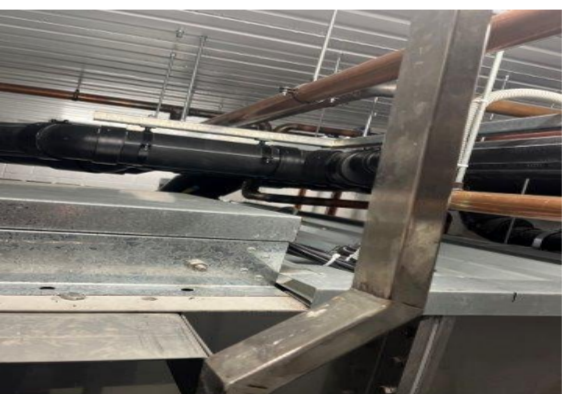
Photo 19: Reduced headroom clearance at the top of the rung ladders/tanks
