Working at Heights Assessment

4 Parramatta Square

Walker Corporation

October 2021

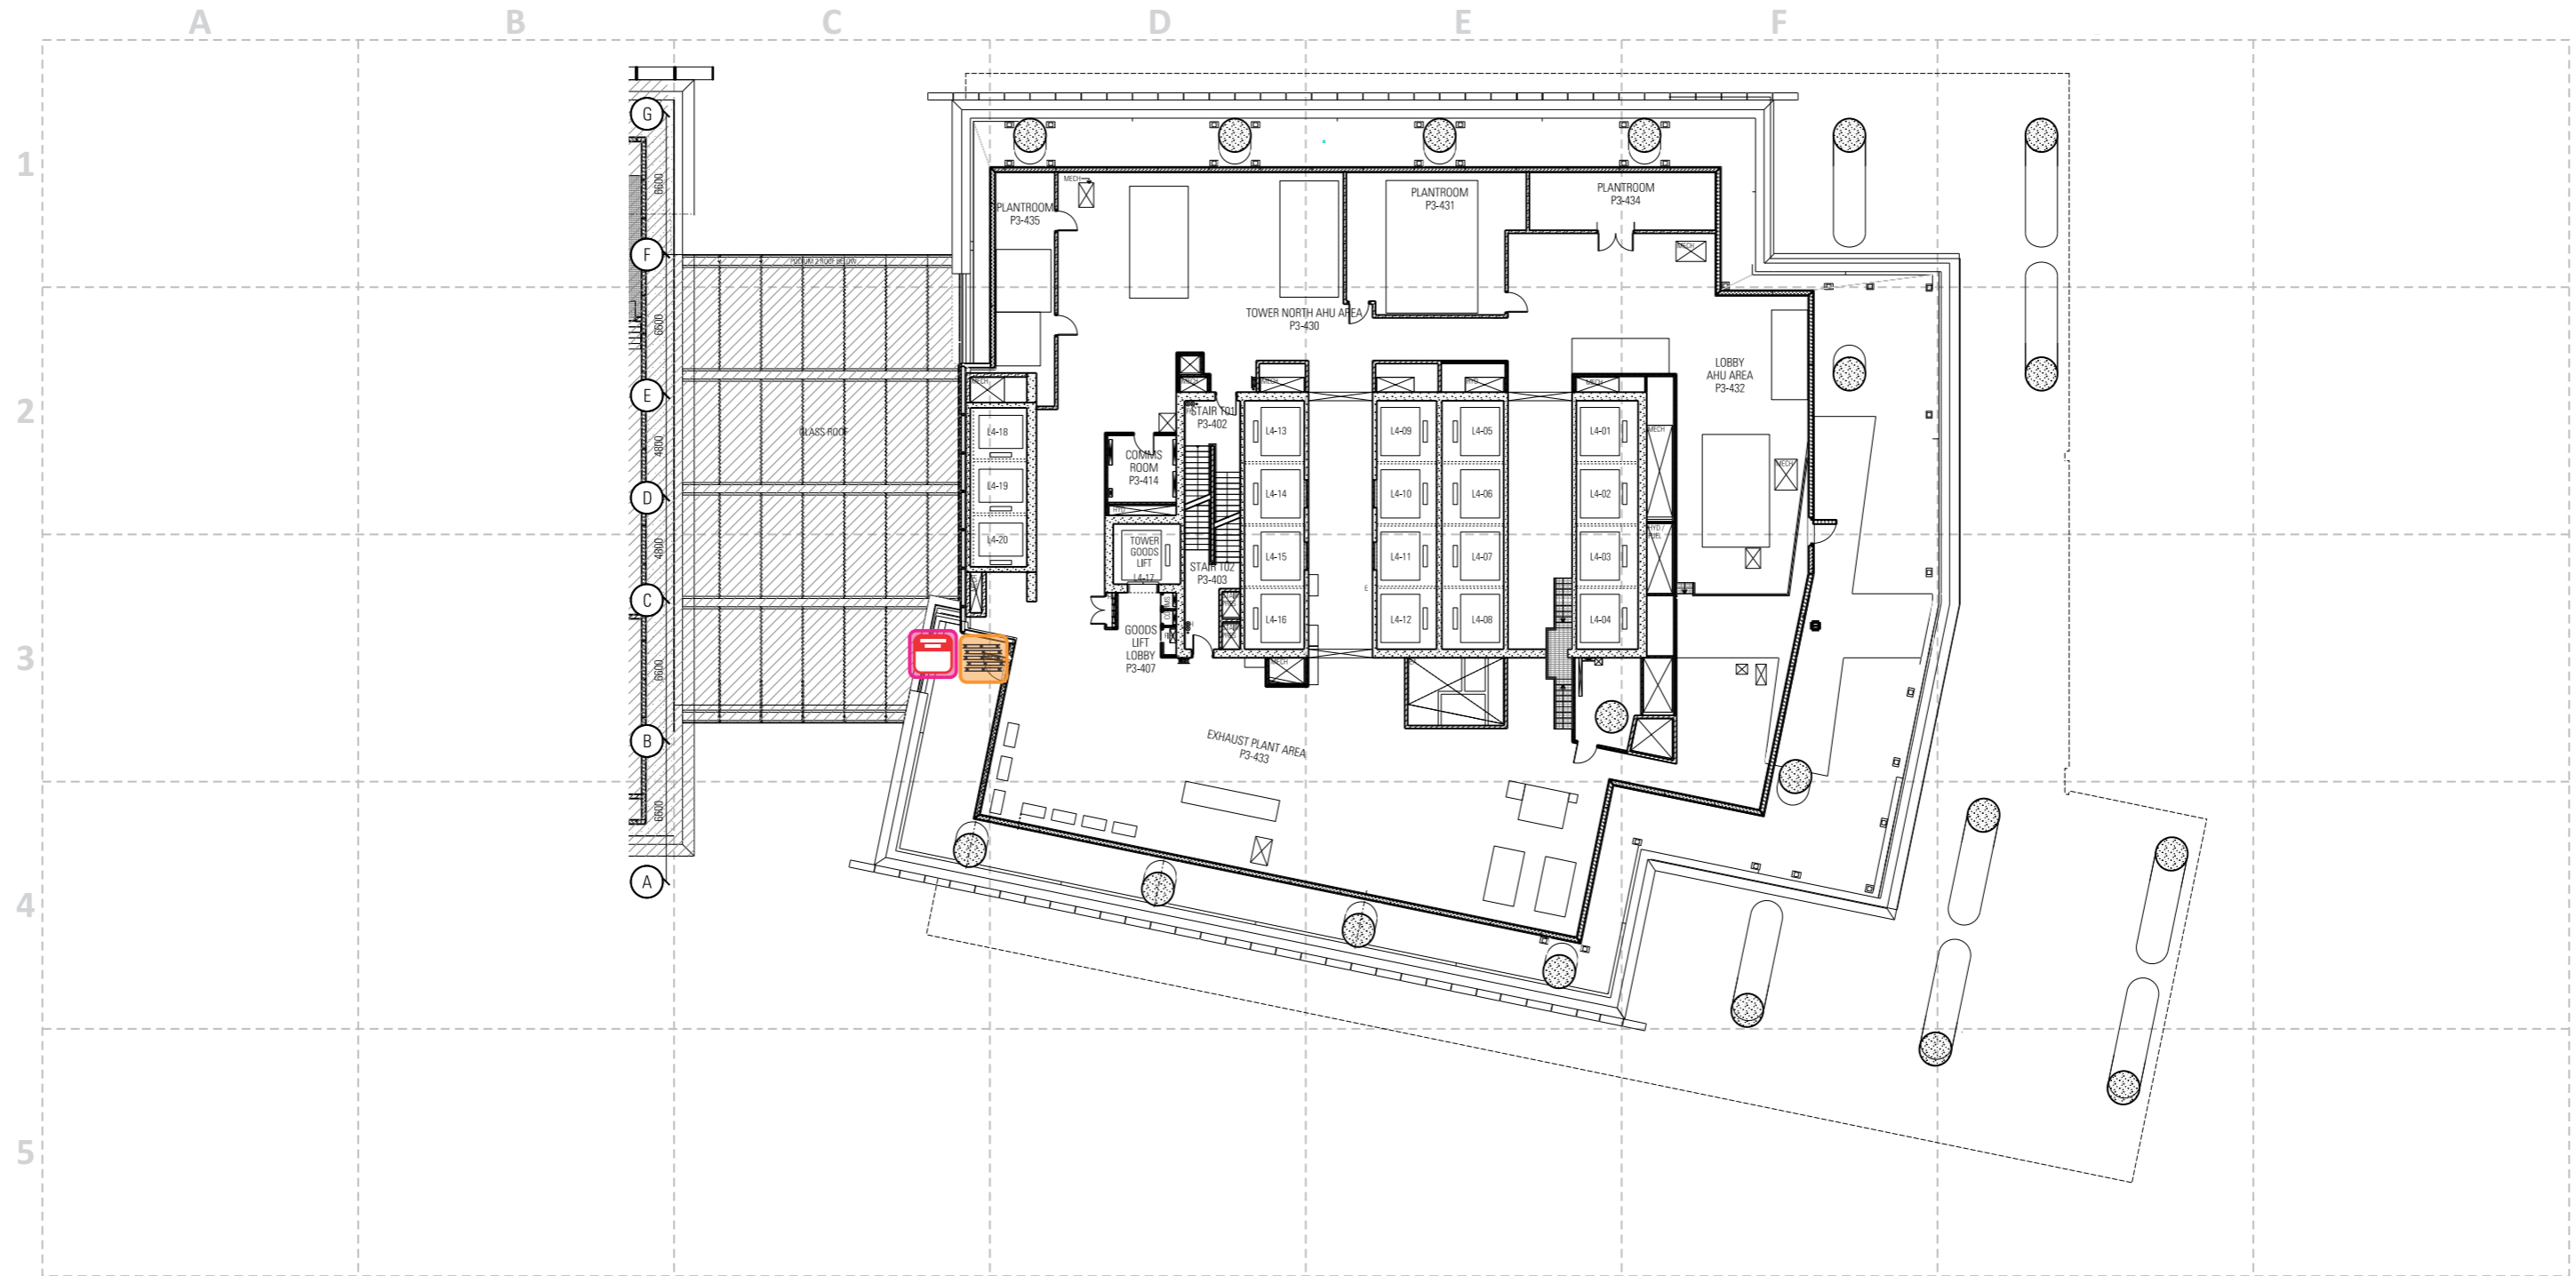
Level P3, Working at Heights Control Measures

Podium 3, Western Elevation Roof

Install a sign displaying the Safe Weight Limit (SWL) of the glass.
