2024 Fall Arrest / Rope Access System
Inspection Report

Collins Square

Project Name:	CSQ Annual Inspection
Address:	727 Collins Street
Client:	Walker
Client Contact:	Stewart Calder
Certification Date:	17/12/2024
Certification Expiry:	12 Months from the certification date

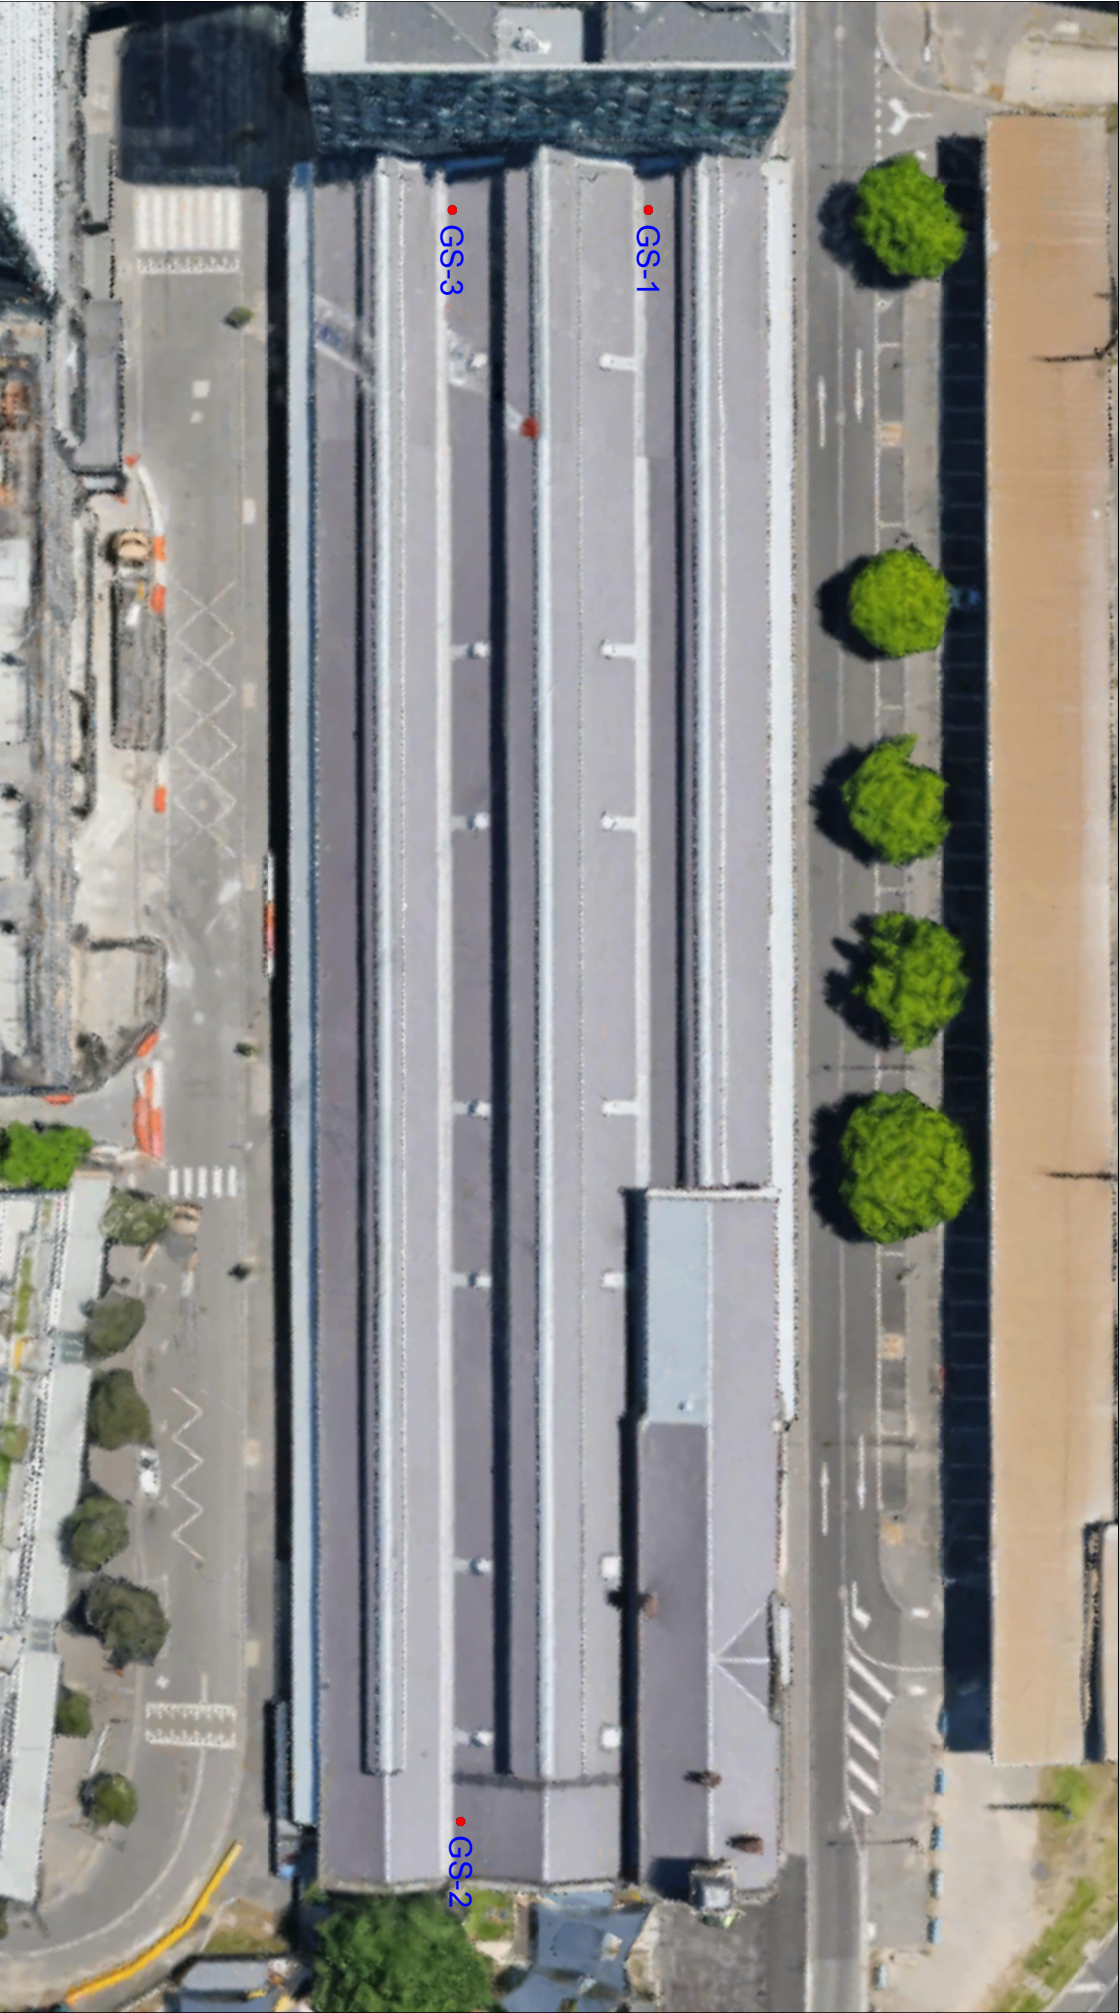
Goods Shed	Drawn: RH	Anchor Point	●	Stop	—○	Ladder Bracket	□	Biltasafe – The Experts in Roof Safety T: (03) 8319 0679 F: (03) 8880 0733 M: 0414 588 843 P: 1 Rocklea Drive, Pent Welsburn, 3207
	Design: RH	Static Line	●	●	●	Walkway	▤	
	Review: CB	Guardrail	—	—	—	Roof Access Hatch	▤	
	NTS	Fixed Ladder	▤			No Access	▤

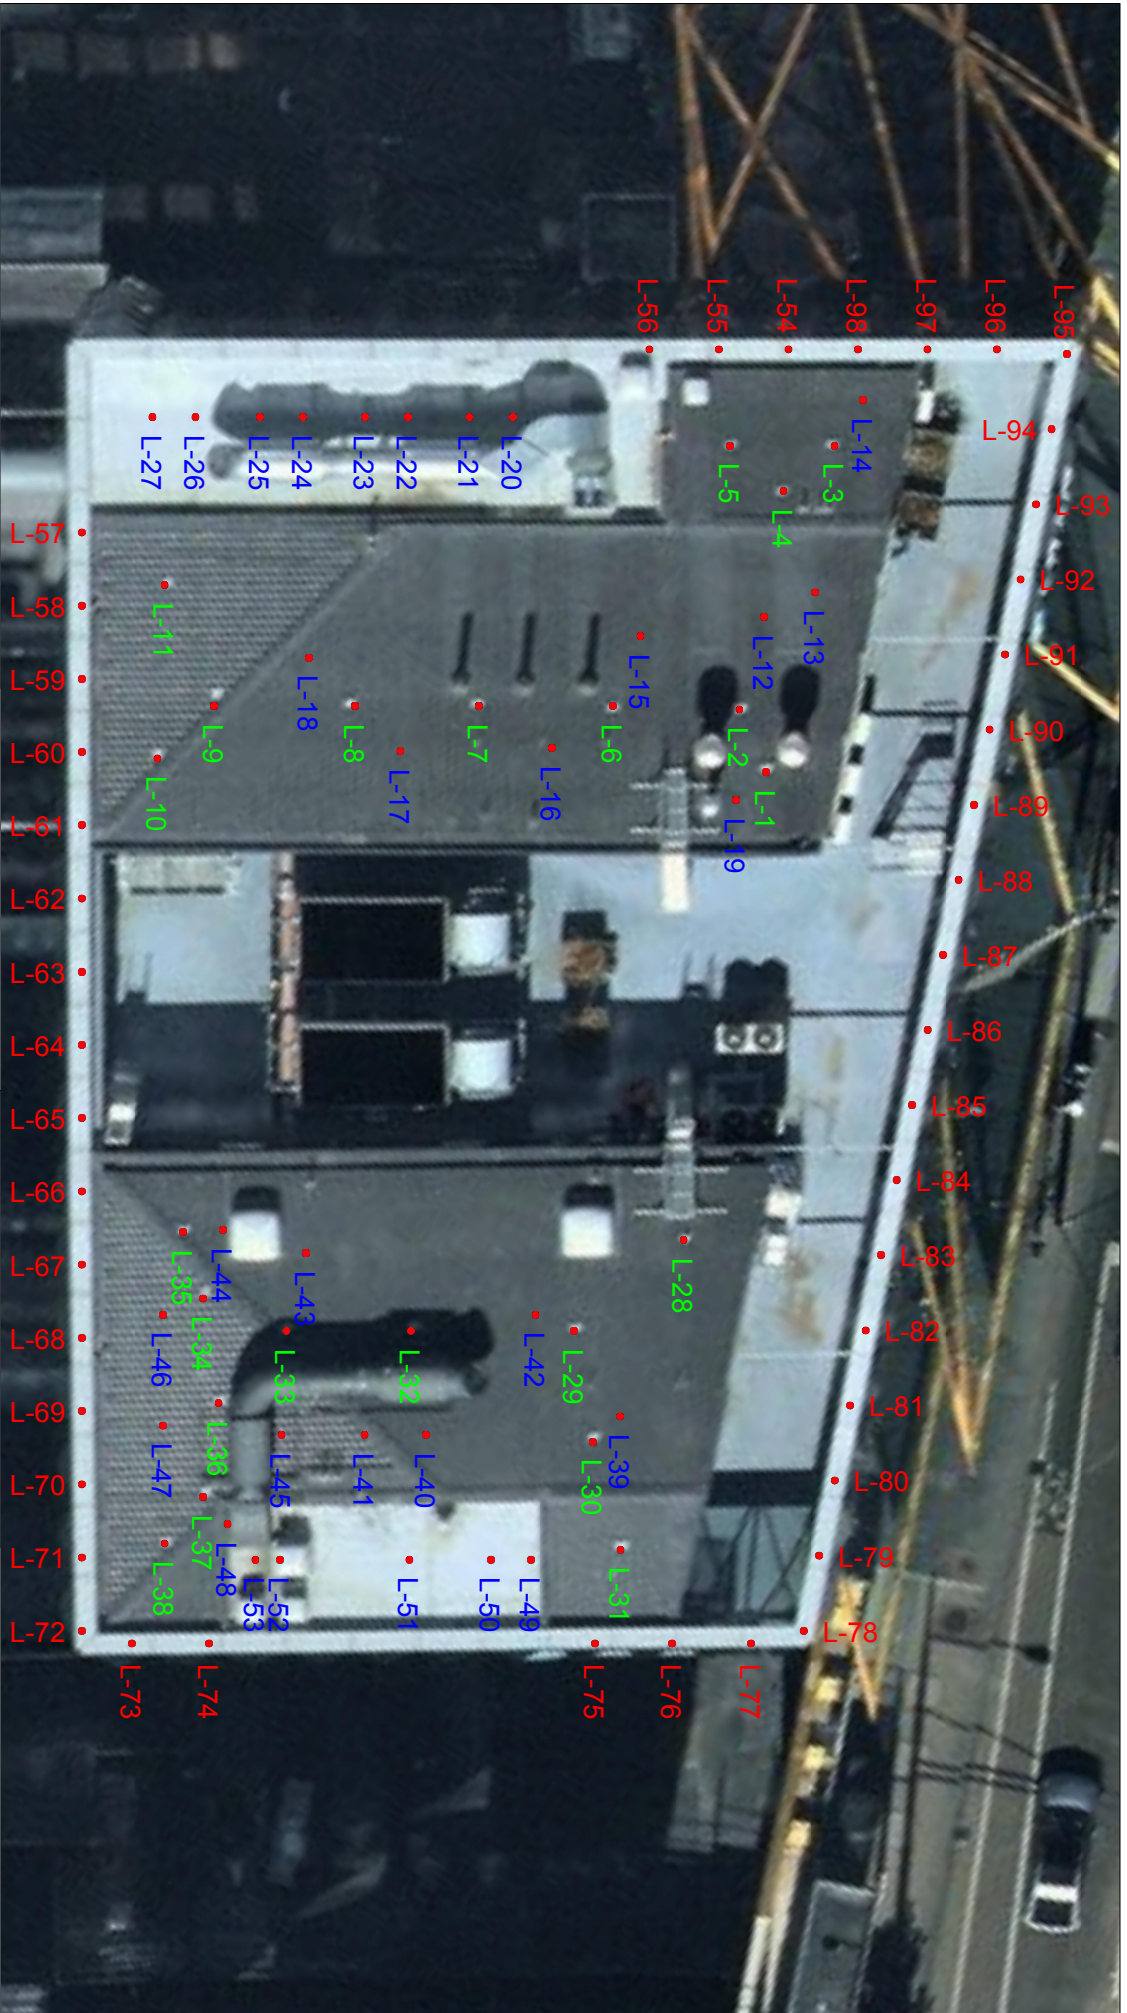
<h3>Lantern Building</h3>		Drawn: RH	Anchor Point	●	Strop	—○	
		Design: RH	Static Line	●—●	Strop	—○	
<h3>Lantern Building</h3>		Review: CB	Guardrail	—	Roof Access Hatch	▽	
		NTS	Fixed Ladder	▨	No Access	⊗	
		Ladder Bracket		▢	Walkway		▤
		Roof Access Hatch		▽	No Access		⊗
		Bitesafe – The Experts in Roof Safety T: (03) 8319 0979 F: (03) 8800 0735 M: 0414 540 543 P: Rocklea Drive, Port Melbourne 3207

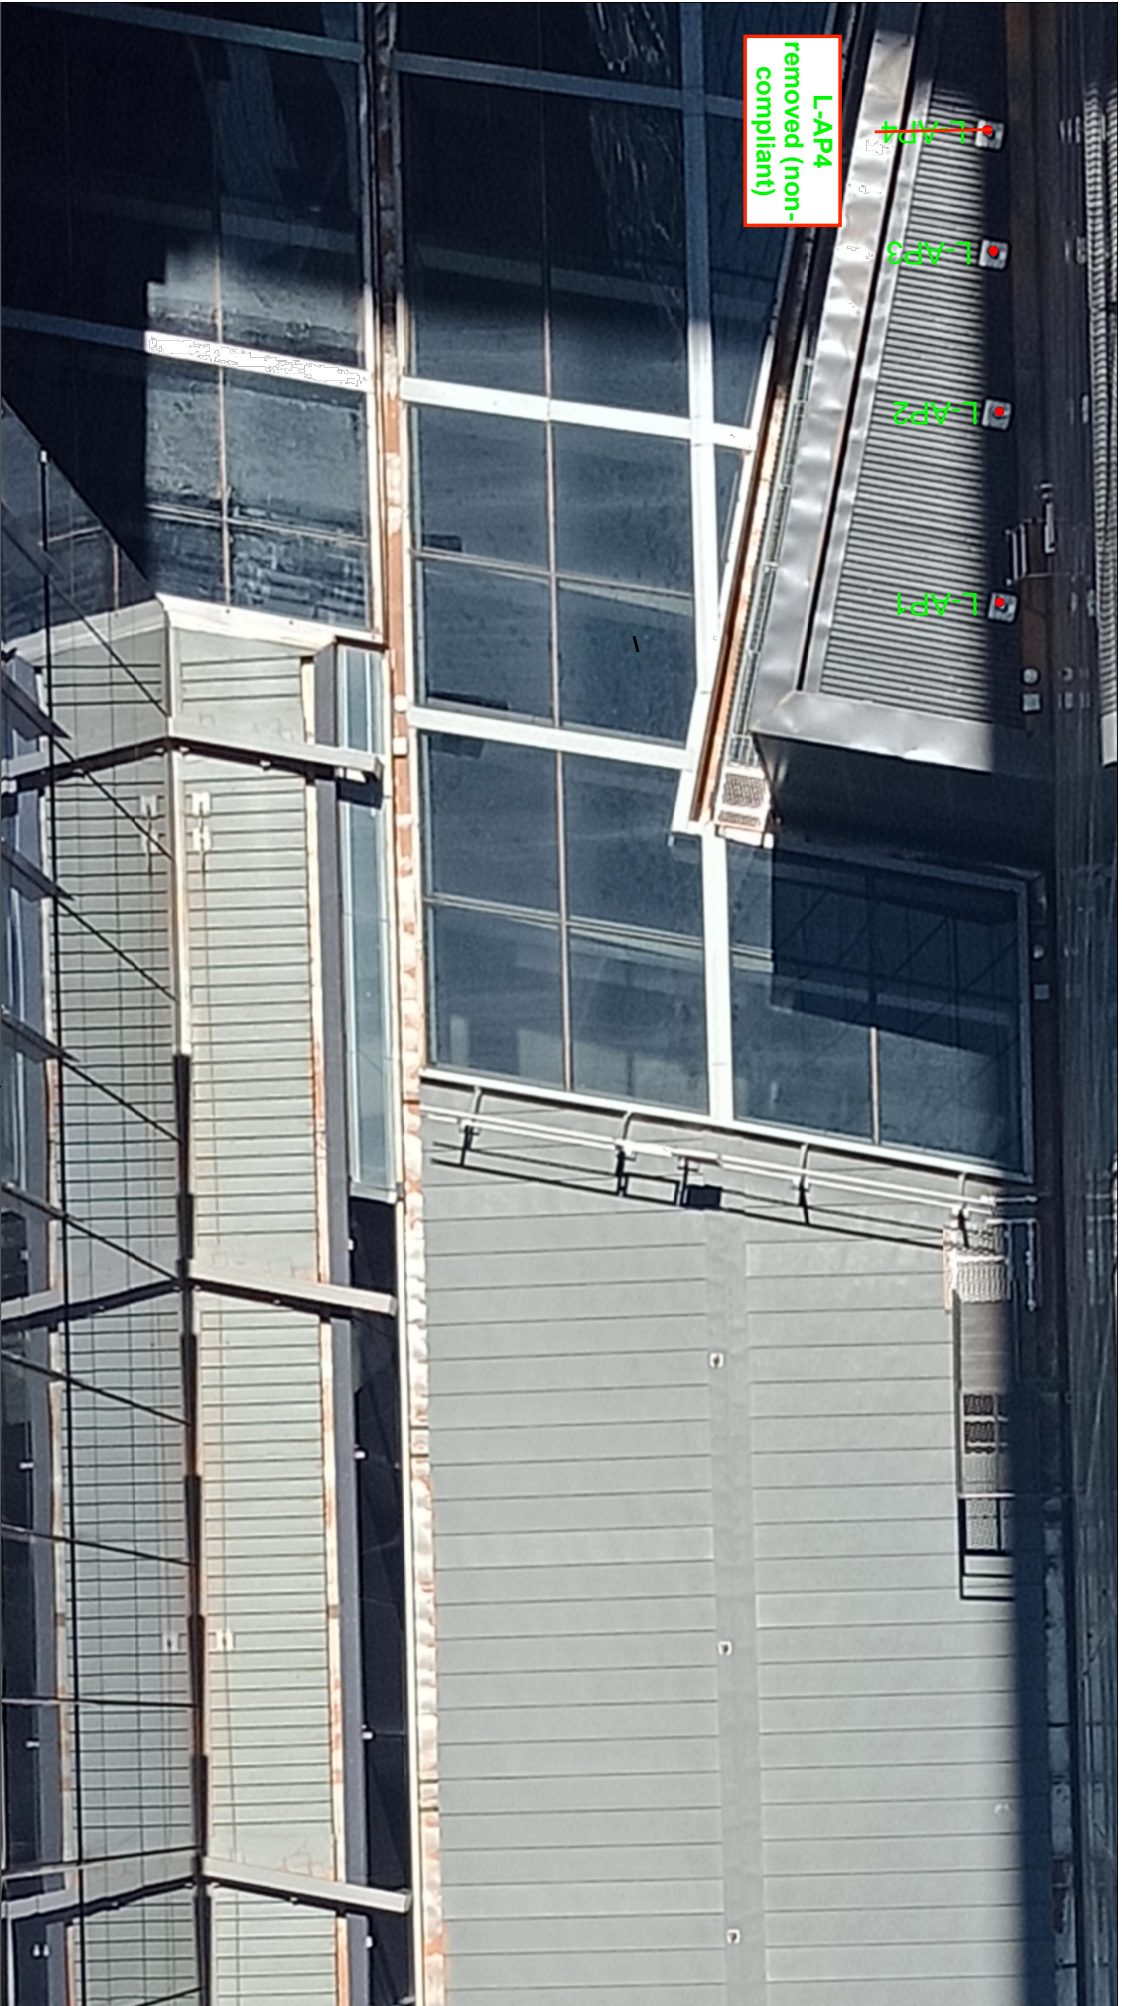
Linked	Drawn: RH	Anchor Point	●	Strop	—○	Ladder Bracket	□	Bitesafe – The Experts in Roof Safety T: (03) 8310 0979 F: (03) 8680 0733 M: 0414 549 843 P: Rocklea Drive, Port Melbourne 3207
	Design: RH	Static Line	●—●		Walkway	▤		
	Review: CB	Guardrail	—		Roof Access Hatch	▤		
	NTS	Fixed Ladder	▤		No Access	▤

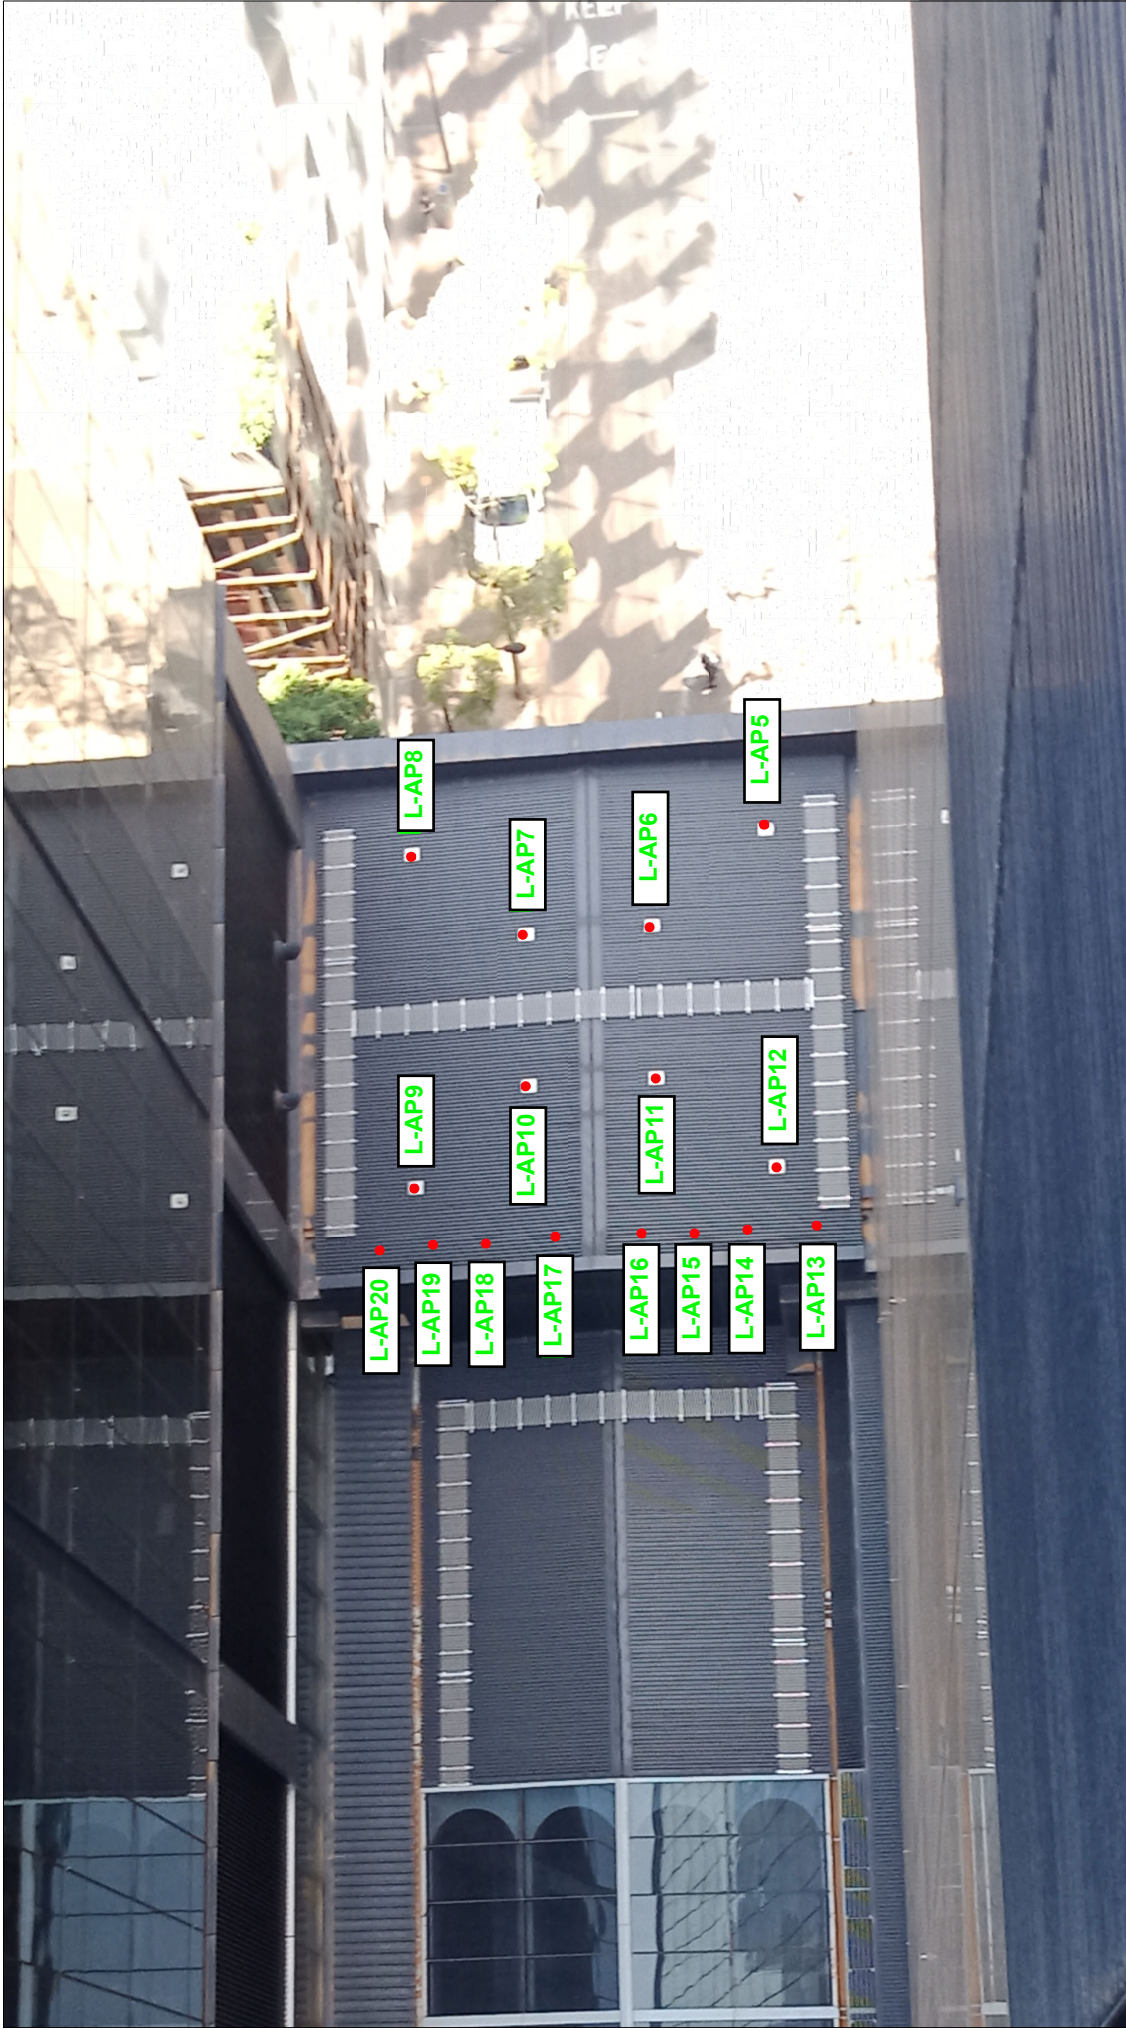
Linked		Drawn: RH	Anchor Point	●	Strop	—○	Ladder Bracket	┌	Bittesafe – The Experts in Roof Safety	
Design: RH	Static Line	●—●	●	●	●	●	Walkway	▤	T: (03) 8319 0979	F: (03) 8680 0733
Review: CB	Guardrail	—	—	—	—	—	Roof Access Hatch	▤	M: 0414 549 943	P: 4 Rocklea Drive, Port Melbourne 3207
NTS	Fixed Ladder	┌	┌	┌	┌	┌	No Access	▤	Verify all dimensions and site measure before commencing work. Do not scale from this drawing. This drawing is copyright and should not be reproduced or copied without the written permission of Bittesafe, unless specified this layout is for gutter edge protection only. Skylights are deemed as a fall hazard. Bittesafe suggest skylight covers are used.

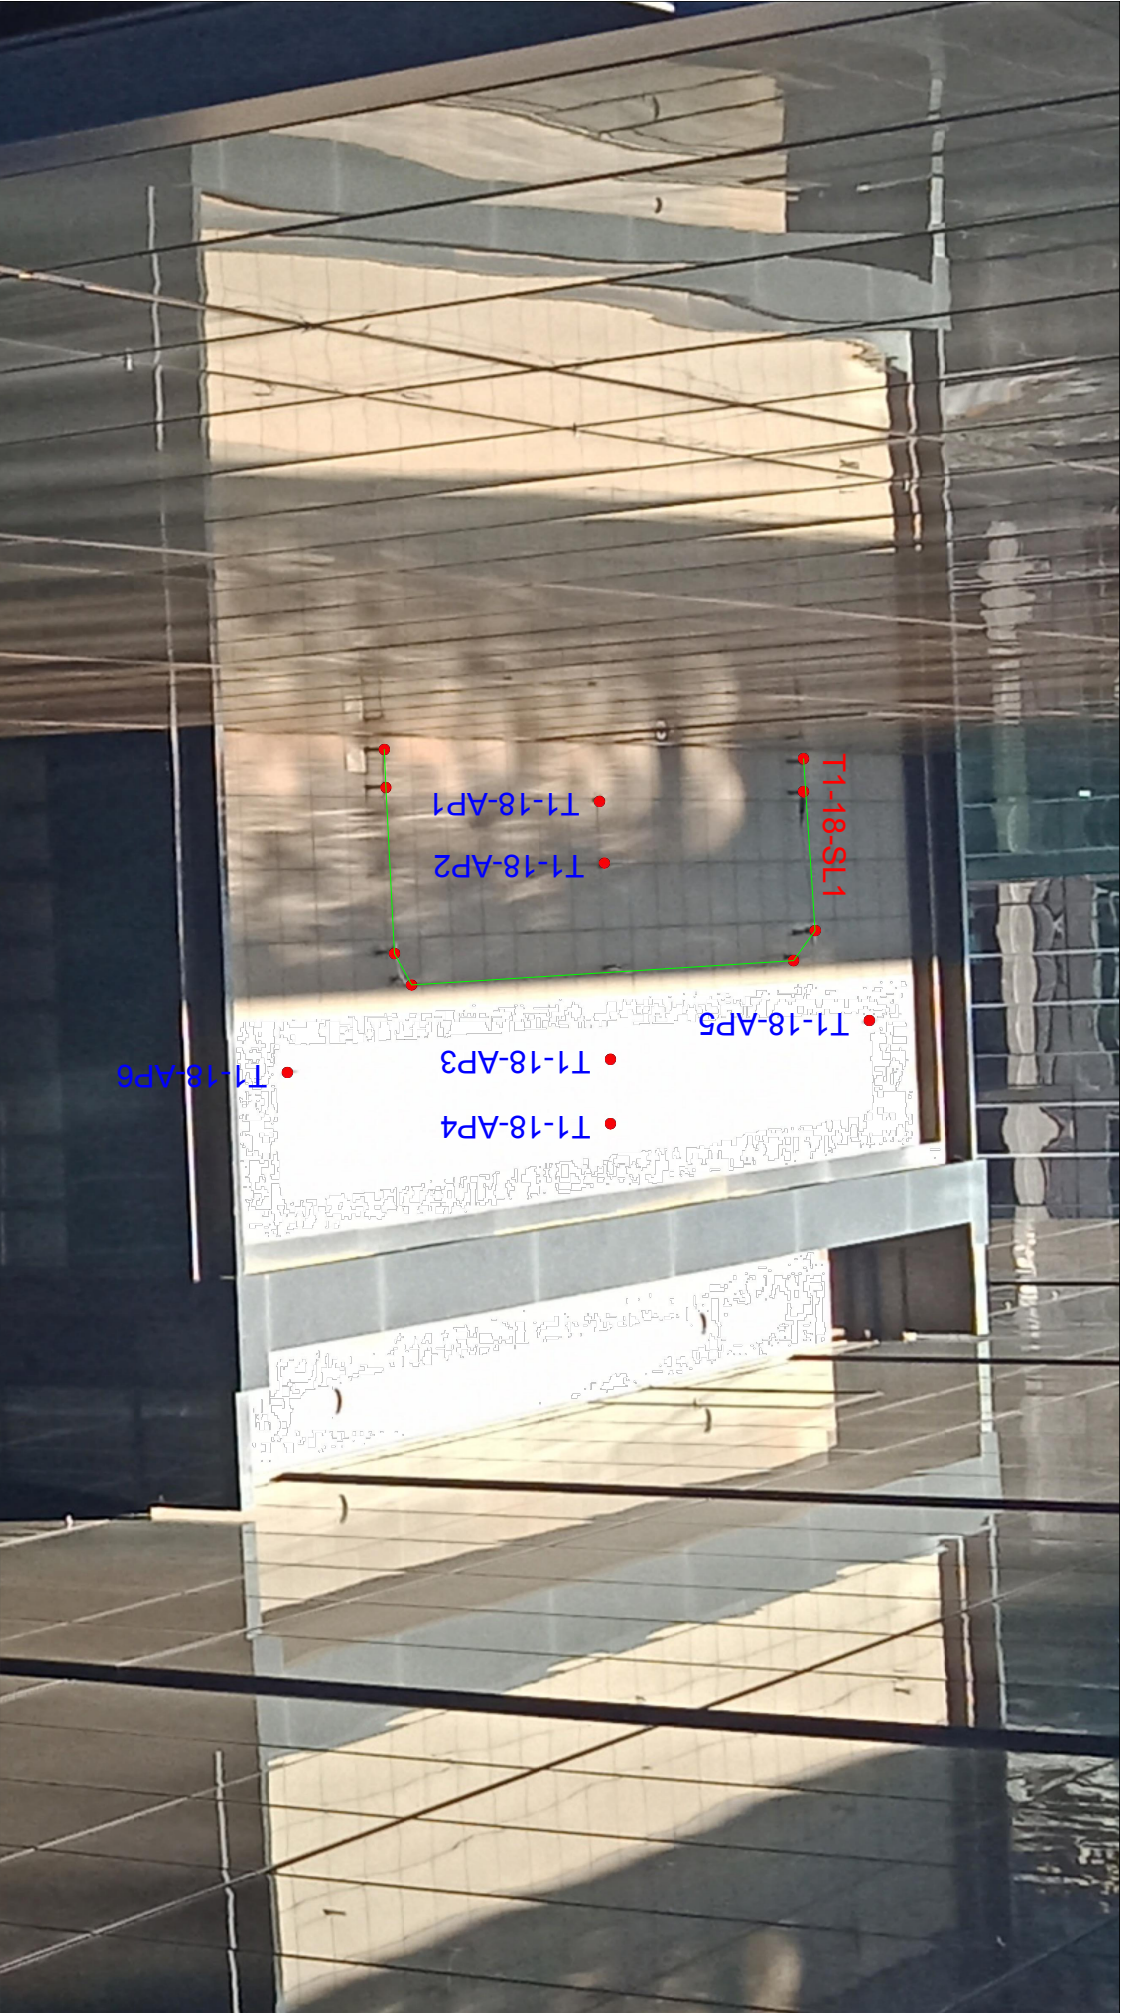
Tower 1 - Level 18

Drawn: RH	Anchor Point	●	Strop	—○—	Ladder Bracket	□	Biltresafe – The Experts in Roof Safety T: (03) 8319 6979 F: (03) 8890 0733 M: 0414 819 943 P: 3 Fockens Drive, Port Melbourne 3207
Design: RH	Static Line	●—●	Guardrail	—	Walkway	□	
Review: CB	Fixed Ladder	▨	No Access	▨	Roof Access Hatch	▨	
NTS

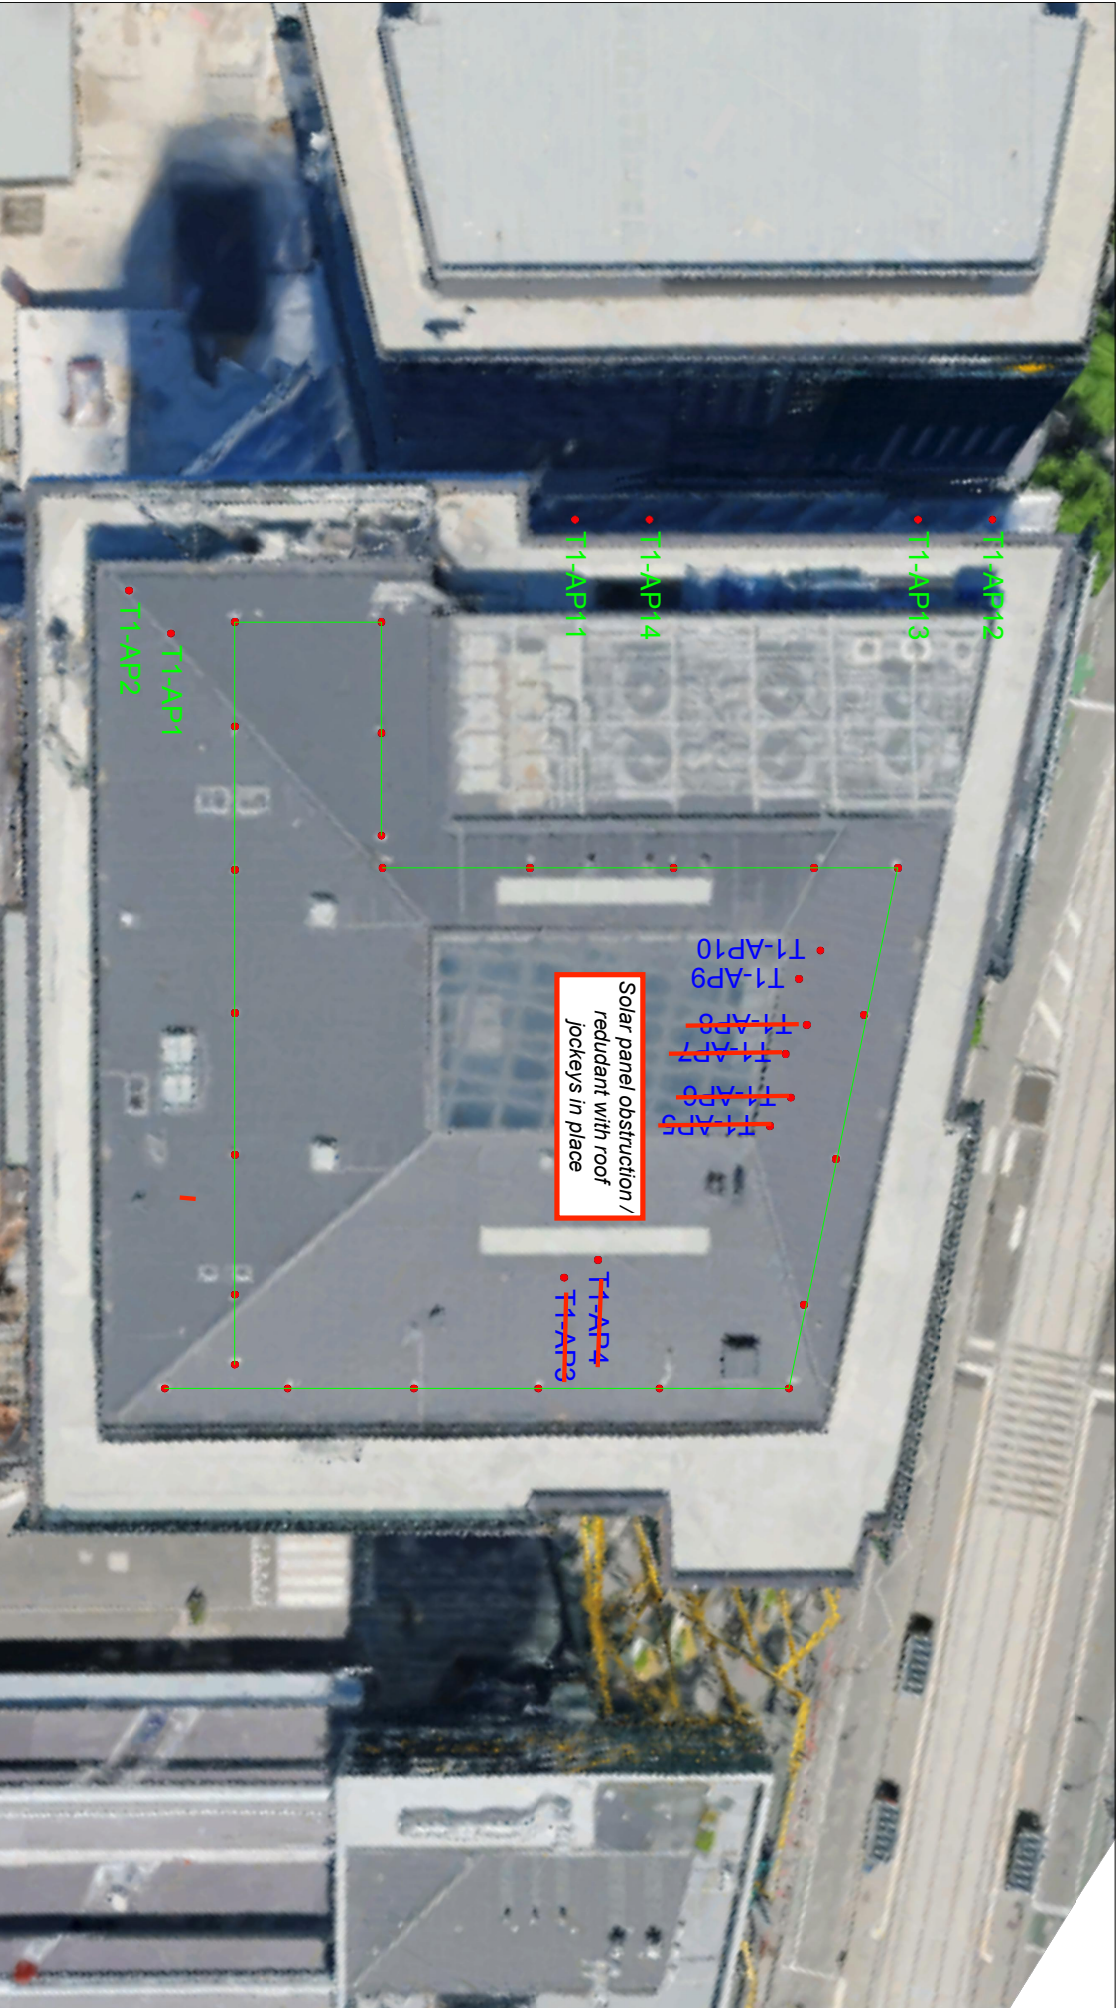
Tower 1

Drawn: RH	Anchor Point	●	Stop	○	Ladder Bracket	□	Britesafe – The Experts in Roof Safety T: (03) 8319 8979 F: (03) 8680 0733 M: 0414 549 843 P: 3 Rocklea Drive, Port Melbourne 3207
Design: RH	Static Line	●—●			Walkway	▤	
Review: CB	Guardrail	—			Roof Access Hatch	▣	
NTS	Fixed Ladder	▤			No Access	▣

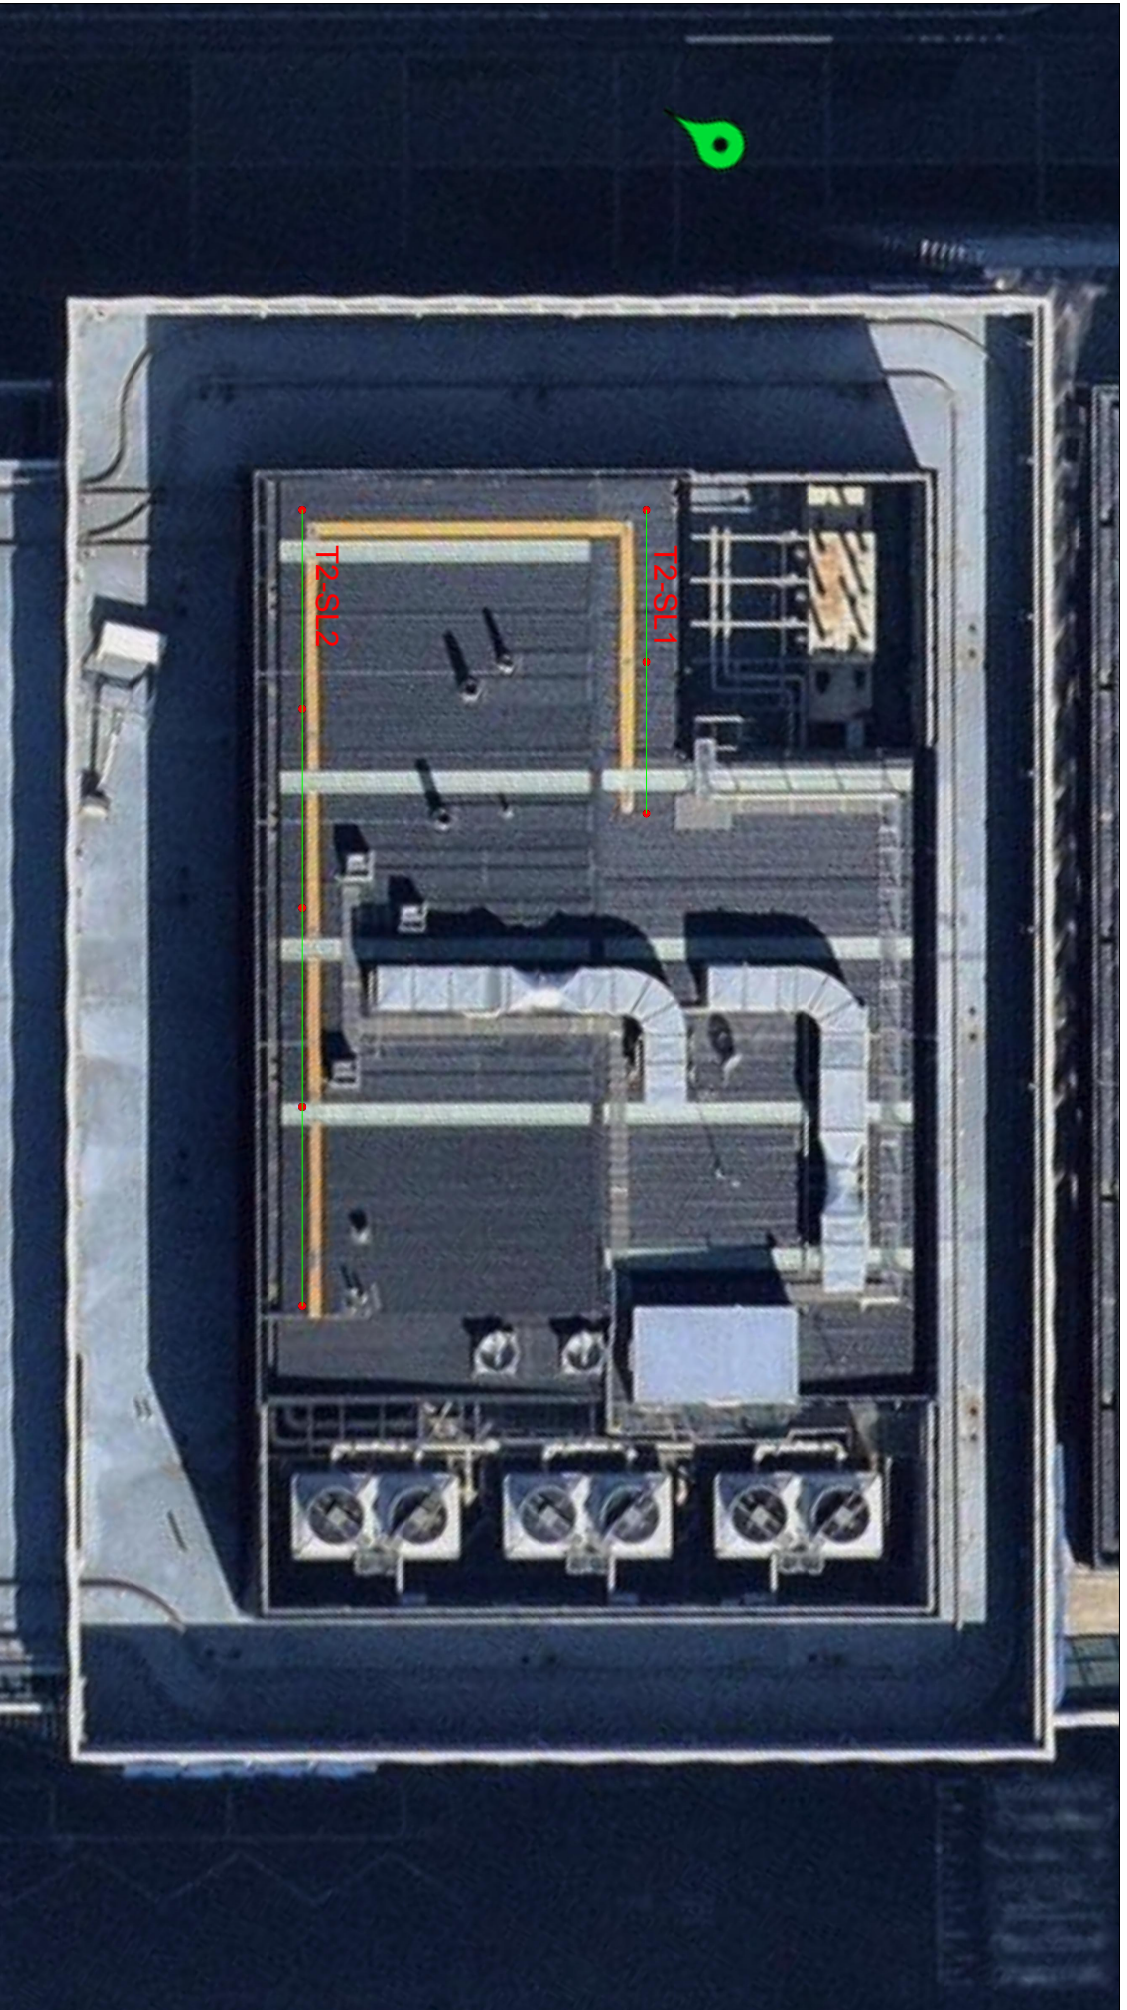
Tower 2

Drawn: RH	Anchor Point	●	Strop	○
Design: RH	Static Line	●	Strop	○
Review: CB	Guardrail	—	Strop	○
NTS	Fixed Ladder	▨	Strop	○
	Ladder Bracket	▭	Strop	○
	Walkway	▨	Strop	○
	Roof Access Hatch	▨	Strop	○
	No Access	▨	Strop	○

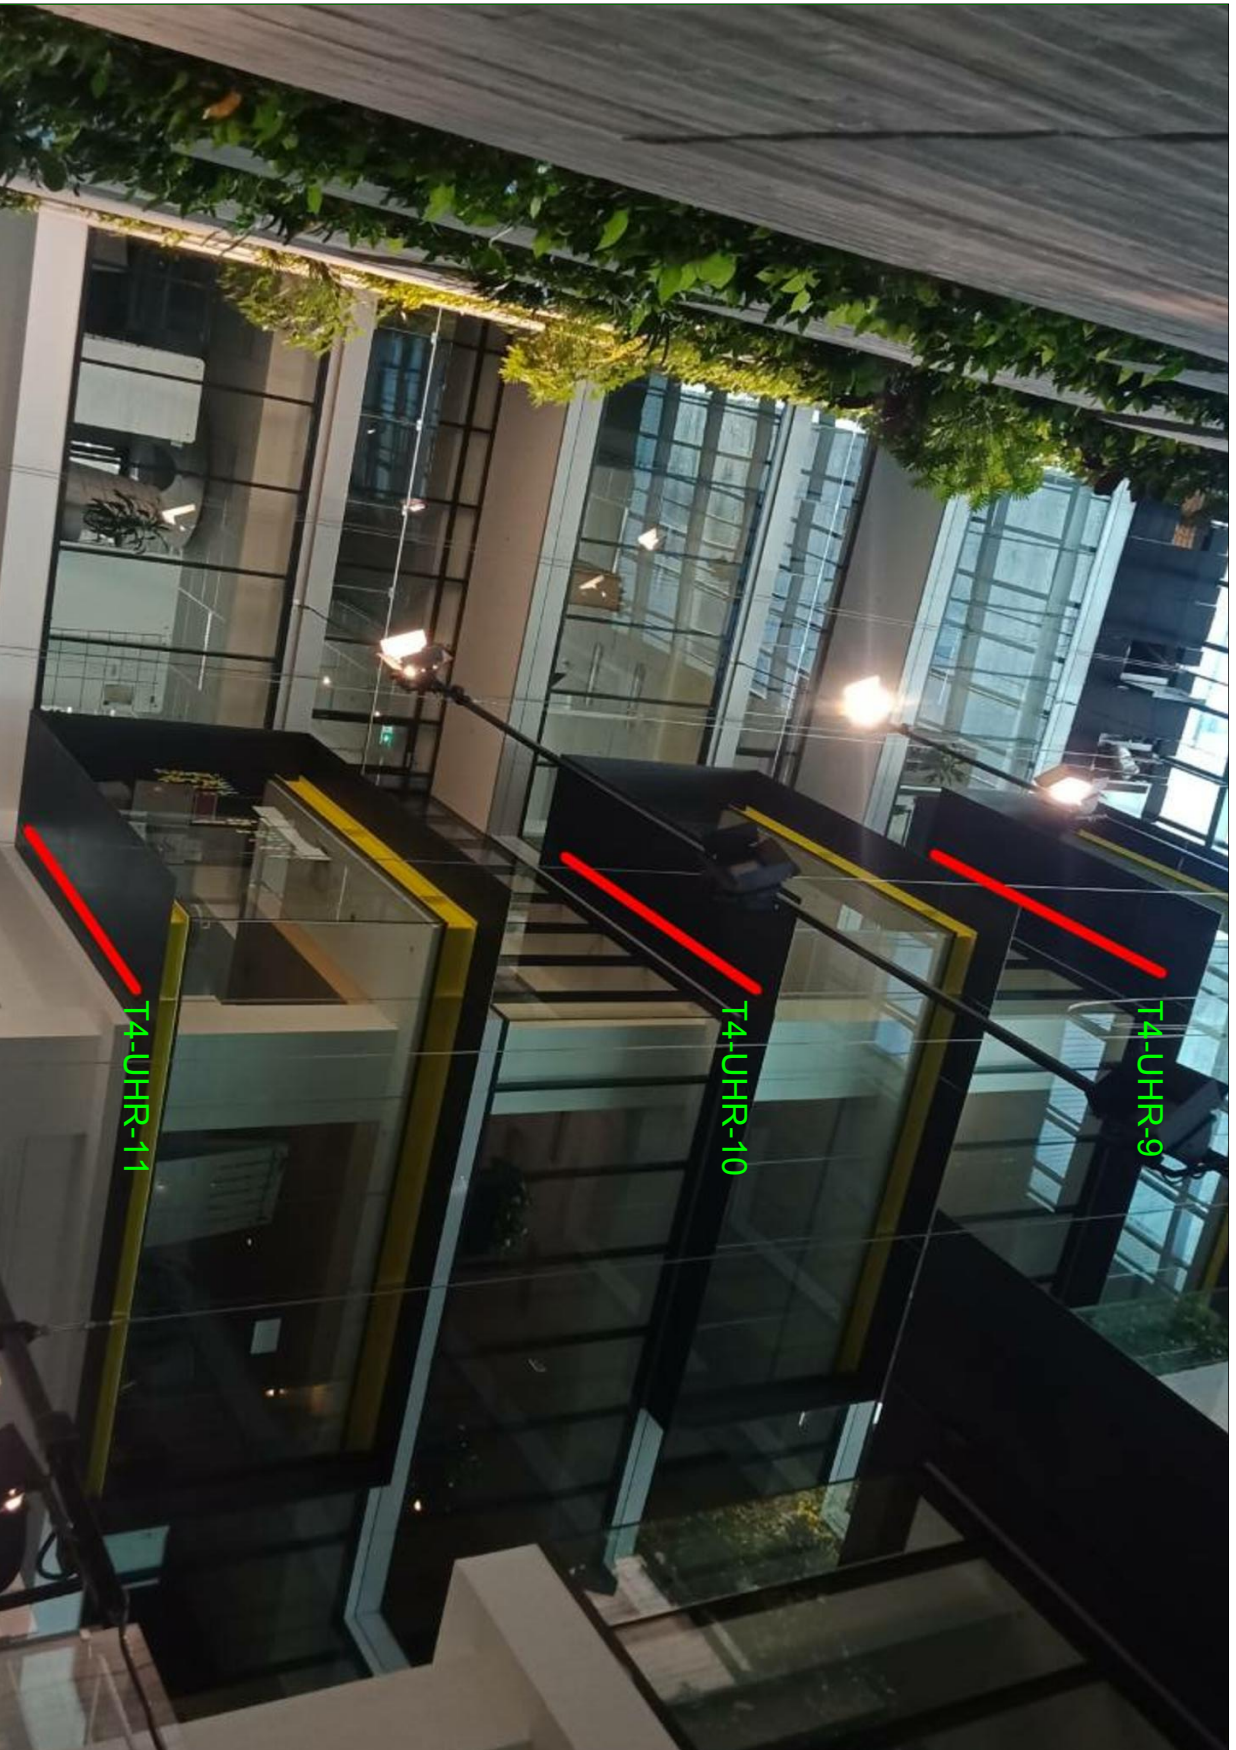
Collins Square Tower
4

- FALL ARREST ANCHOR POINT
- ROPE ACCESS ANCHOR POINT
- STROP

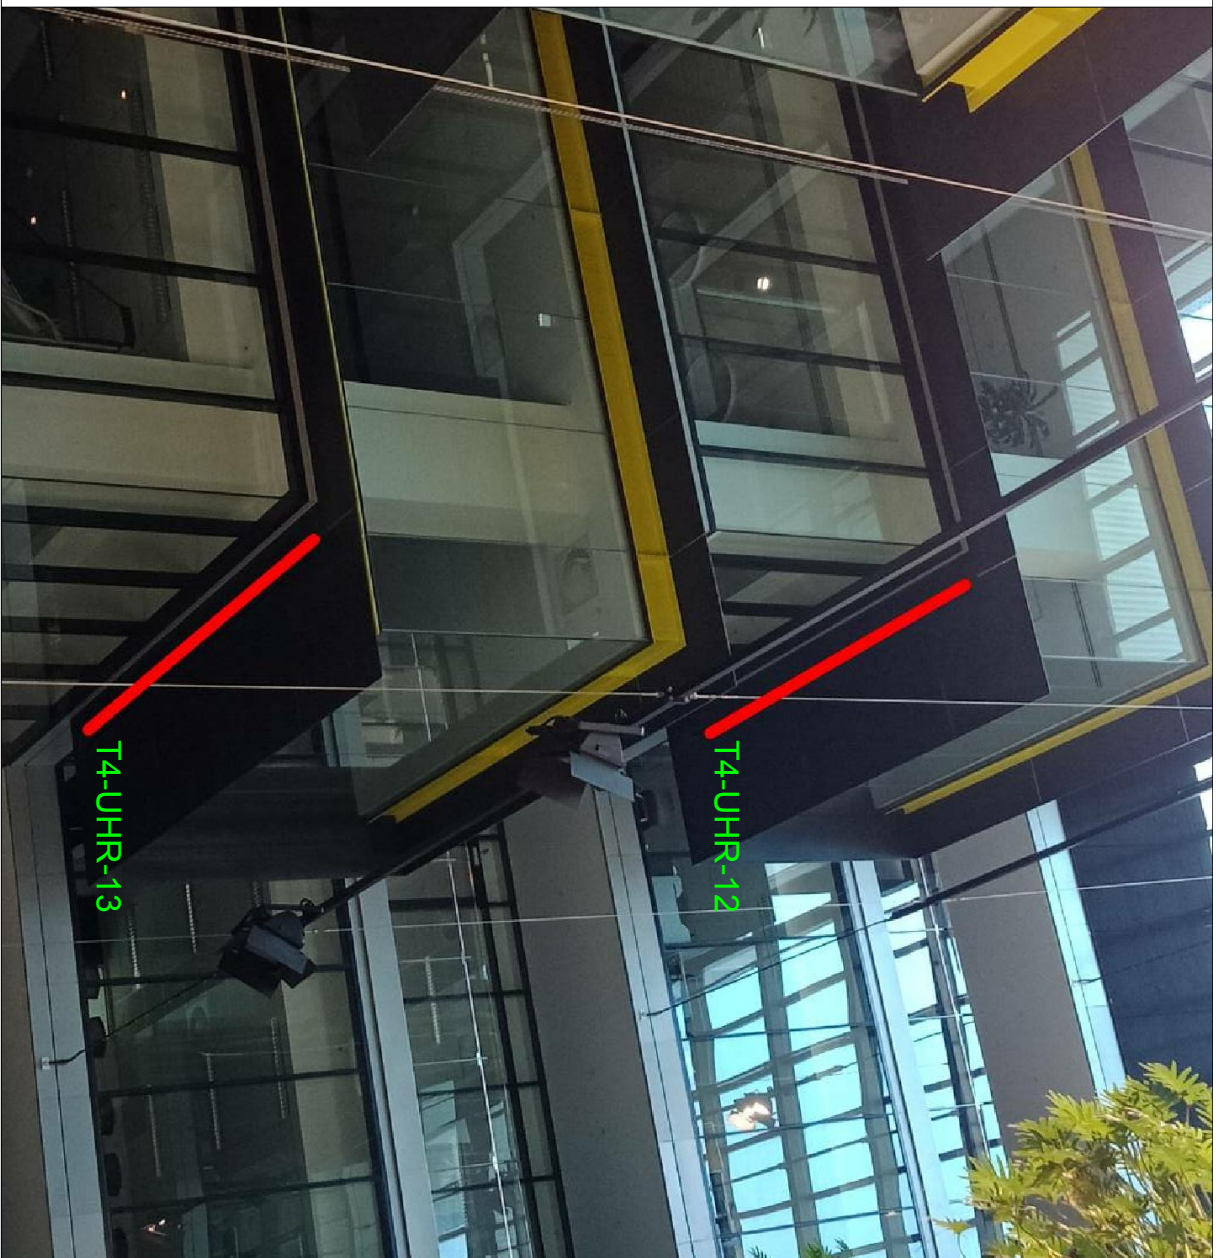
Collins Square Tower
4

- FALL ARREST ANCHOR POINT
- ROPE ACCESS ANCHOR POINT
- STROP

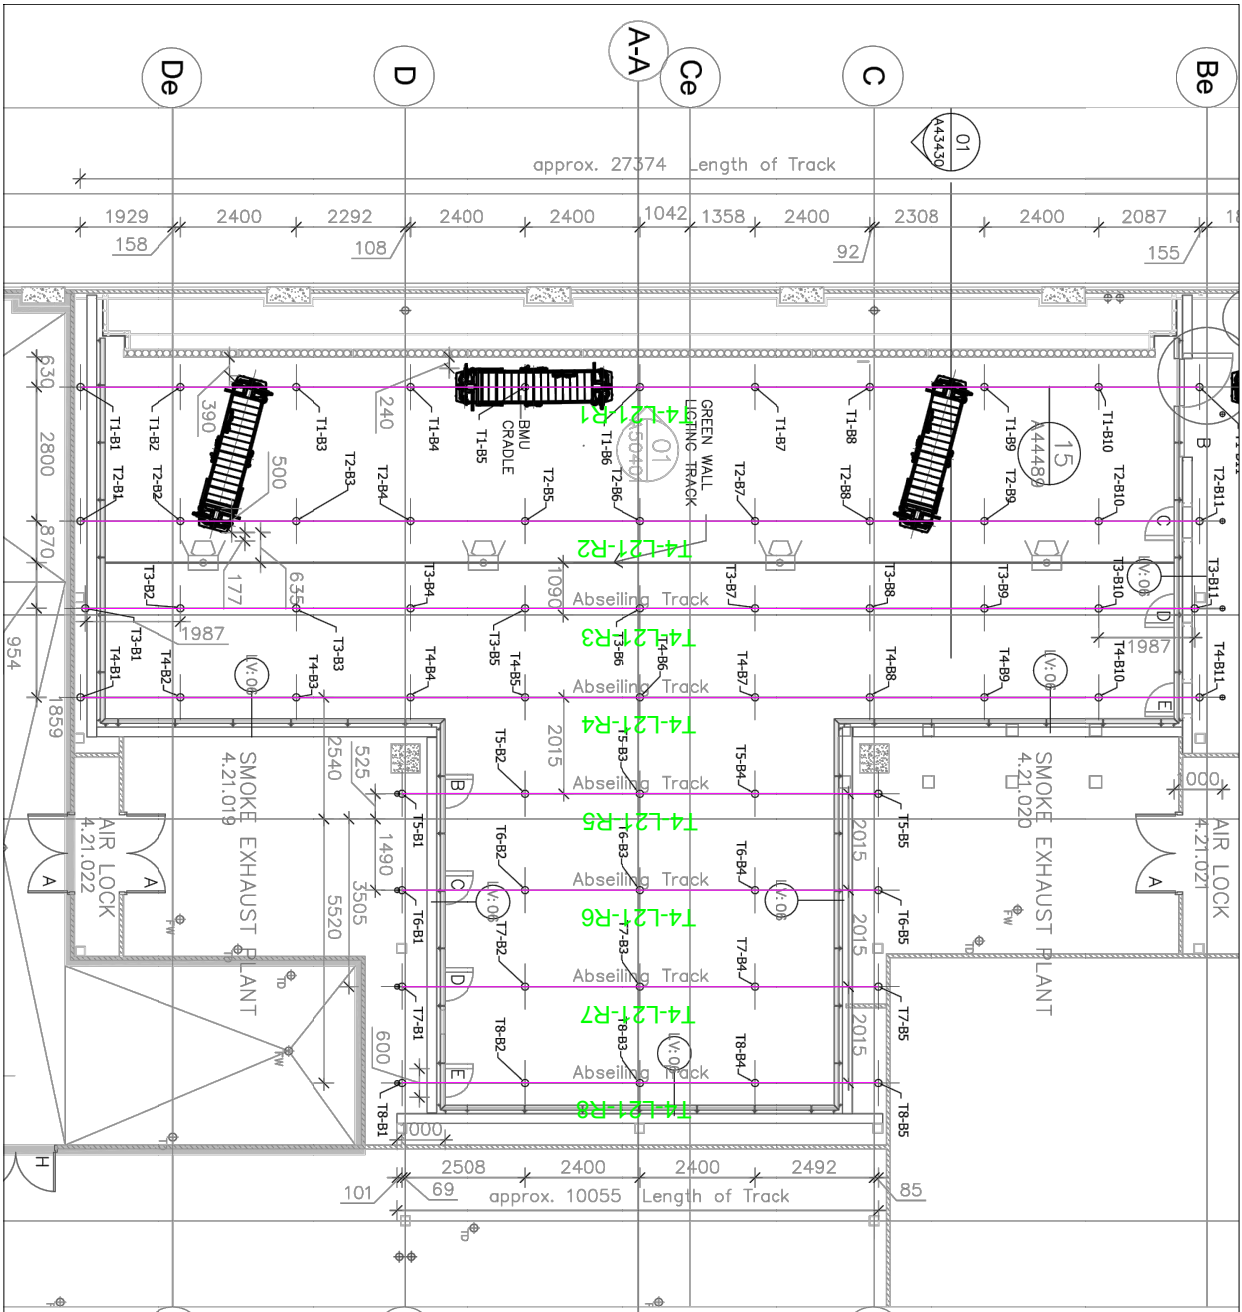
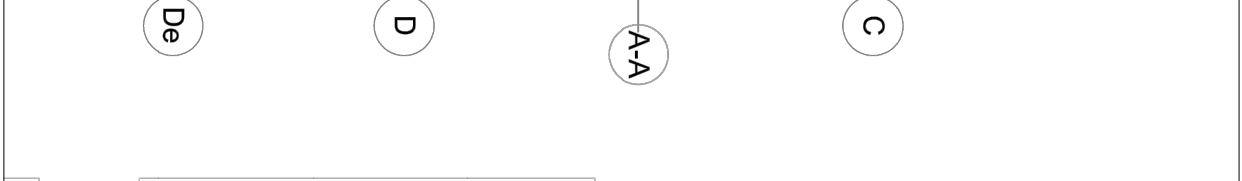
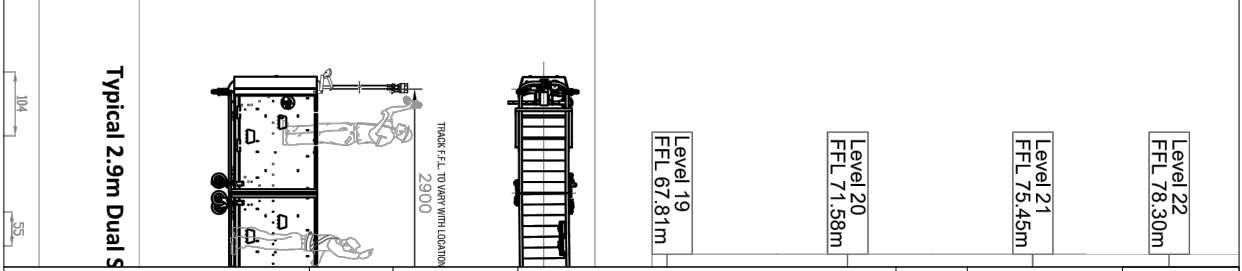
FALL ARREST ANCHOR POINT ROPE ACCESS ANCHOR POINT STROP STATIC LINE	FIXED LADDER UNDER 3.5m FIXED LADDER OVER 3.5m LADDER BRACKET ROOF HATCH
RAPTOR RAIL WALKWAY NO ACCESS	Tower 4 Atrium
