2024 Fall Arrest / Rope Access System
Inspection Report

Collins Square

Project Name:	CSQ Annual Inspection
Address:	727 Collins Street
Client:	Walker
Client Contact:	Stewart Calder
Certification Date:	17/12/2024
Certification Expiry:	12 Months from the certification date

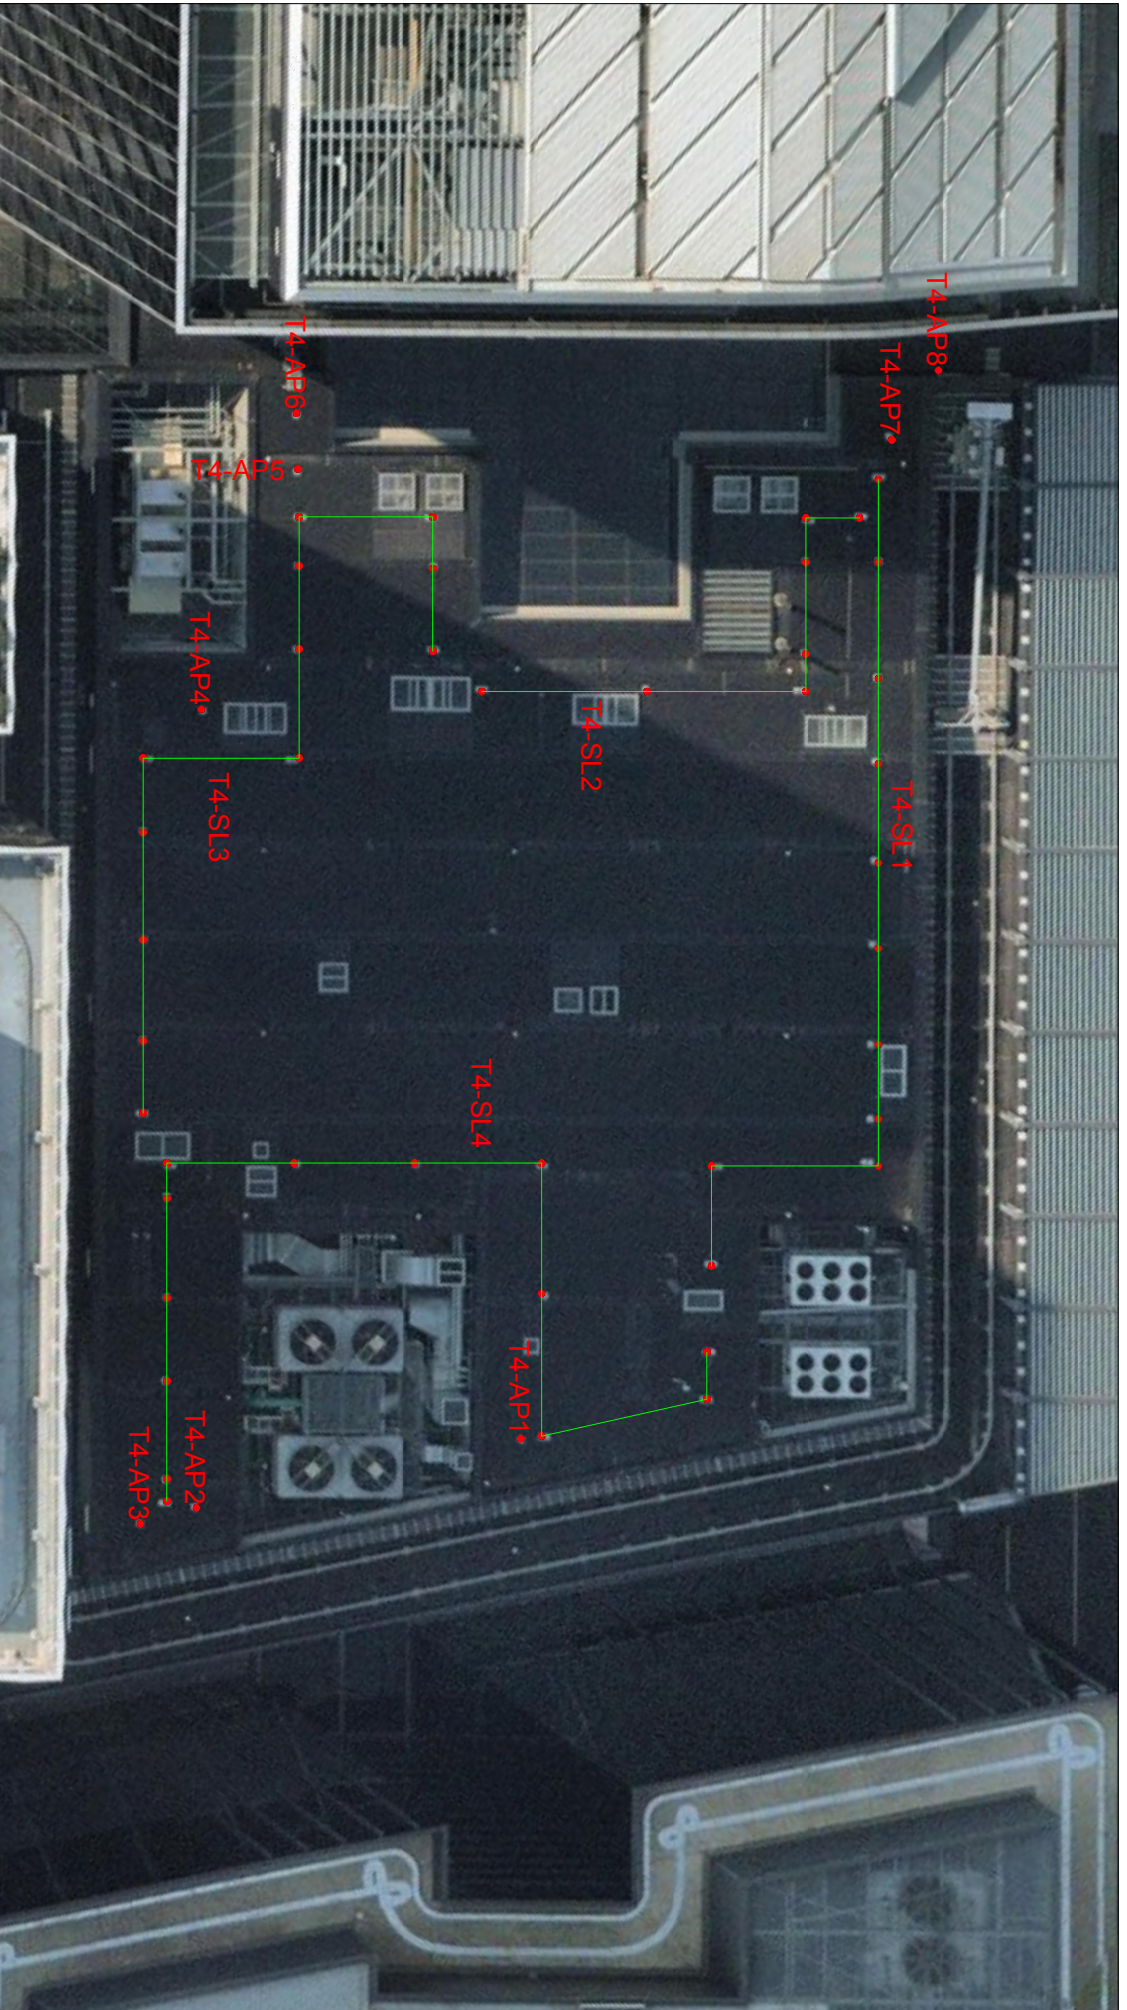
Tower 4

Drawn: RH	Anchor Point	●	Strop	—○
Design: RH	Static Line	●—●	Walkway	—□
Review: CB	Guardrail	—	Roof Access Hatch	—△
NTS	Fixed Ladder	—	No Access	—X

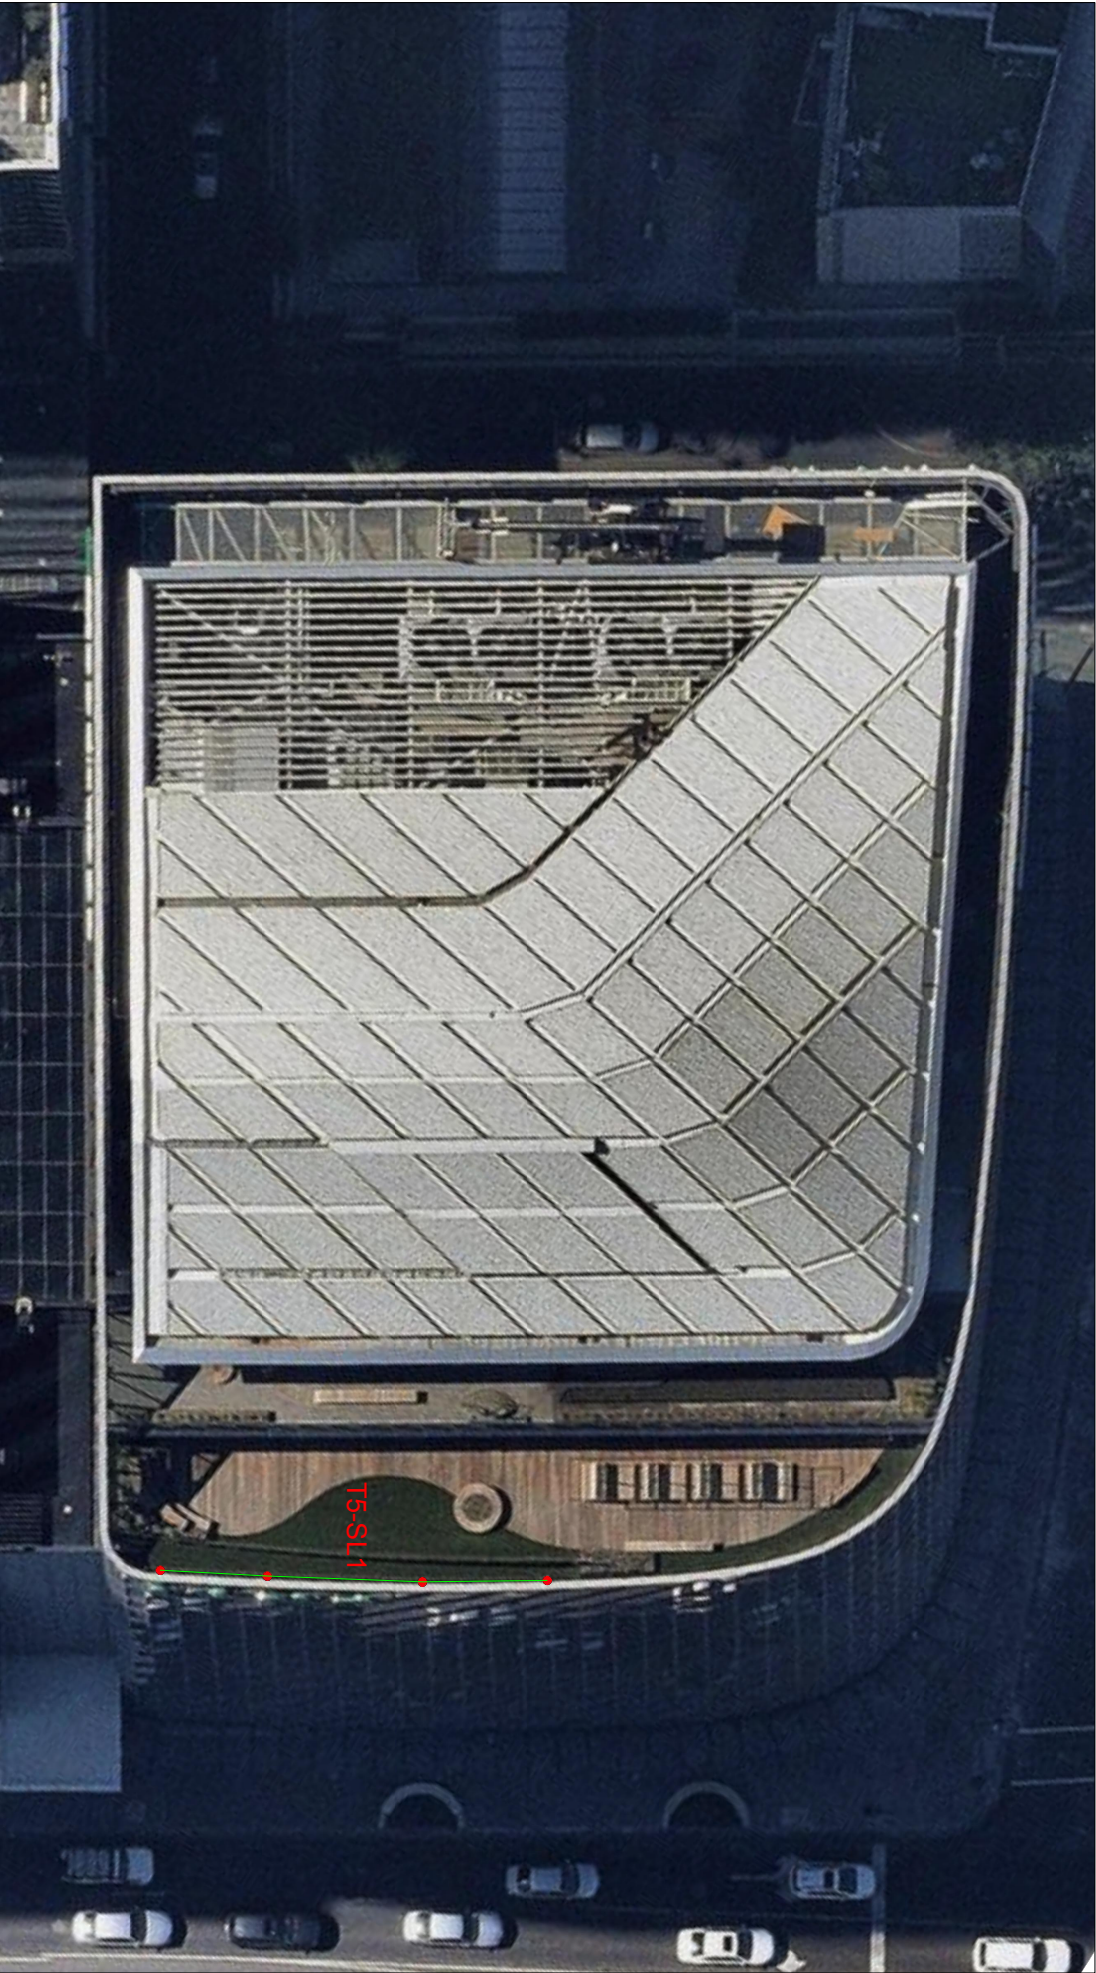
Tower 5

Drawn: RH	Anchor Point	●	Stop	○	Ladder Bracket	□	Britesafe – The Experts in Roof Safety T: (03) 8319 0979 F: (03) 8060 0733 M: 0414 549 843 P: 1 Rocklea Drive, Fort Meador, 3207
Design: RH	Static Line	●—●			Walkway	▤	
Review: CB	Guardrail	—			Roof Access Hatch	▣	
NTS	Fixed Ladder	▤			No Access	▣
